Harrison Park Detention Pond Failure – Lessons Learned

2022 IAFSM Conference – March 8, 2022

Harrison Park Detention Pond Failure

June 19, 2009

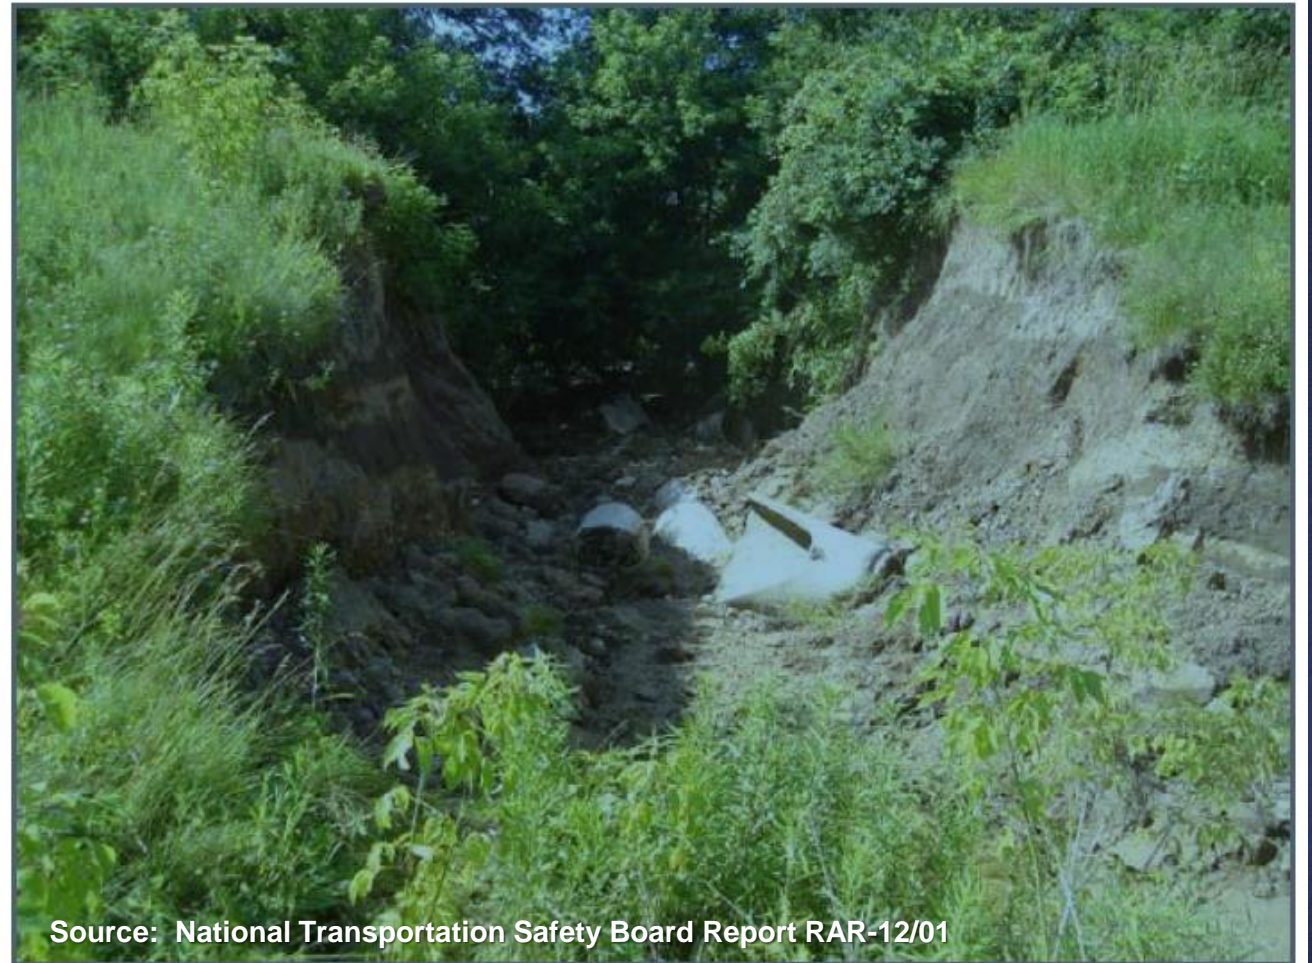
Post-breach Condition

- Breach measured 12-ft high 18-ft wide
- Local newspaper reported that investigators believed 80 percent of the pond drained in 14 minutes, between 7:01 and 7:15 p.m. (~9 ac-ft)
- Looking downstream.

Figure 16. Postaccident photograph showing breach in SWM pond 1 as viewed from inside pond looking south.

- April 2008, bid to repair the damage for **\$23,436**.
- 2009, the association agent began assessing Harrison Park landowners to pay for the repairs.
- June 2009 (failure), balance in the repair fund was **\$23,288.11**.
- September 3, 2009, breach was repaired at a cost of **\$23,500**.

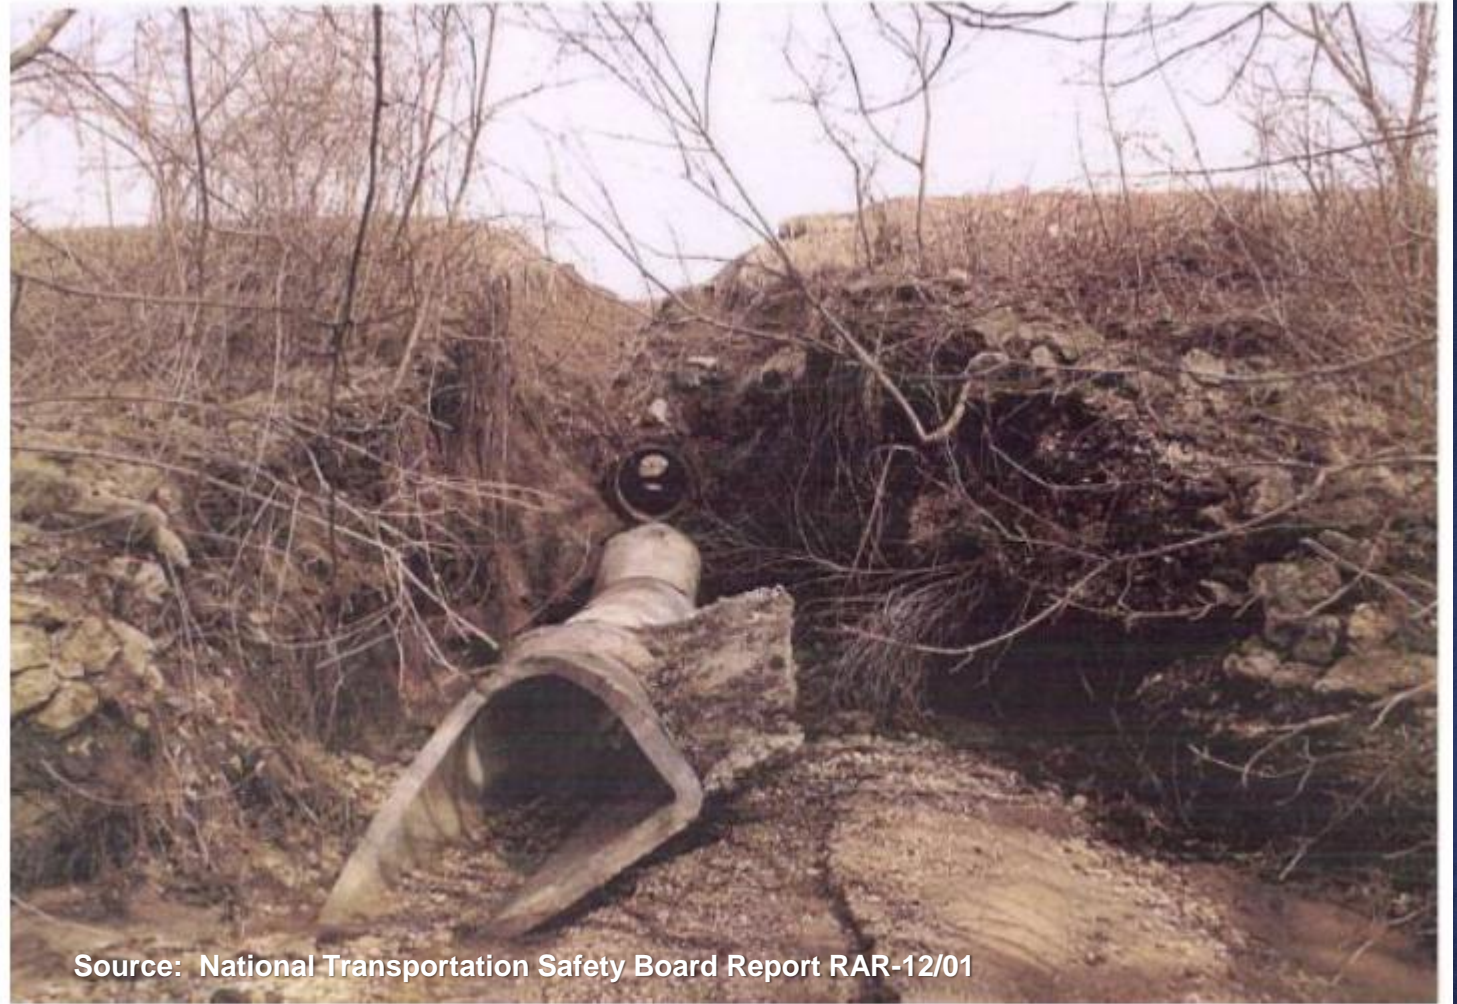
Pre-breach Condition

- **Photo dated April 2008**
 - Looking upstream
- **Failure June 2009**

Figure 17. View looking north from downstream end of outlet area of SWM detention pond 1 showing erosion over top of outlet culvert and erosion below outlet. (Photo taken in April 2008.)

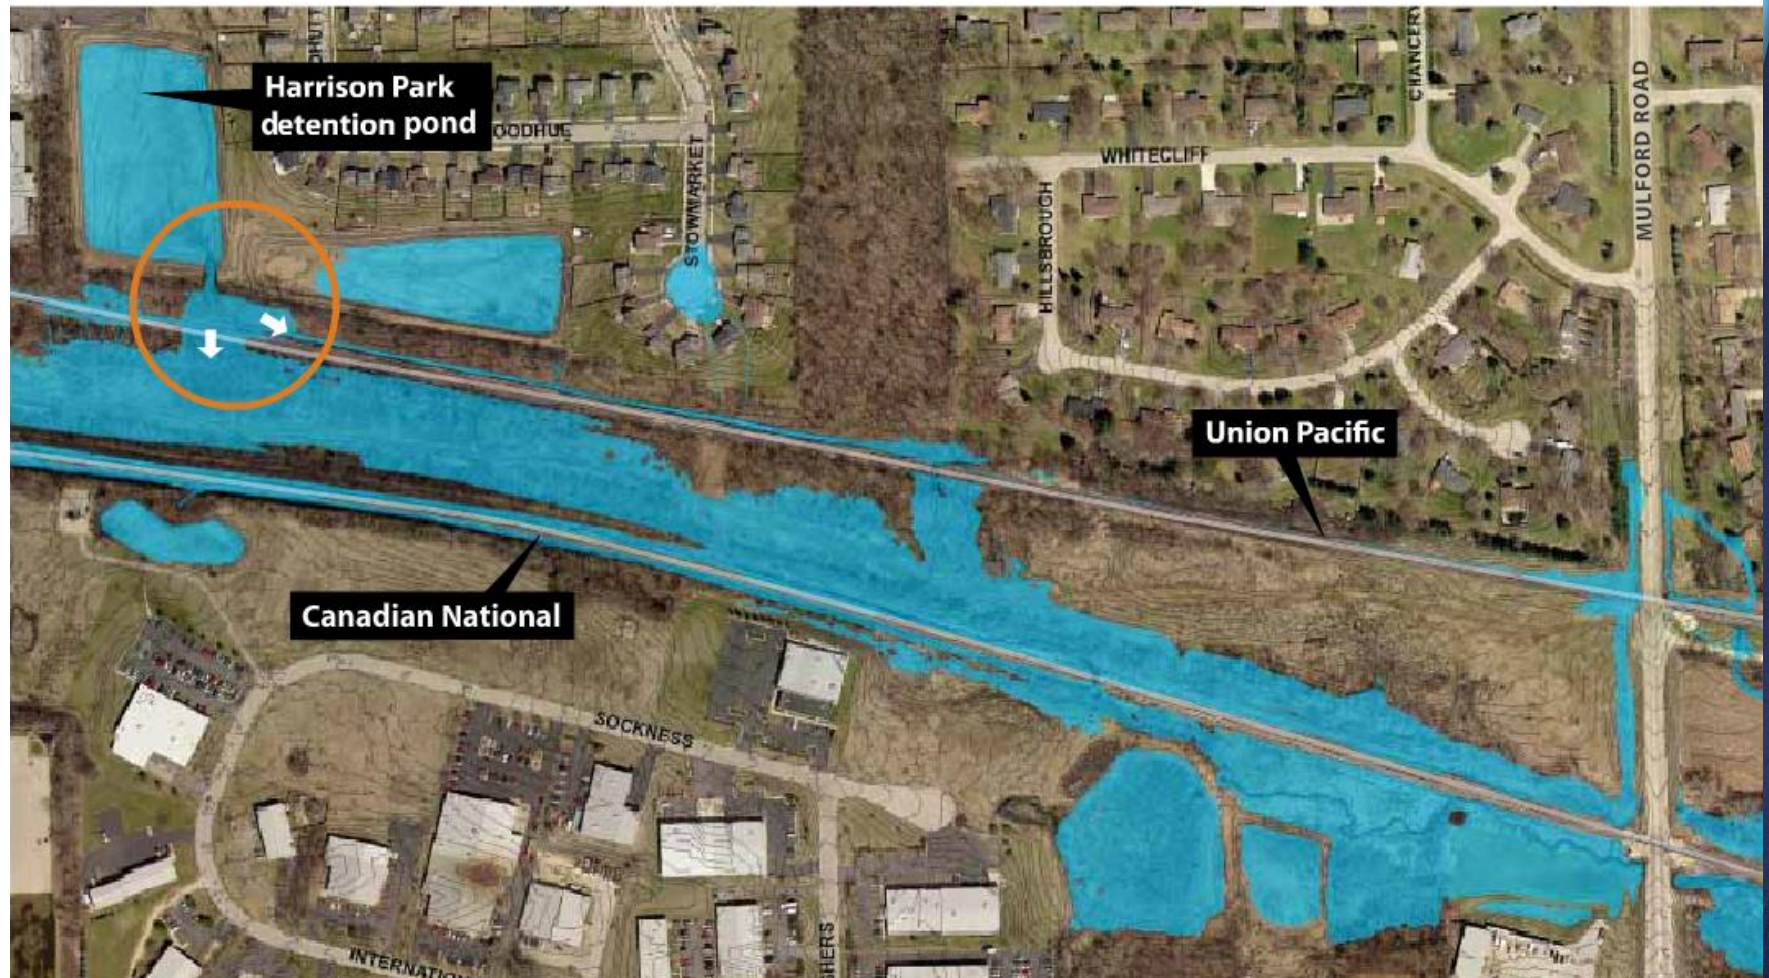
7:01-7:02 p.m. Water breaches the southeast corner of a Harrison Park stormwater detention pond. The pond releases 2.9 million gallons of water — enough to cover each of seven football with a foot of water.

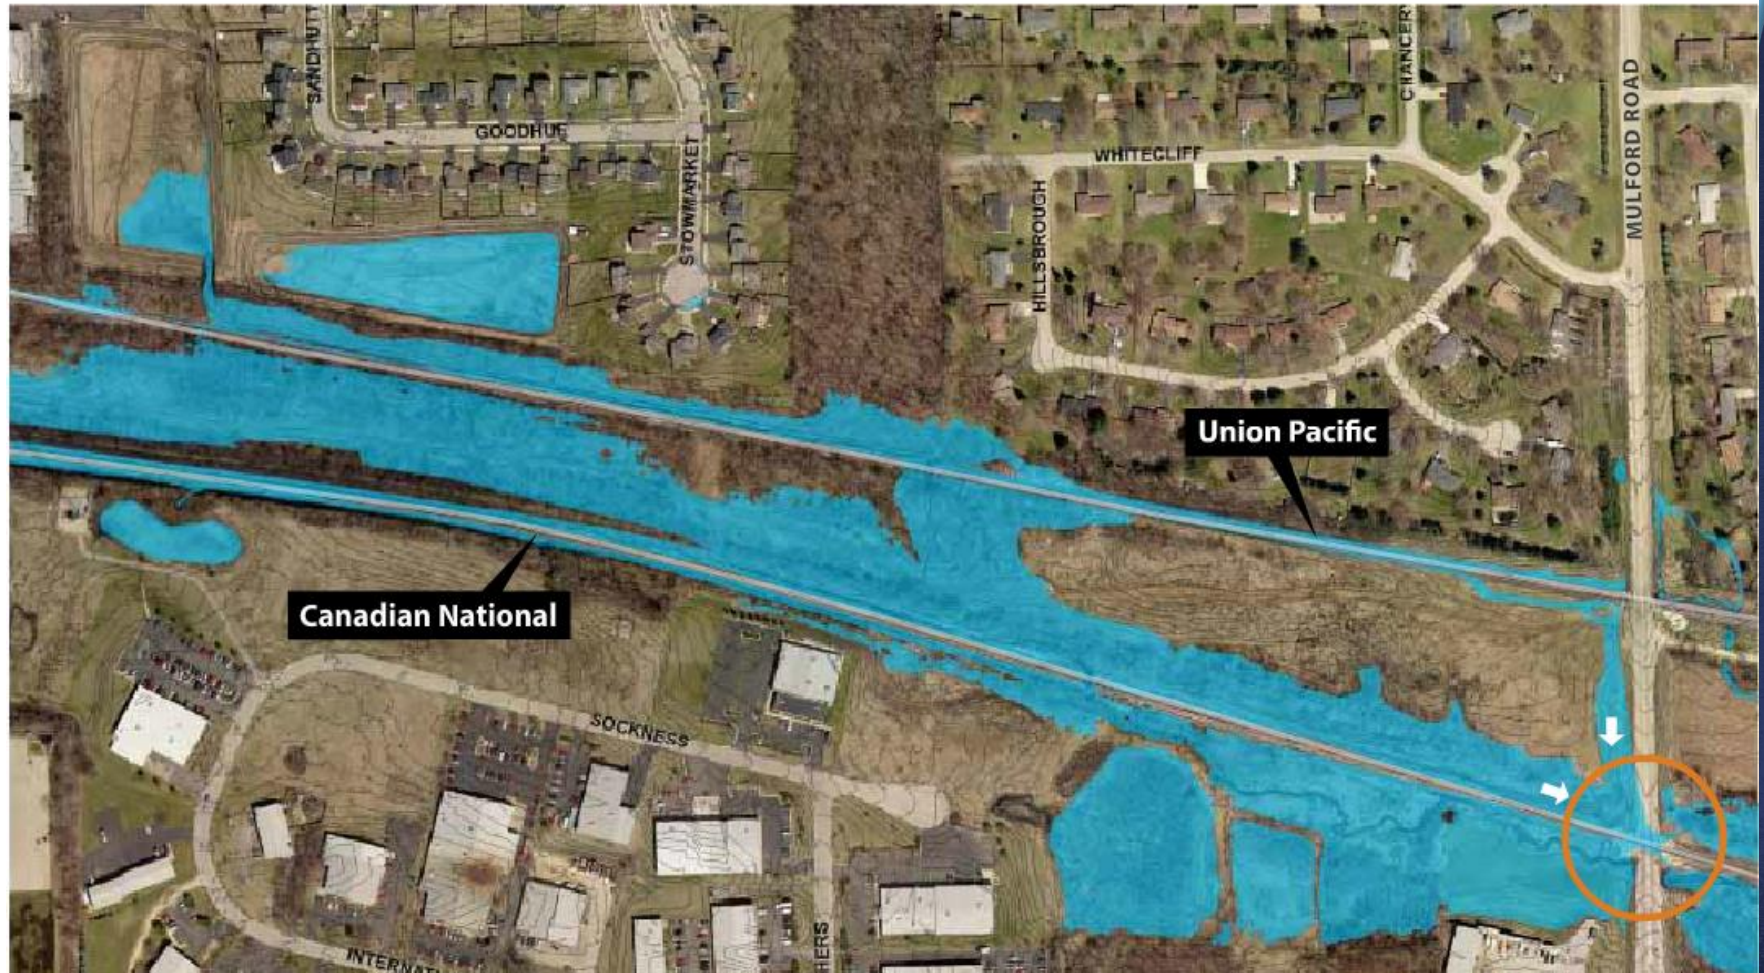
7:26 p.m. Most of the water in the Harrison Park detention pond has drained. Water reaches its maximum depth at South Mulford, washing out tracks where the Canadian National train would derail 70 minutes later.

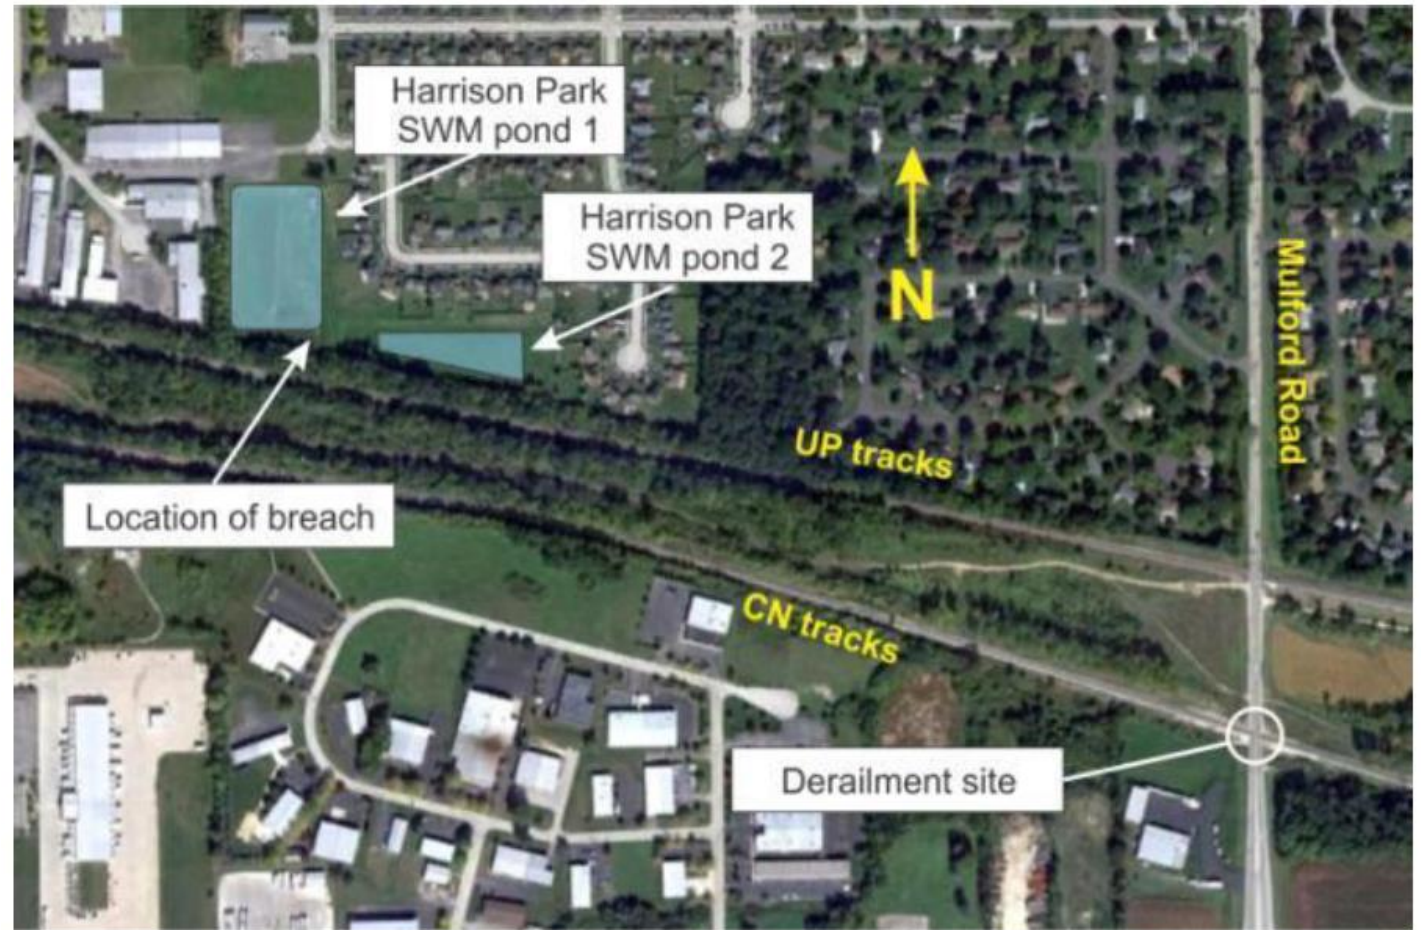
- 458-ft x 306-ft
- Designed for 100-year event
- The recorded plat of the Harrison Park subdivision notes that "the maintenance of the drainage and storm water detention easement shall be the sole responsibility of the individual property owner."

Figure 15. Aerial view showing location of Harrison Park subdivision detention ponds in relation to accident site.

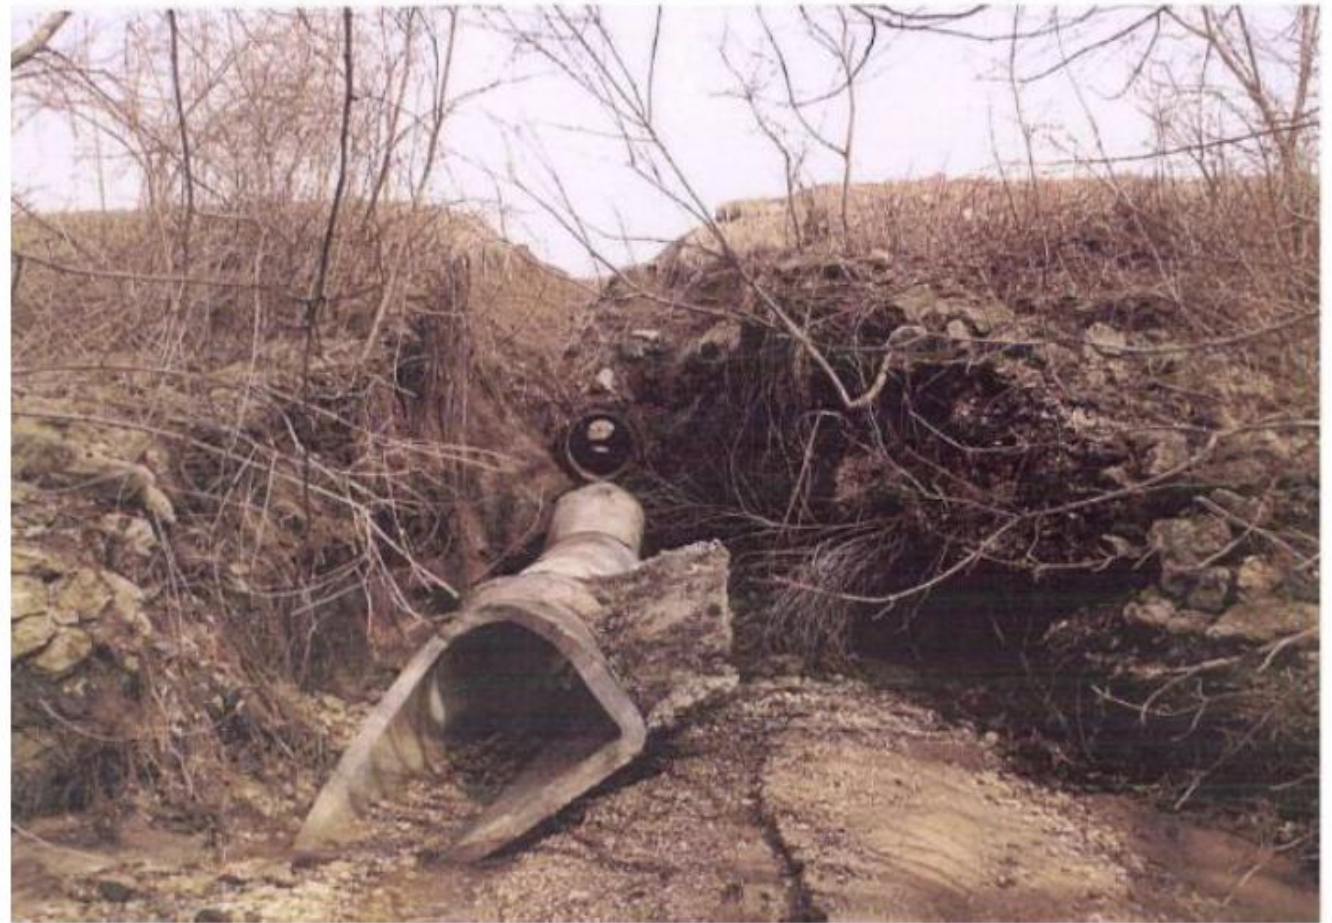
Figure 17. View looking north from downstream end of outlet area of SWM detention pond 1 showing erosion over top of outlet culvert and erosion below outlet. (Photo taken in April 2008.)

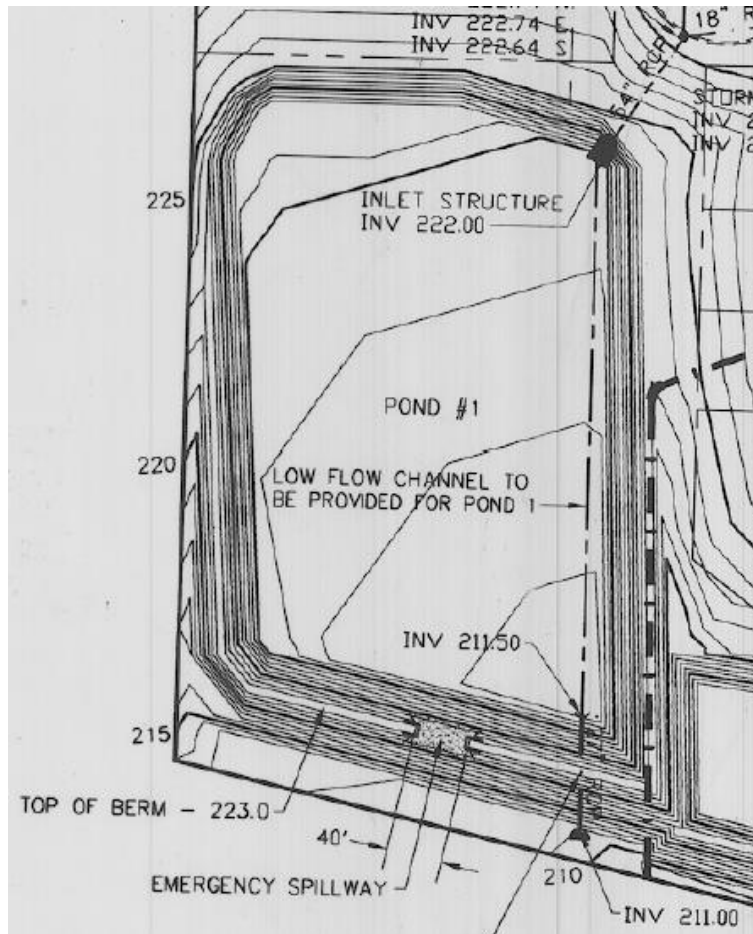
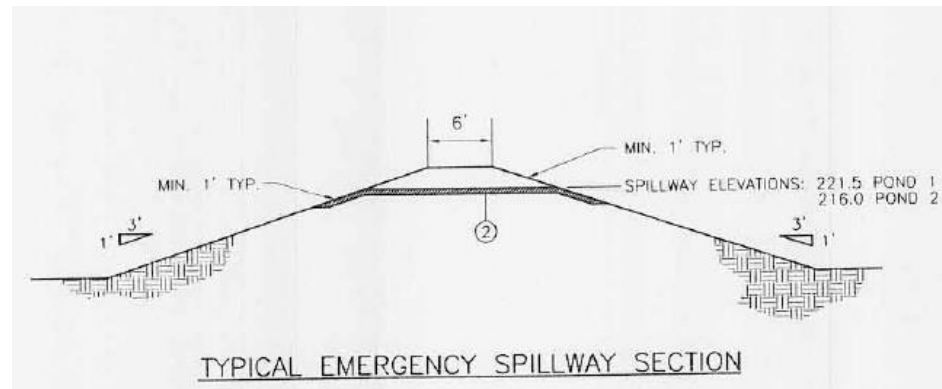
Record Drawings of Pond 1

- Date of Plans: June 1997
- Reported 100-year design capacity
- Invert: 211.5-ft
- Top of Berm: 223.0-ft (11.5-ft deep at outlet)
- Emergency Spillway: 221.5-ft 40-ft wide (1.5-ft freeboard)
- Rock protection at outlet and emergency spillway.

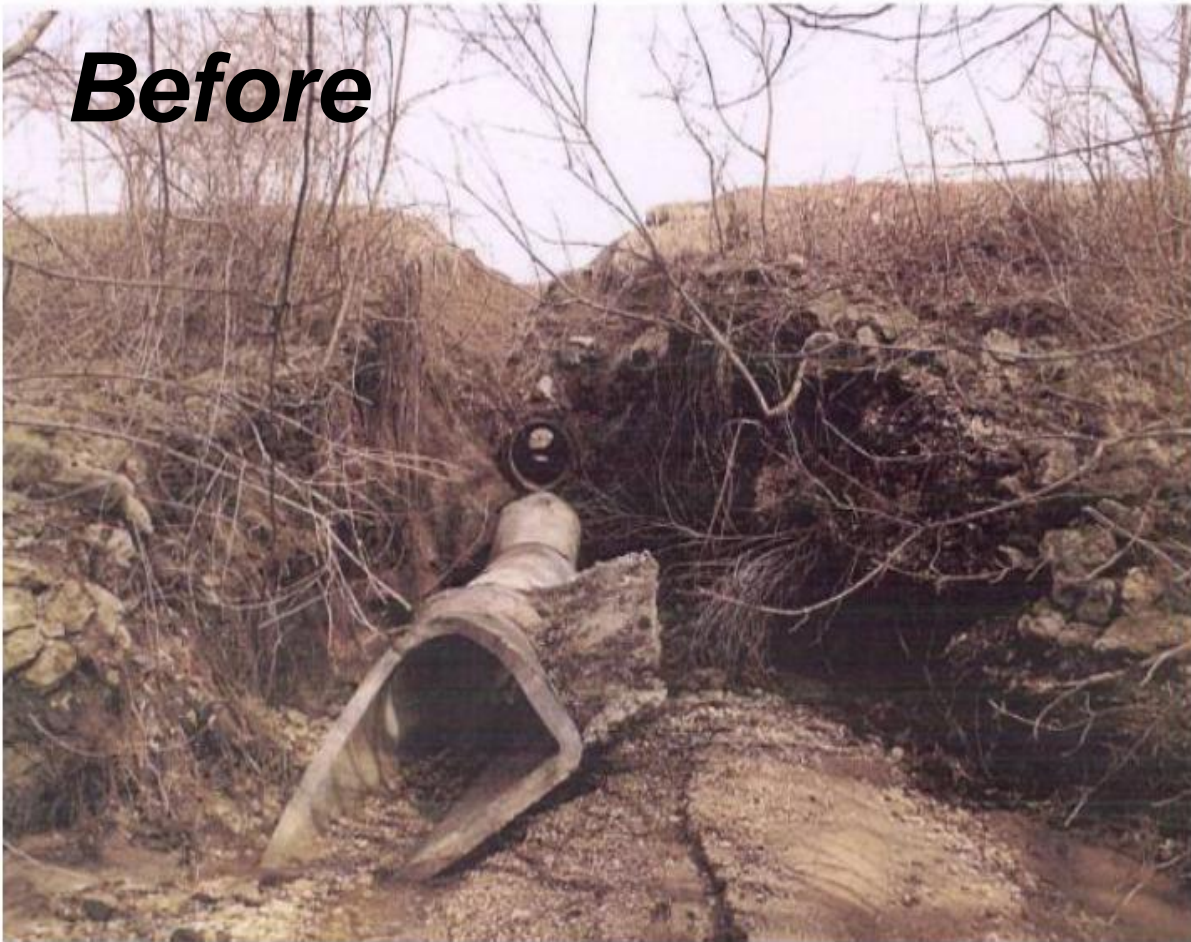
Figure 17. View looking north from downstream end of outlet area of SWM detention pond 1 showing erosion over top of outlet culvert and erosion below outlet. (Photo taken in April 2008.)

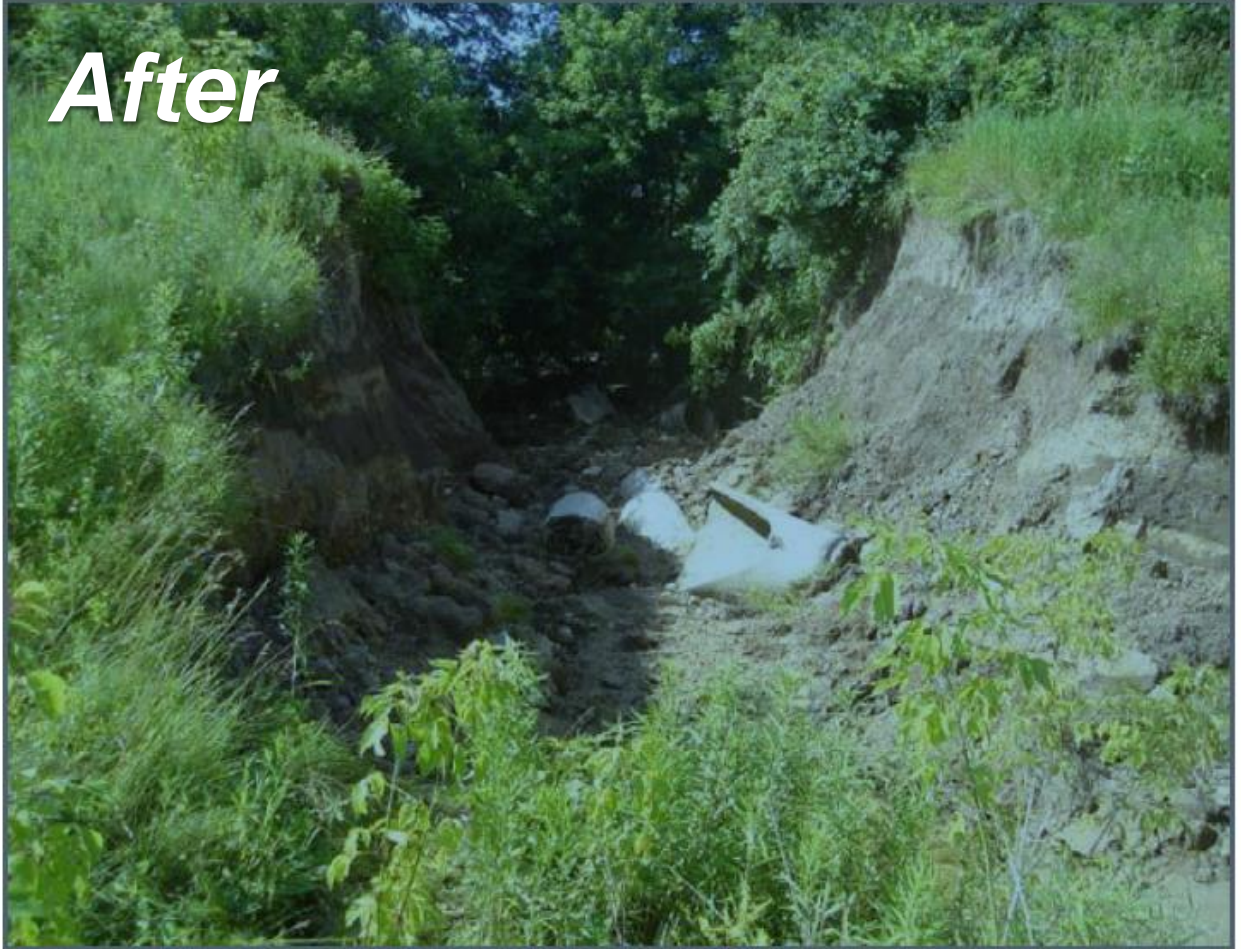
Figure 16. Postaccident photograph showing breach in SWM pond 1 as viewed from inside pond looking south.
