Coal Combustion Waste Impoundment Evaluations in Illinois

By Cleighton Smith, PE, CFM, Dewberry

Presented to IAFSM Conference

March 2011

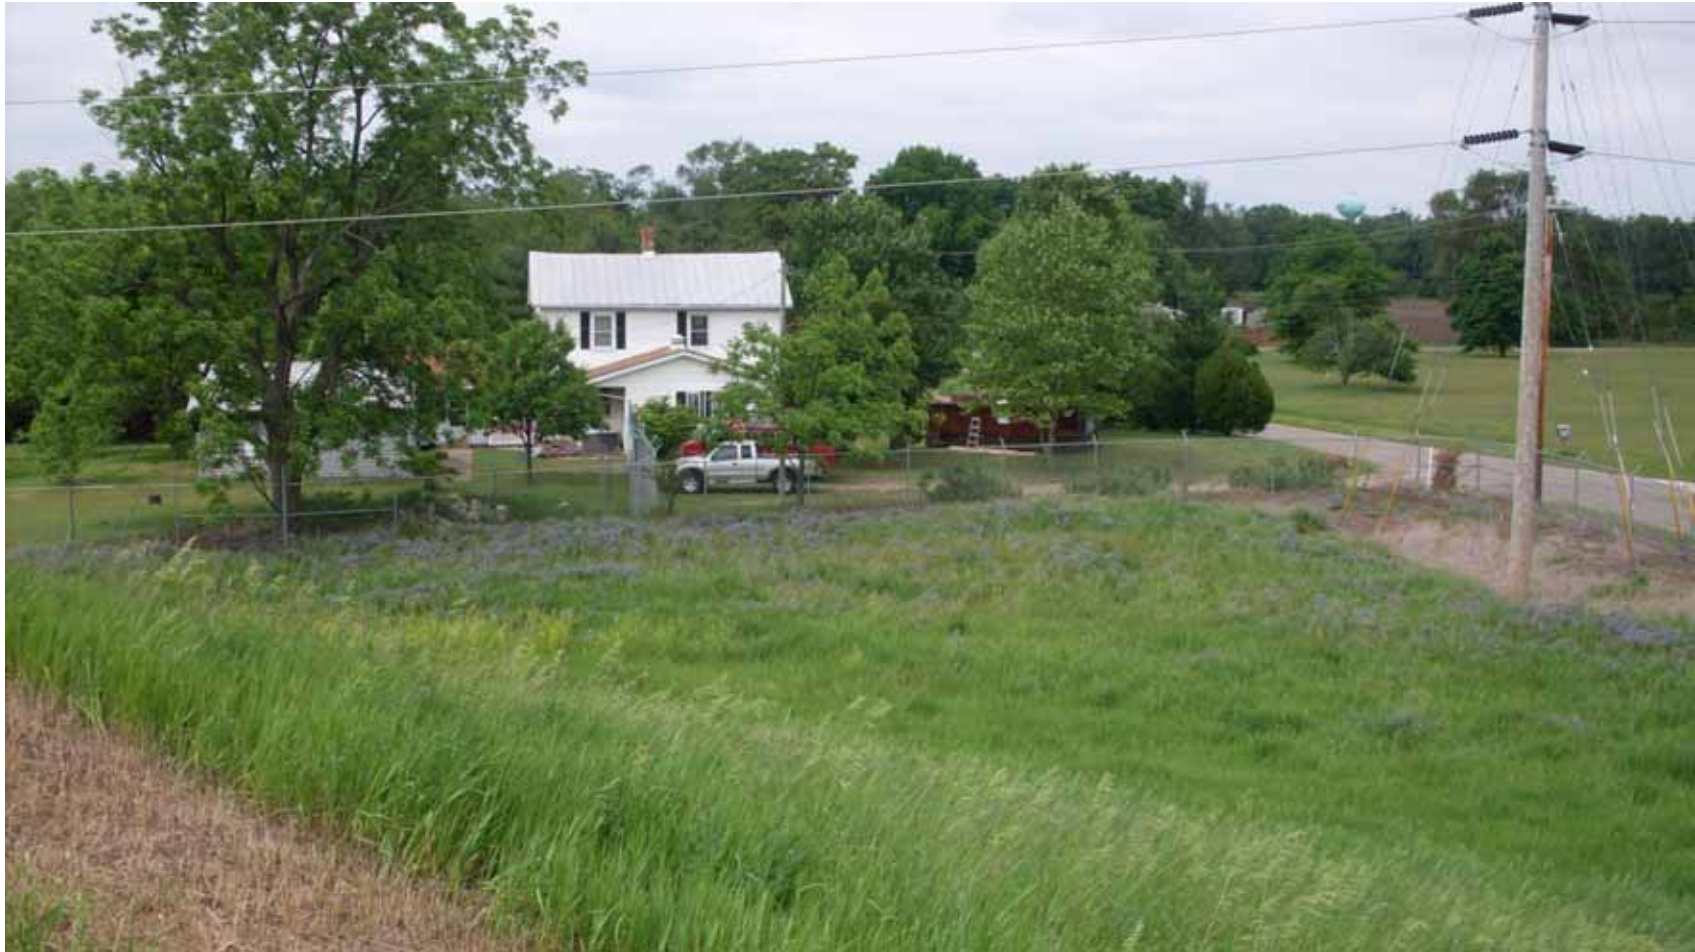
Havana Photo – home near toe of embankment

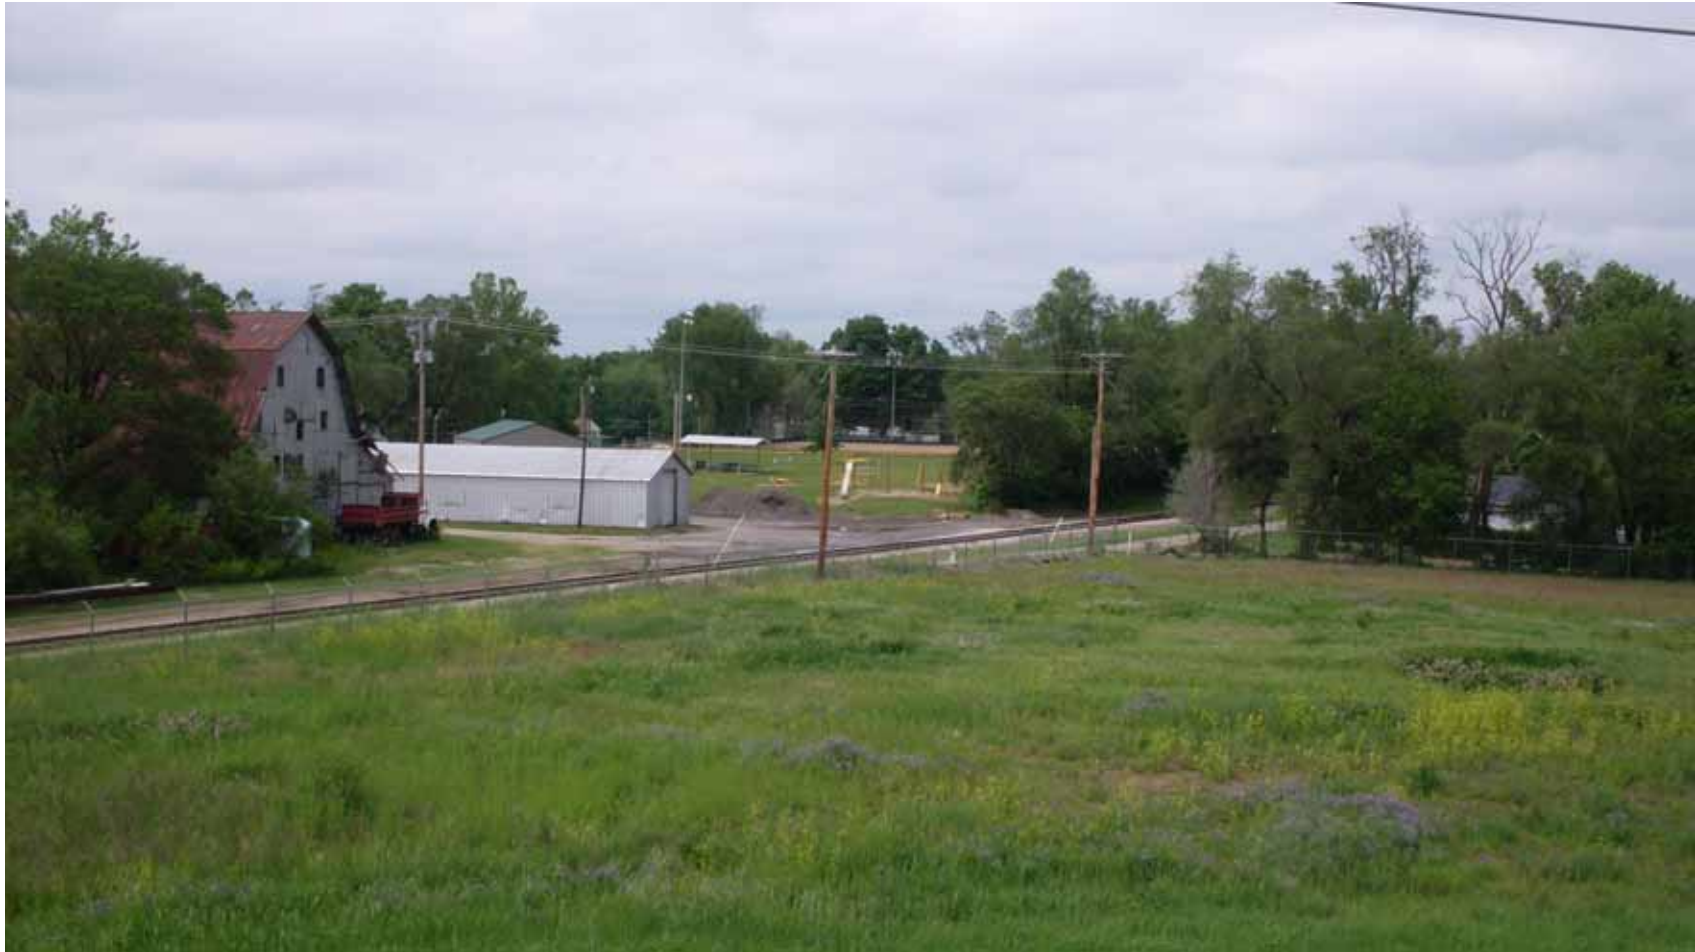
Havana Photo – other development near toe of impoundment

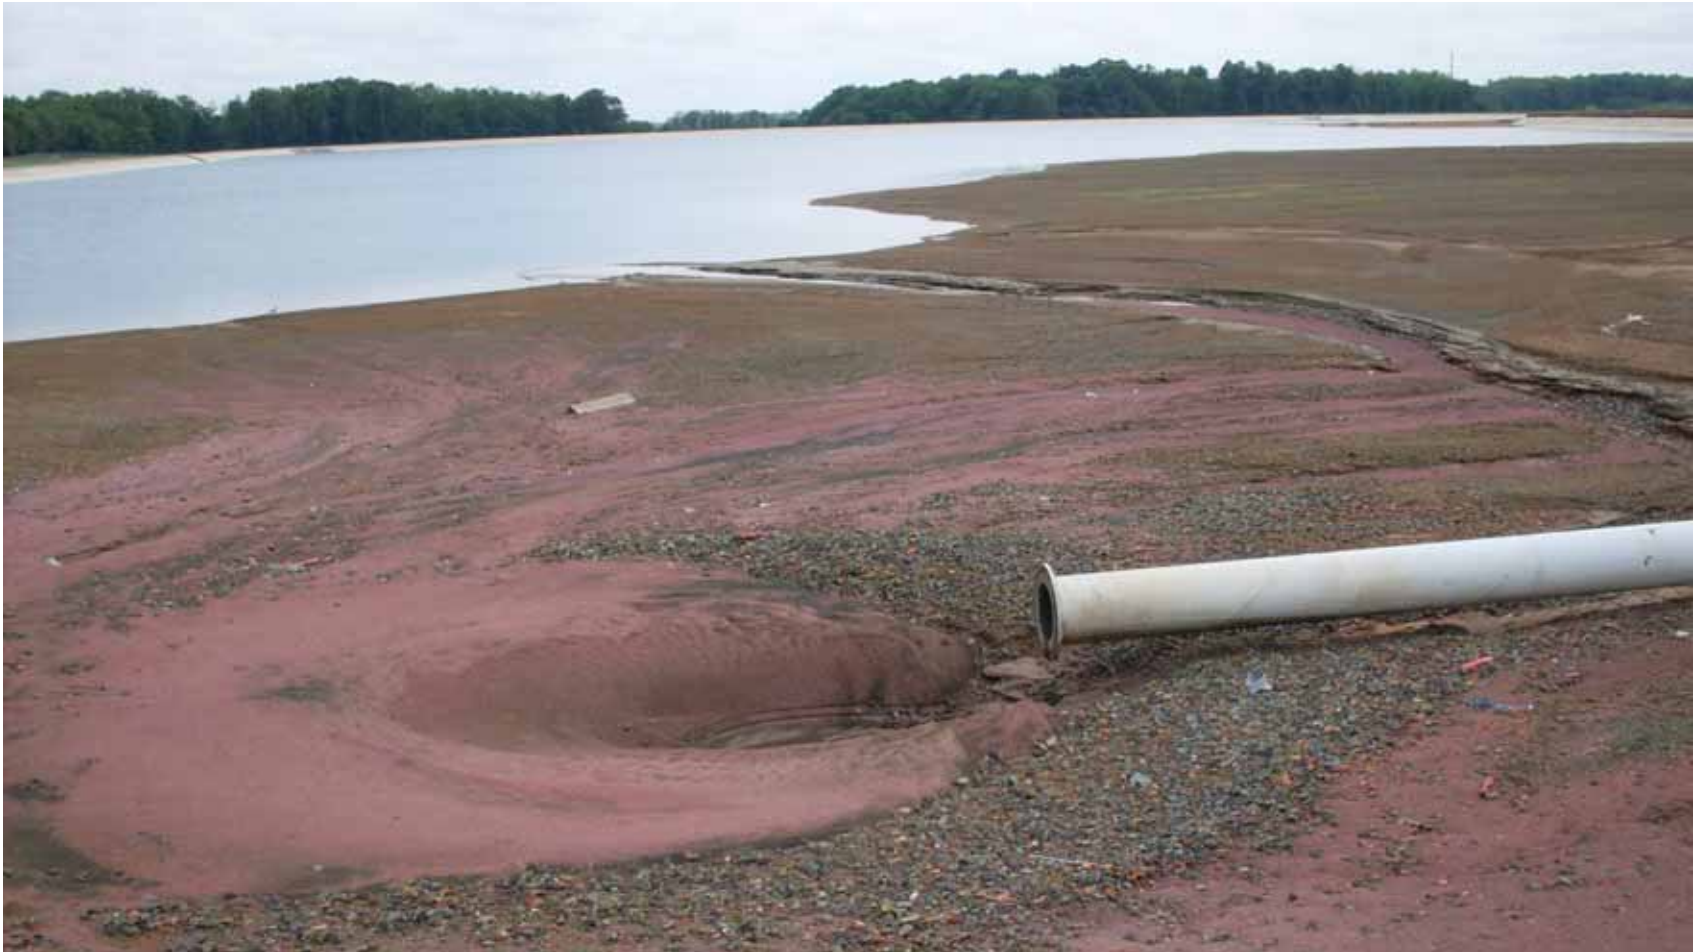
Havana Photo – Fly Ash

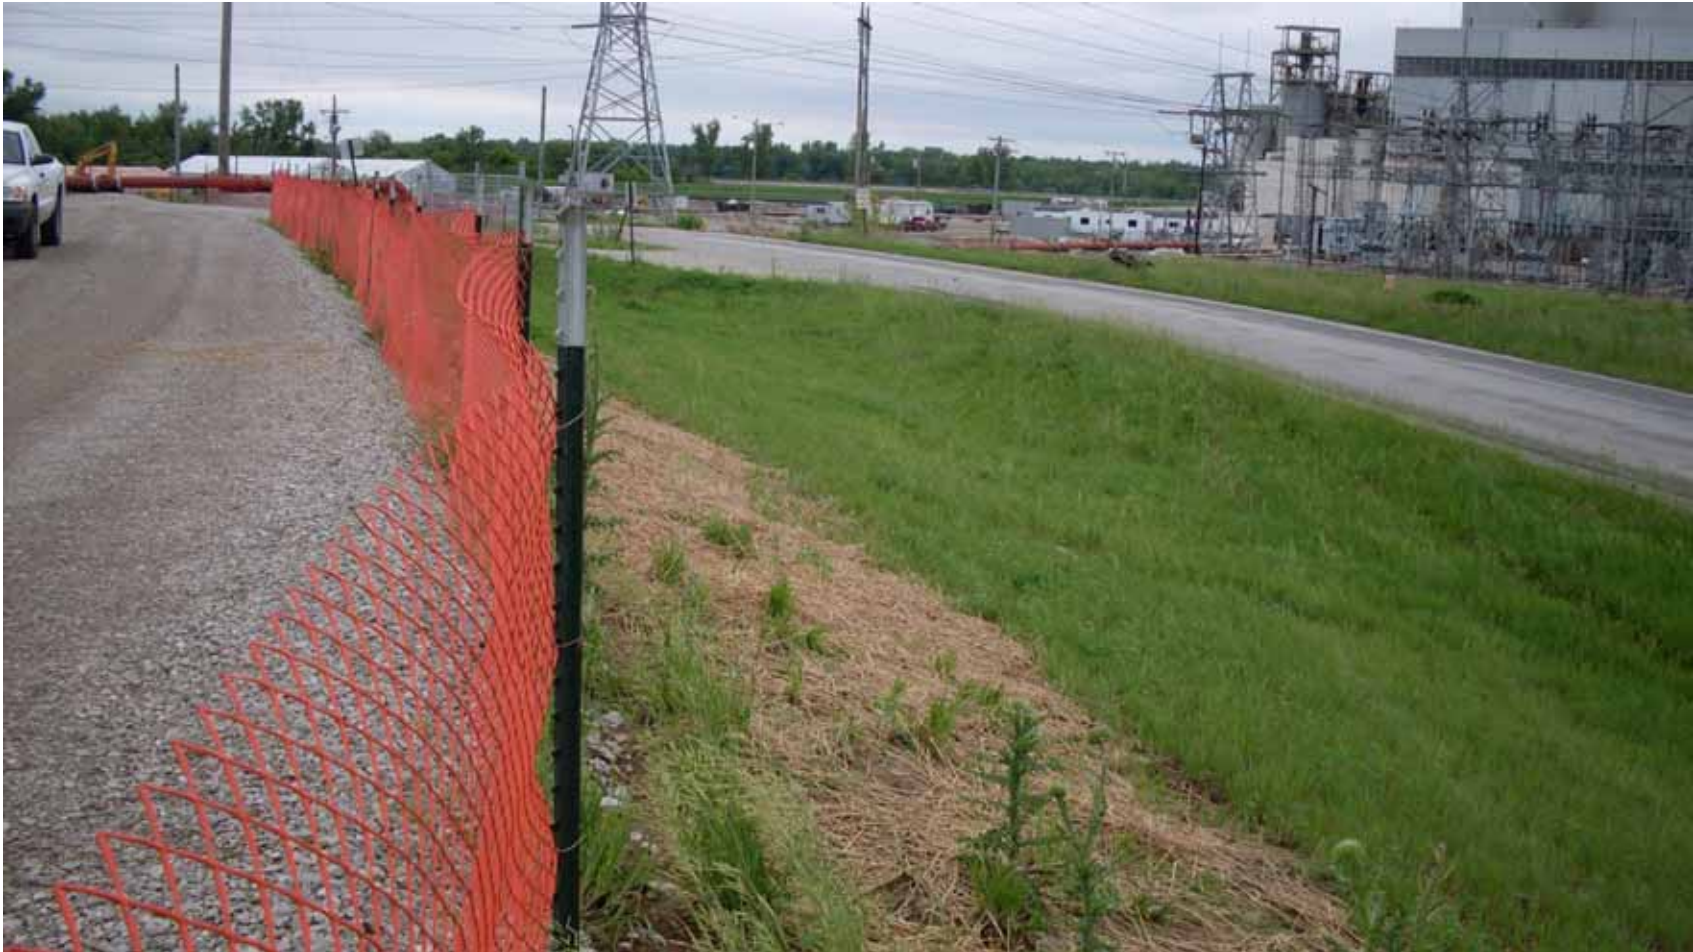
Wood River photo – plant entrance road at toe of CCW impoundment

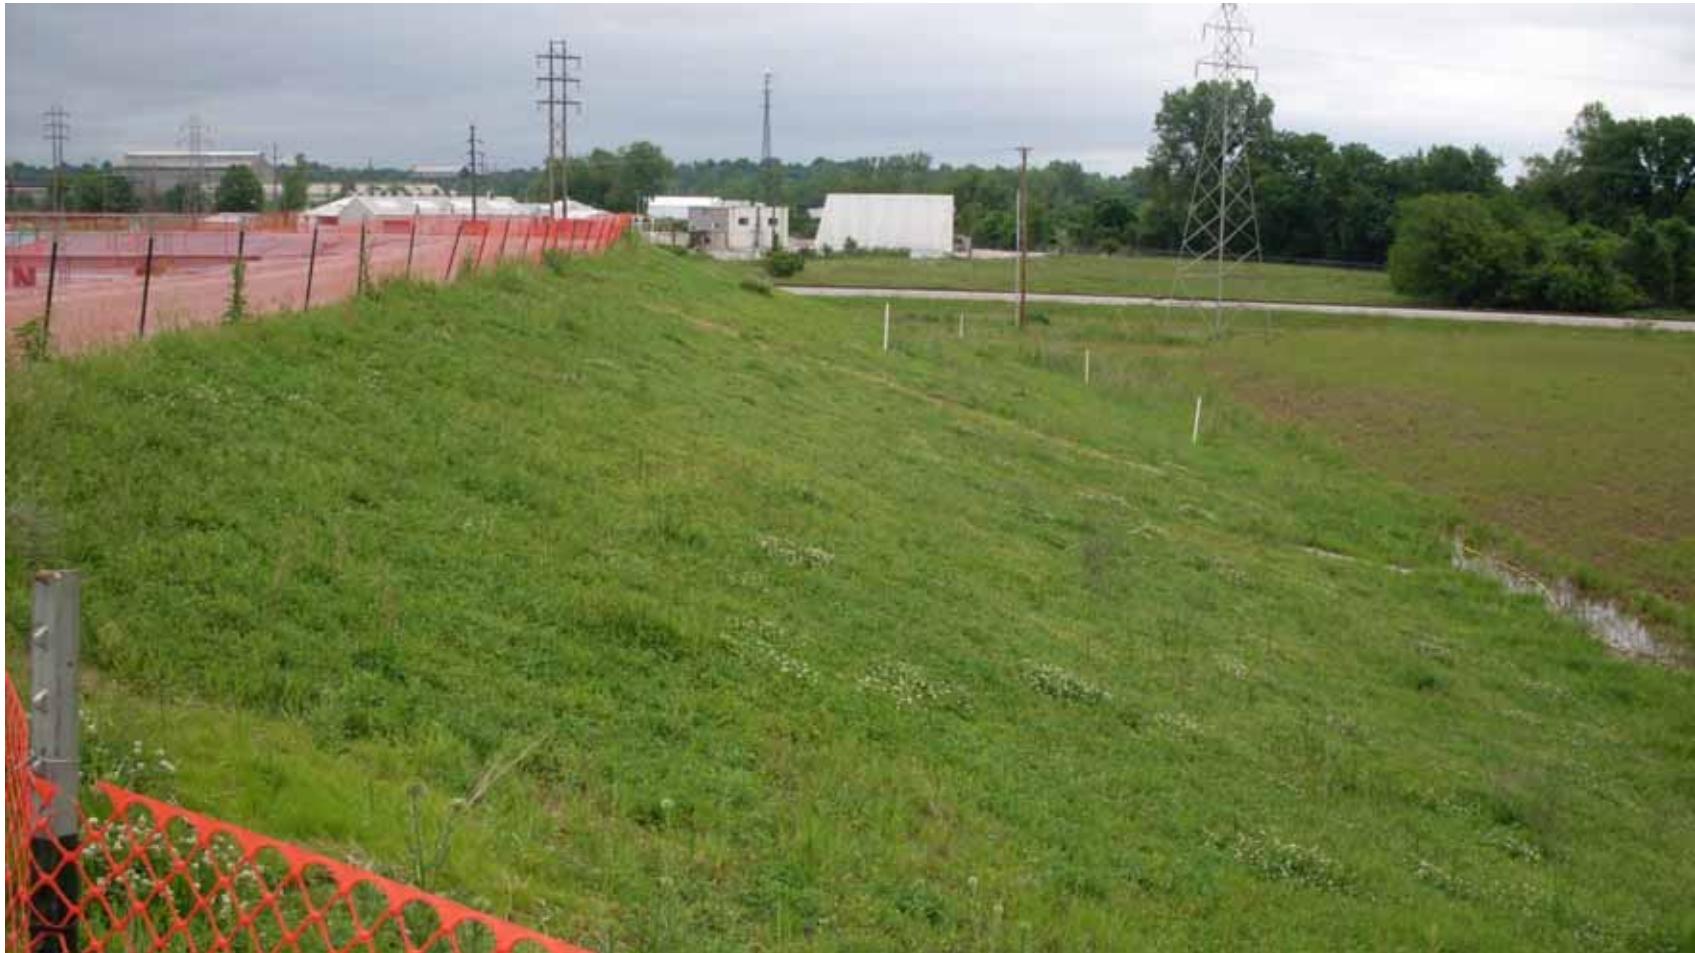
Wood River – few industrial structures near toe
