Reischl Dam  
Overtopping –  
Embankment and  
Spillway Restoration  
Paul D. Drew, P.E., CFM  
March 6<sup>th</sup>, 2013

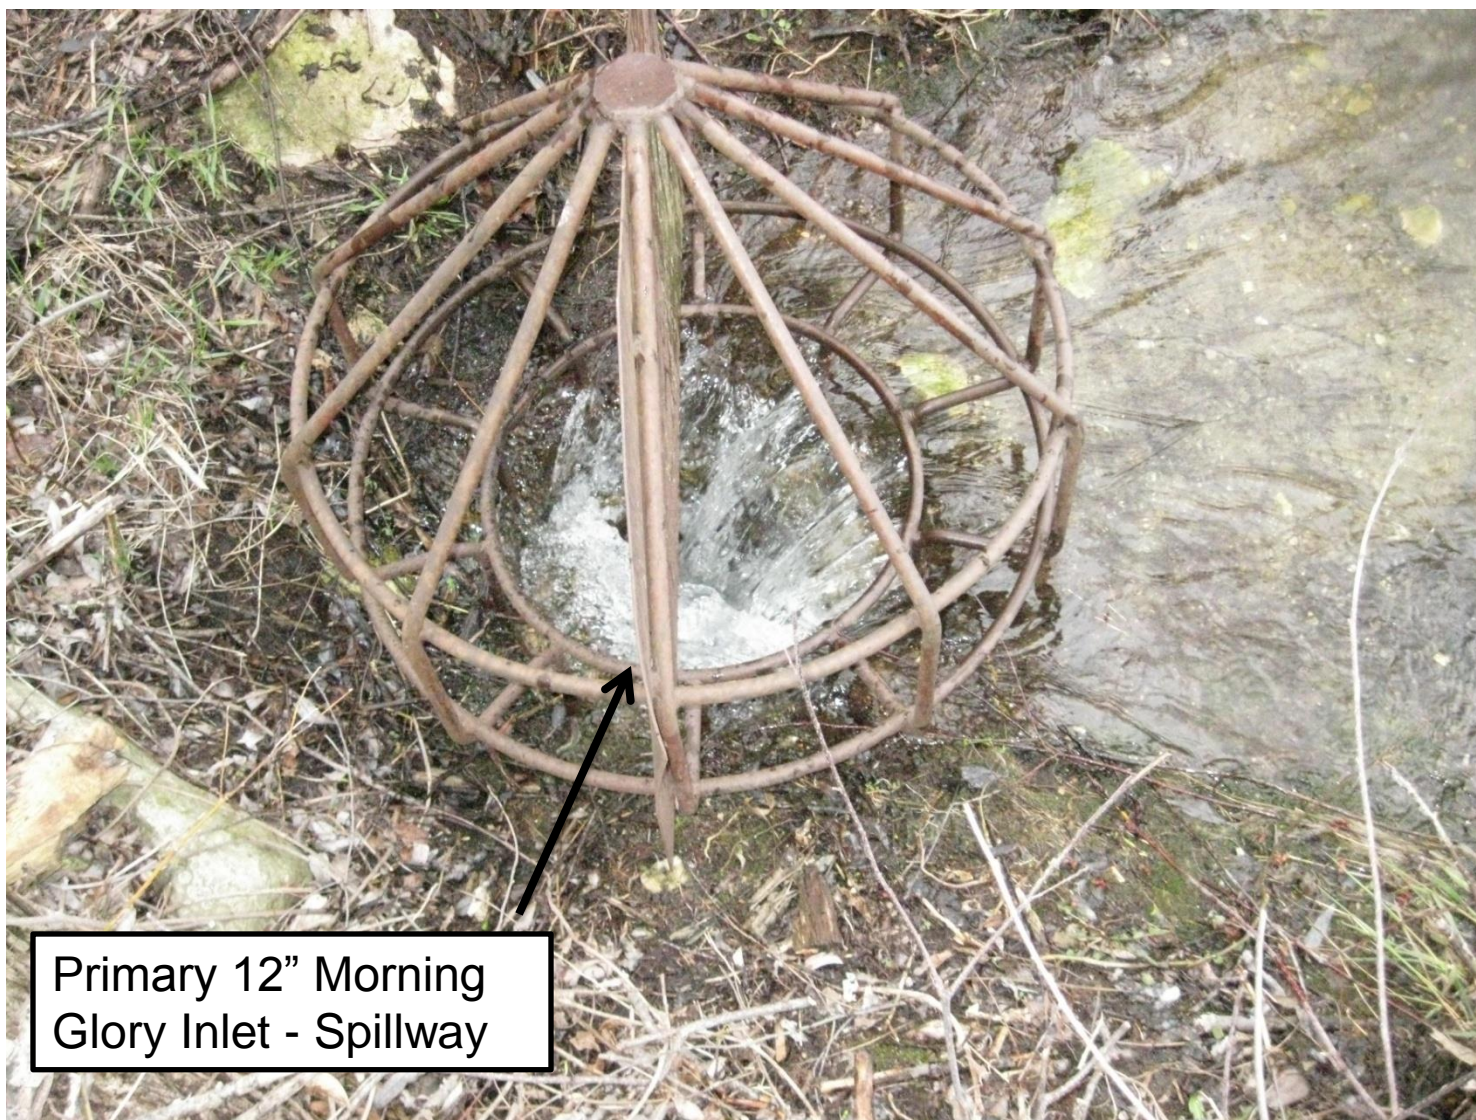
Primary 12" Morning  
Glory Inlet - Spillway

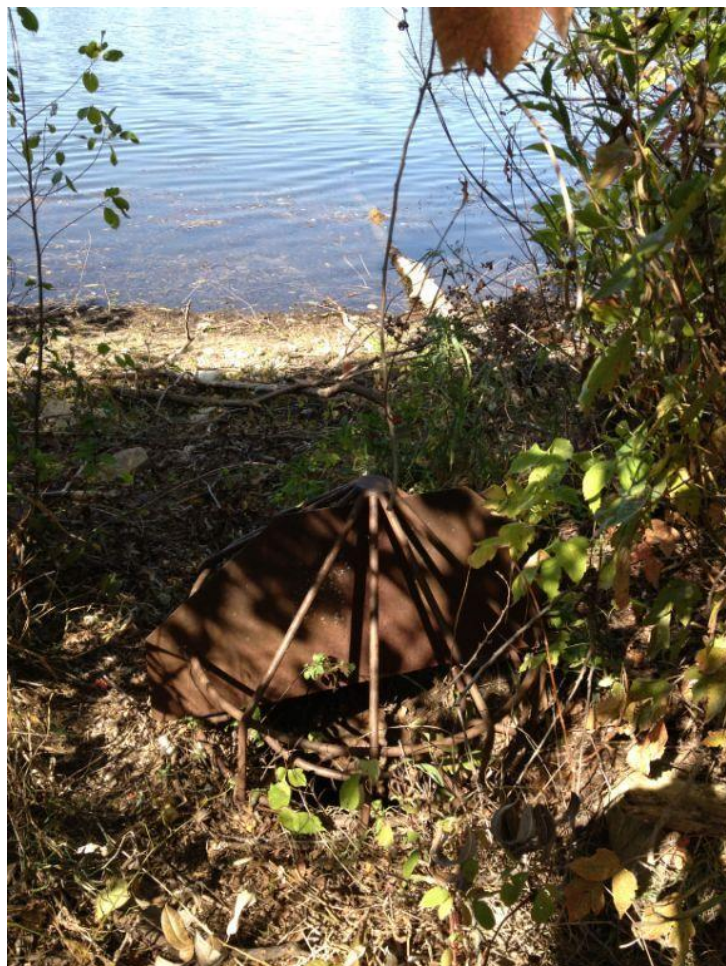
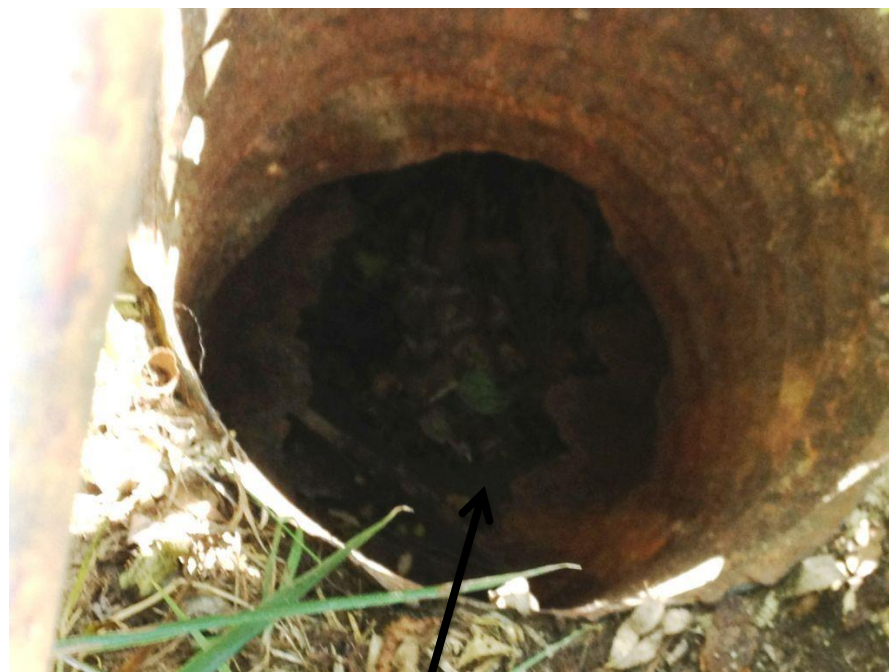
Corroded Drop Inlet CMP

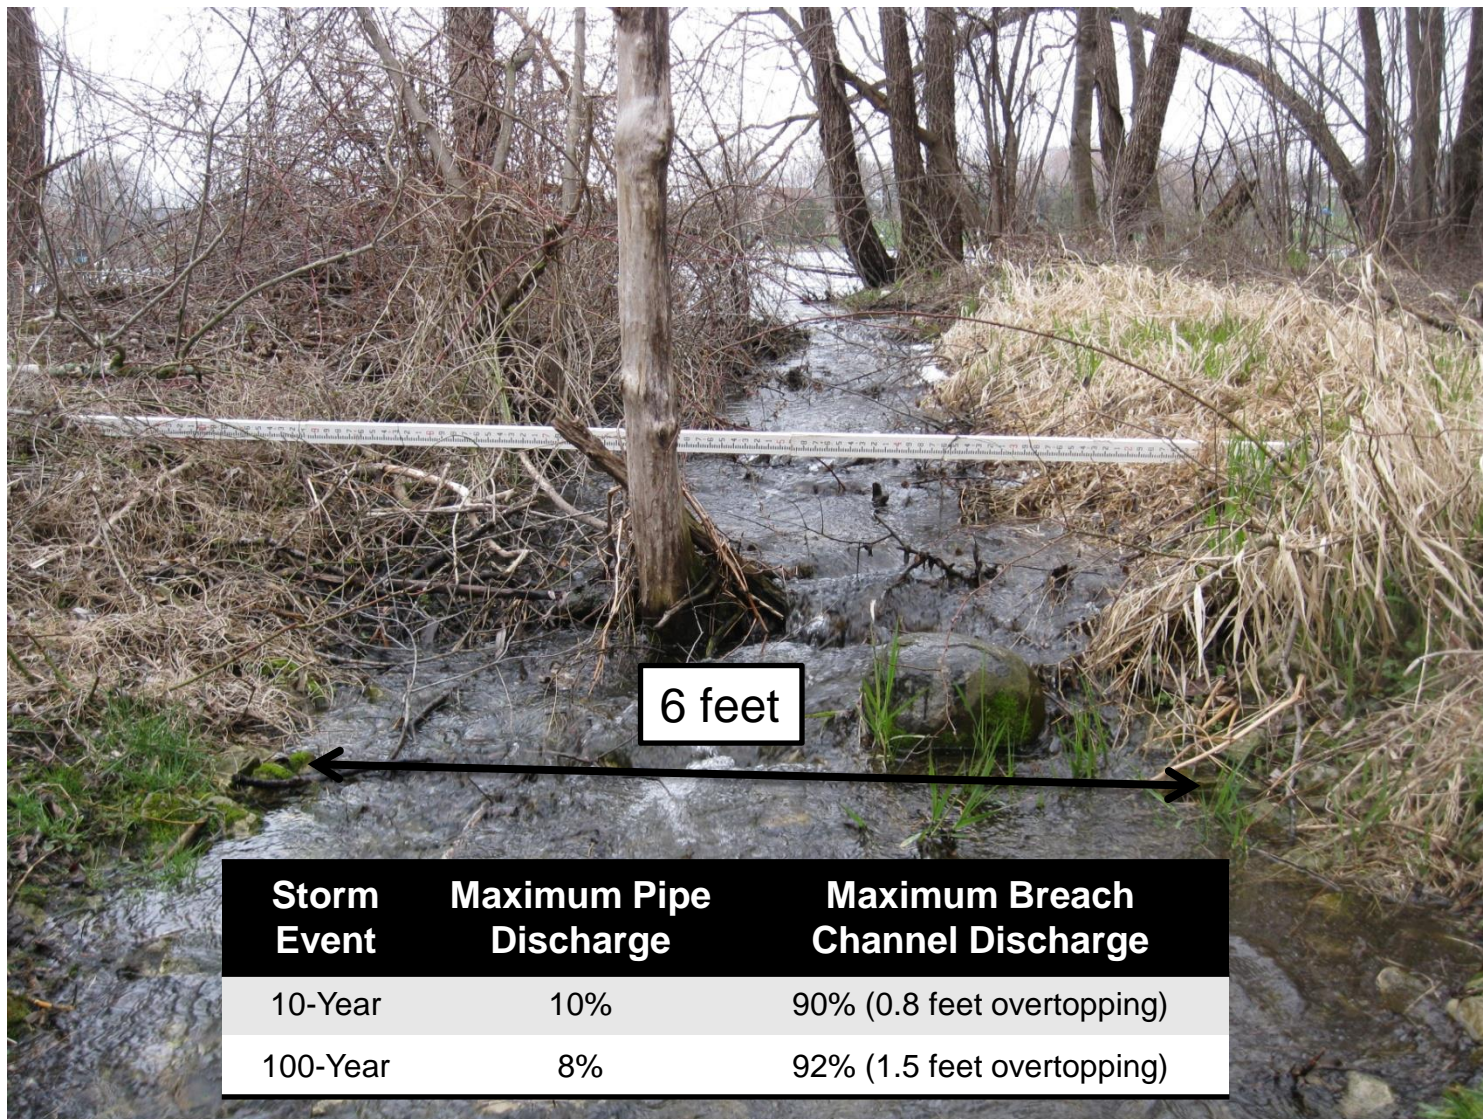
Storm Event	Maximum Pipe Discharge	Maximum Breach Channel Discharge
10-Year	10%	90% (0.8 feet overtopping)
100-Year	8%	92% (1.5 feet overtopping)

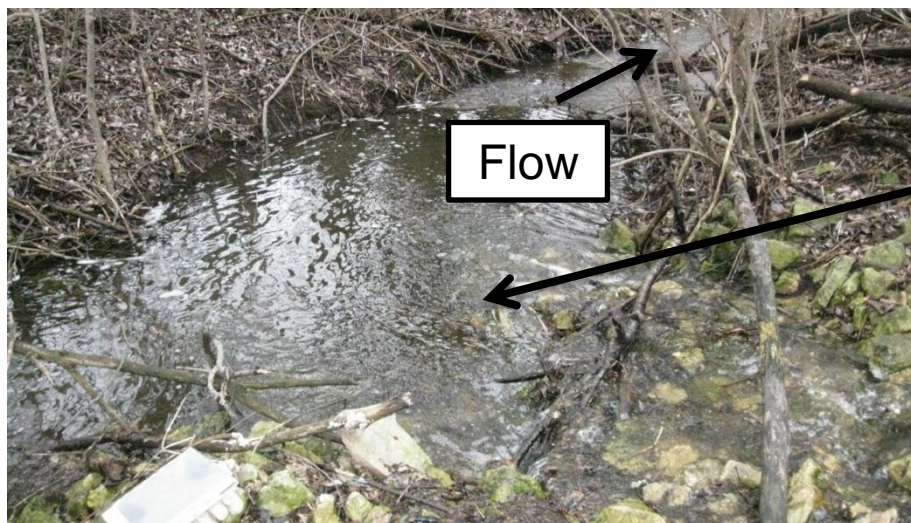
Downstream of Outlet

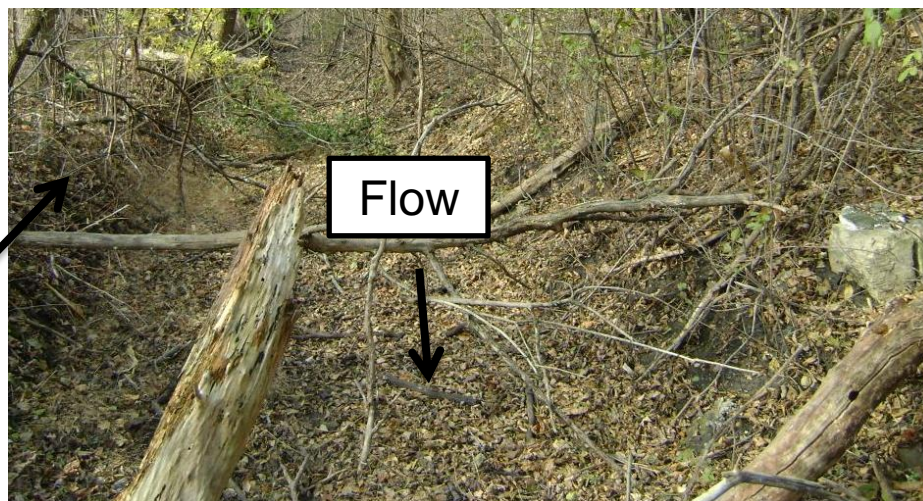
Toe of Dam

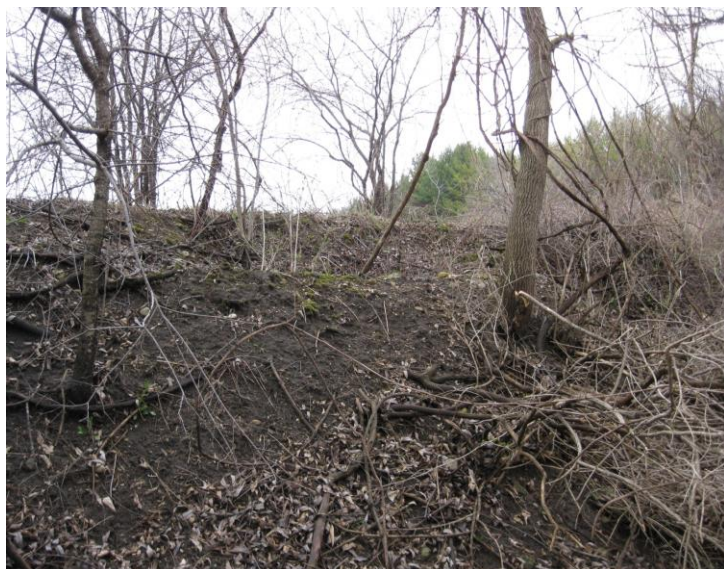
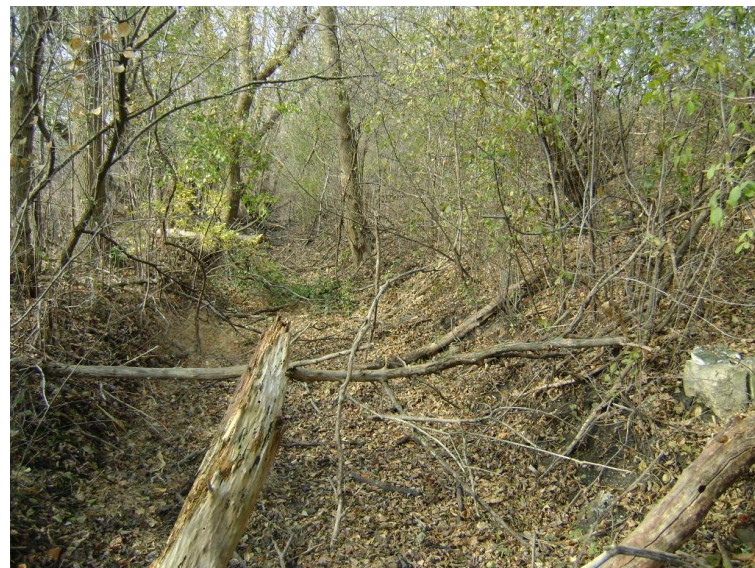
- Embankment covered with trees and woody vegetation
- No ground cover
- Steep Slopes (1.5:1 max, 2:1 min.)
- Non-Engineered Channel at toe of embankment
