NRCS DAM RISK ASSESSMENTS

Sites 6 and 8

Eddy and Chaves Counties, New Mexico

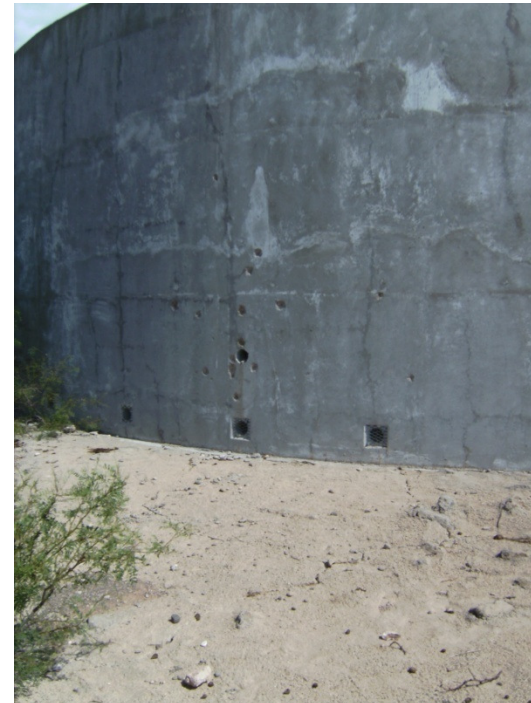
Pockmarks

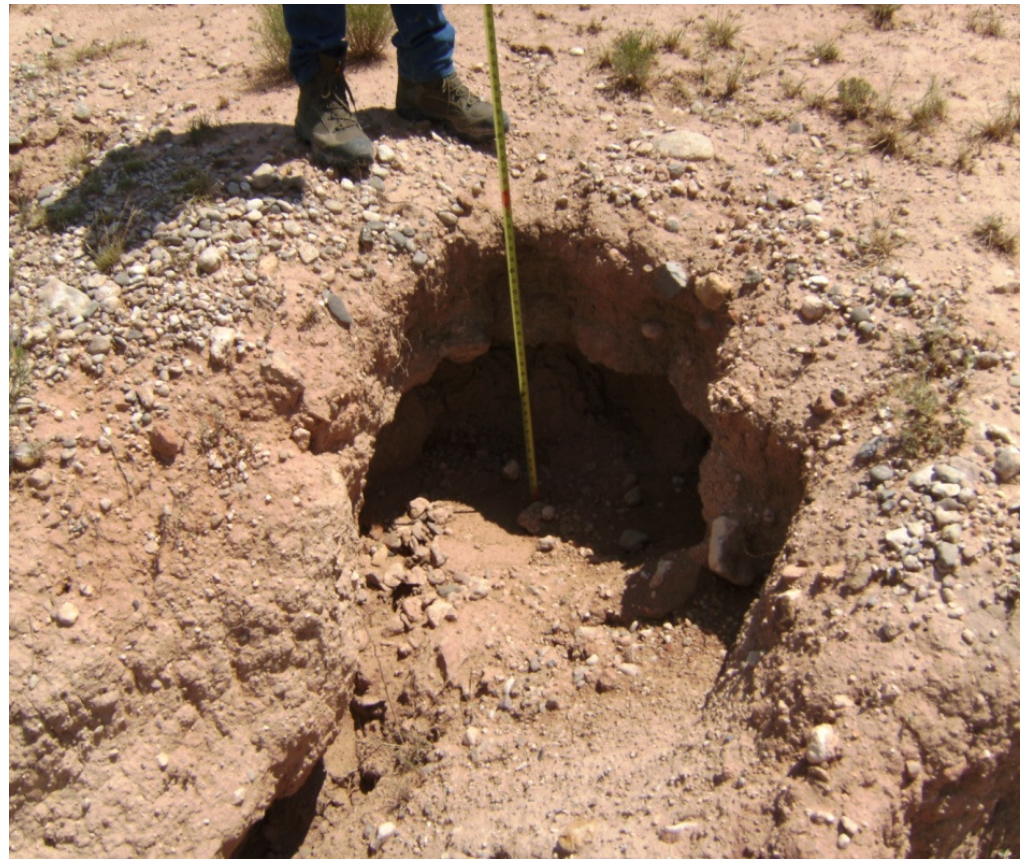
Subsidence
