St. Peters, MO Willott Road

Culvert & West Spencer Creek Improvements

Session 3B – IAFSM 2023

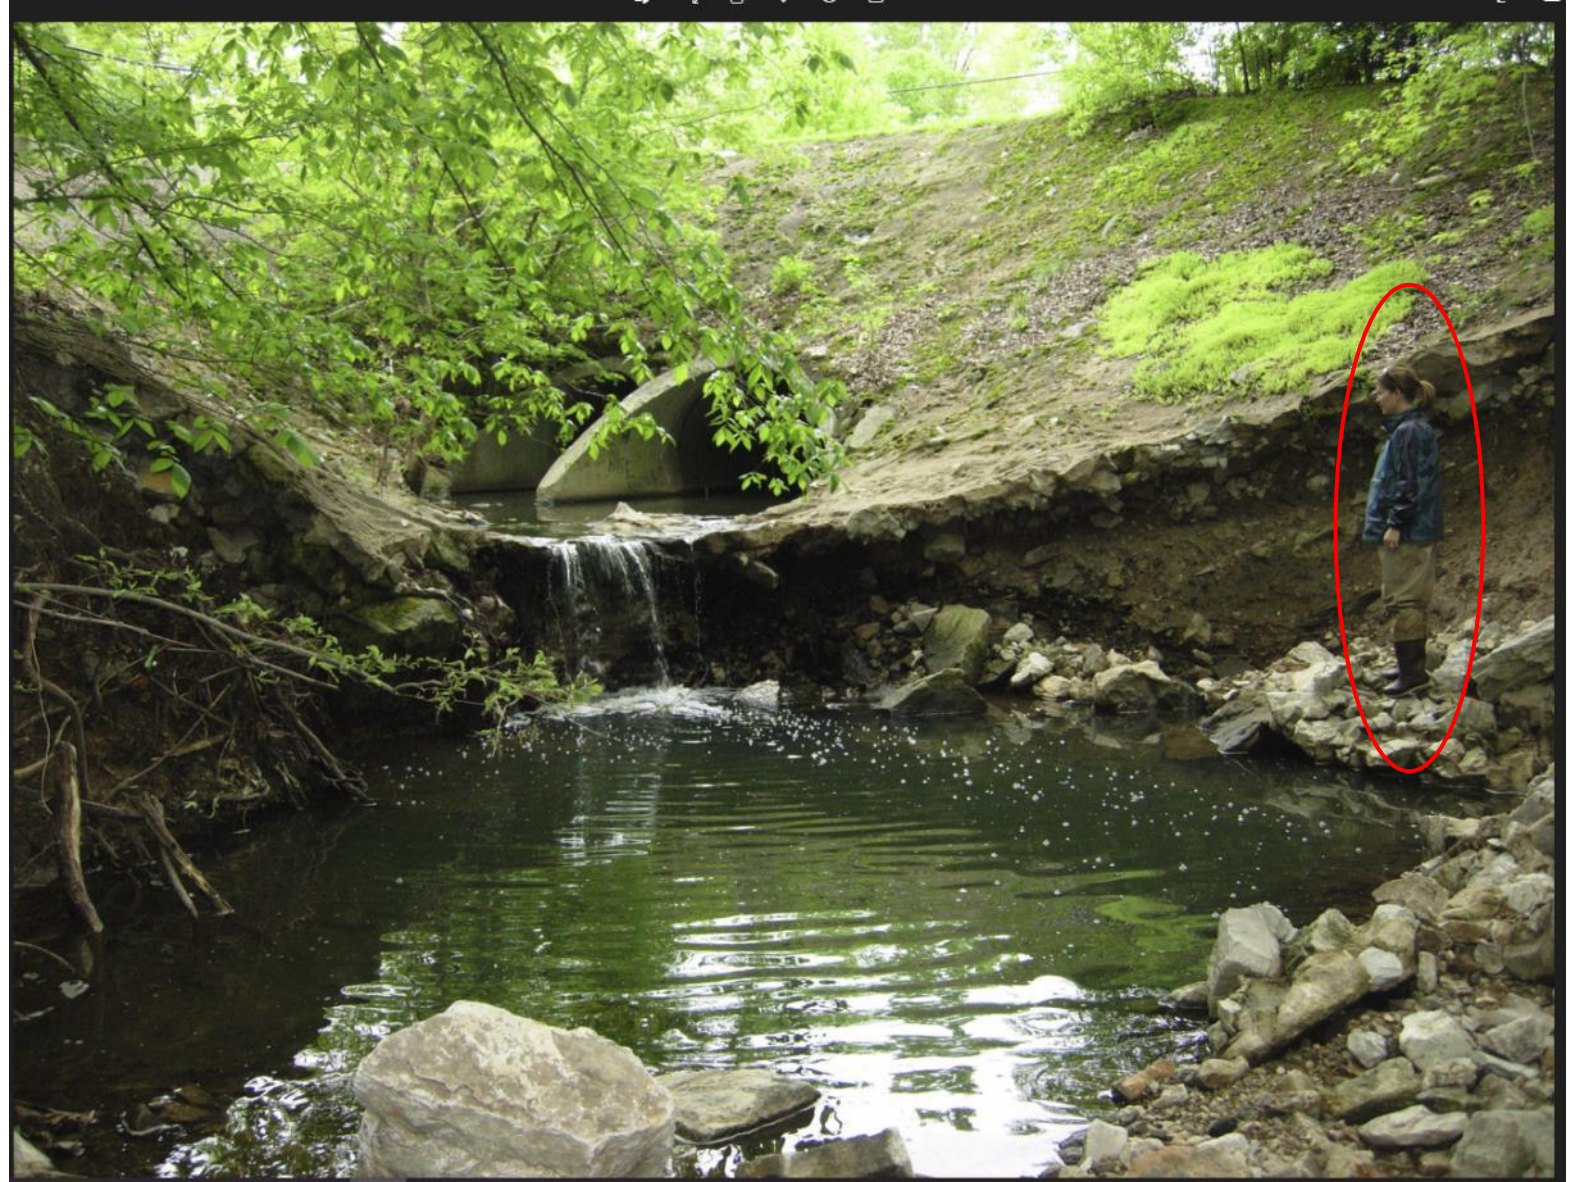
May 2011 Photograph:

- Incised creek channel
- Head-cut migrating towards roadway culverts
- Grout lining and armoring undermined by head cut

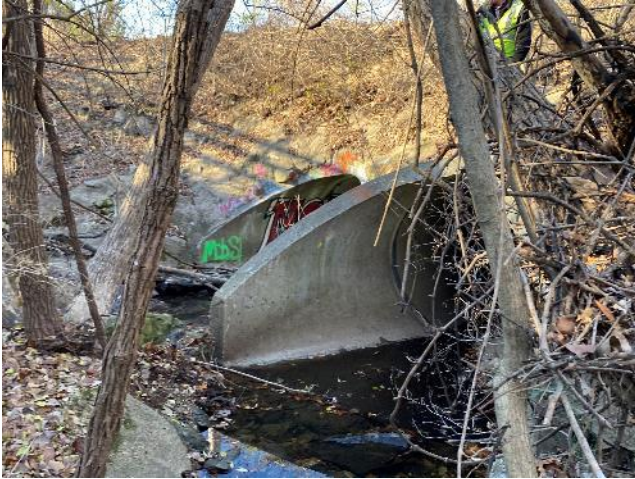
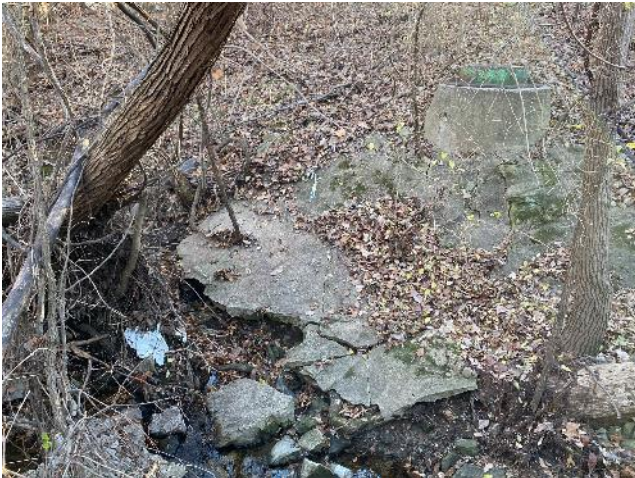
Upstream End: Deterioration of grouted channel & slope above culvert inlets. Overgrowth and debris.

- Realign and replace culvert vs repair
- Extend culvert over exposed sanitary sewer
- Restore creek bank, protect with formal energy dissipation at outlet
- Increase hydraulic capacity to 100-year, 24-hr event
- Design headwall and wingwall to reduce road embankment slopes

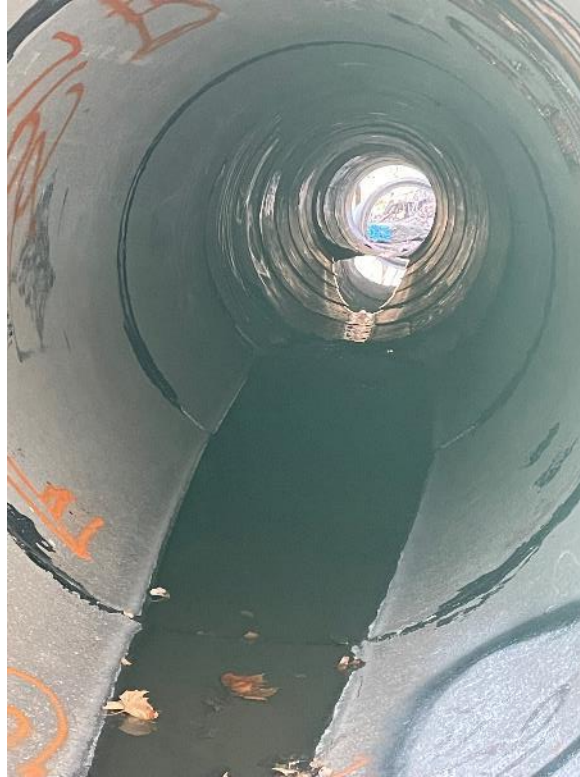
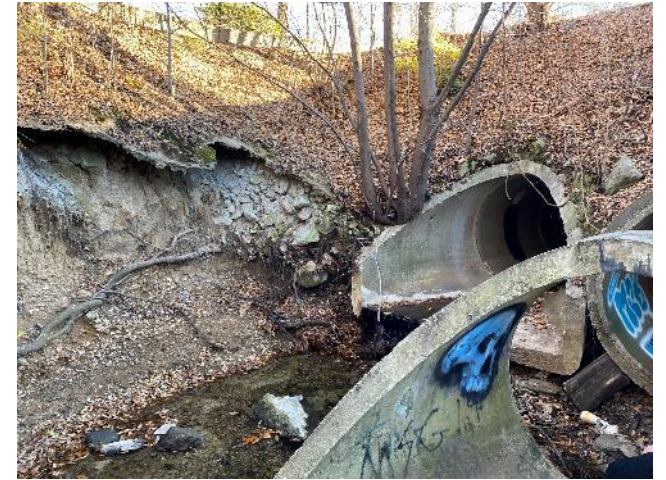
Culvert pipes are settling at both ends

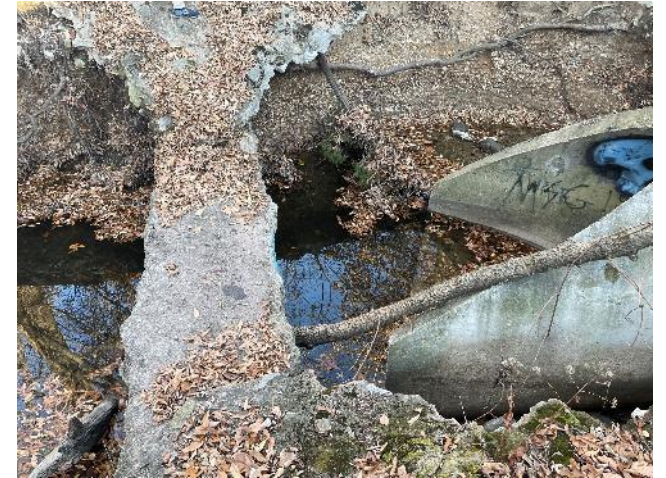
Downstream End: Channel Incising, bank scour, exposed sanitary sewer, & flared end settling/disconnected

- Extended over existing exposed sanitary sewer
- Energy dissipation structure at discharge
- Head and wingwalls provide lower embankment slope

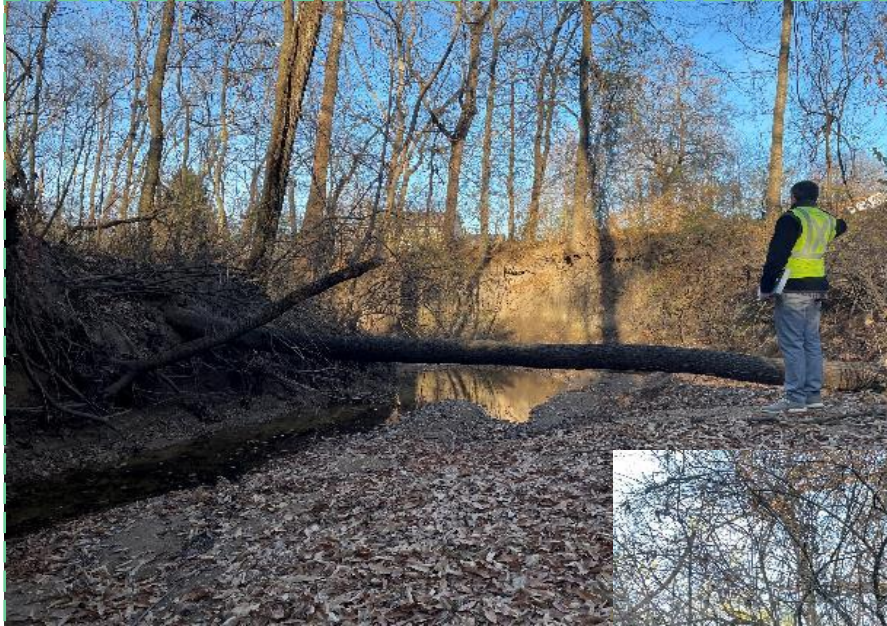
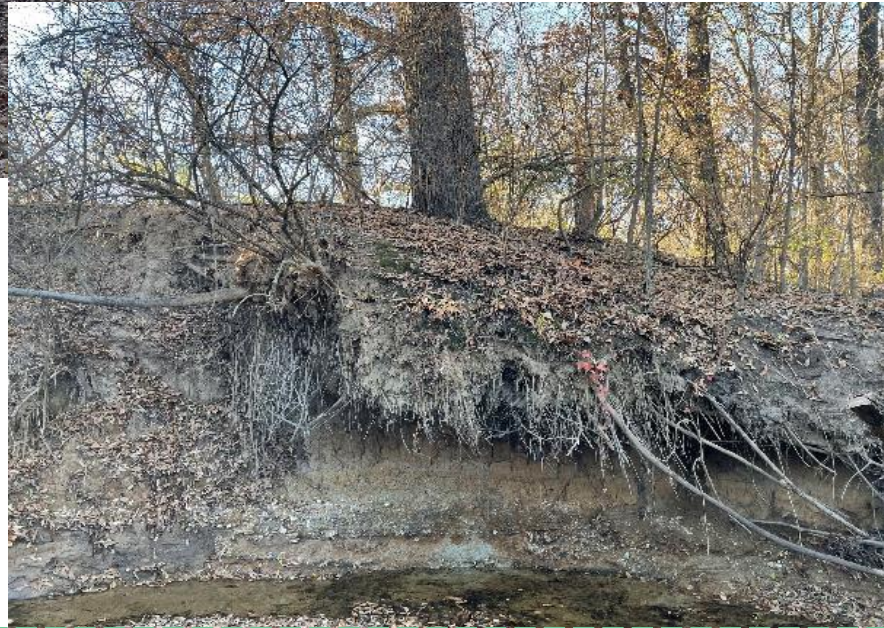
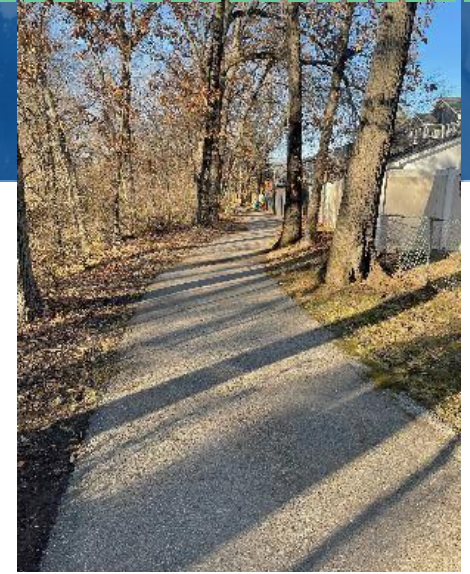
Incising, Bank Scarps, Slope Destabilization & Root Exposure

- Restore and stabilize slopes
- Re-introduce gentle sinuosity in creek alignment
- Design grade control structures
- Reduce bed and side slopes
- Integrate hard armor with angular stone and boulder toe protection
- Bioengineering on mid & upper creek bank slopes

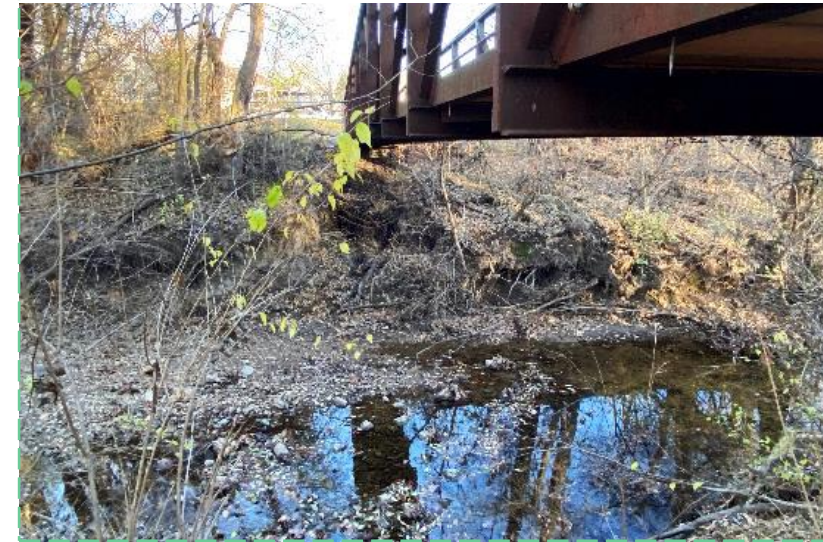
Bank Scour is nearing the Pedestrian Trail & present at Bridge Abutments

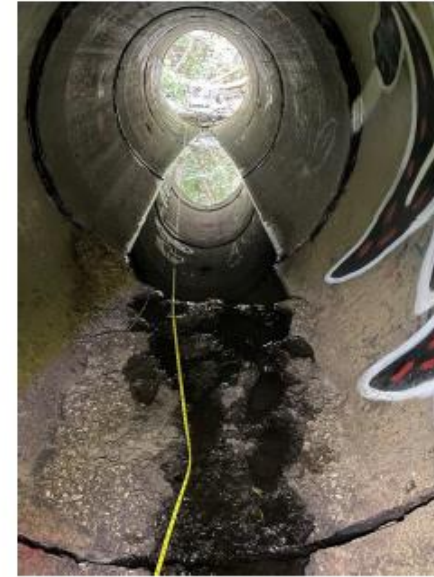
- Detailed assessment of structural conditions
 - Determination to repair or replace infrastructure
 - Provided justification for design decision
 - Develop design to mitigate failures in the future
- Issues identified included:
 - Vertical offsets, circumferential cracks exposing rebar, settlement pools, shear cracking, joint seeps and scour around the culvert pipe ends
- Issues attributed to:
 - Poor foundation support
 - Loads exceeding bedding soil strength
 - Erosion and scour

Above: Vertical Offset

Above: Concrete grout in the invert of the pipe.

Right: Slabbing

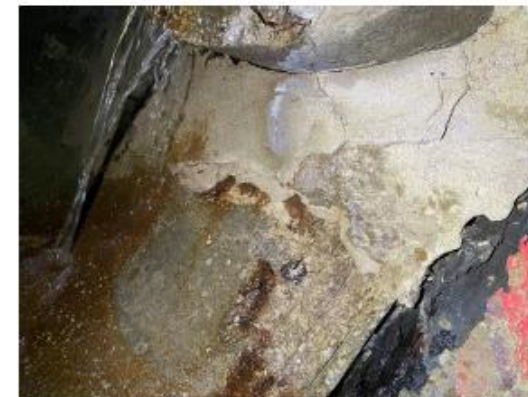
Above: Pipe wall condition below 36 inch RCP penetration.

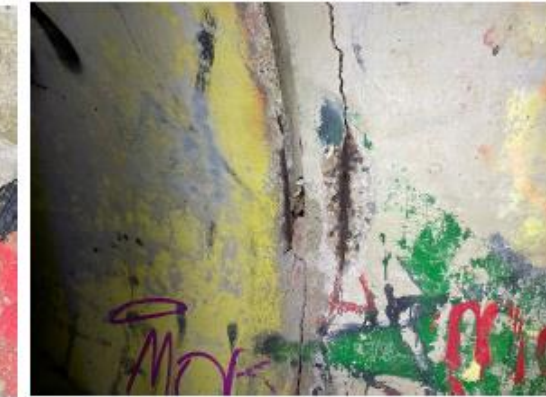
Above: Circumferential cracks at downstream end with exposed rebar.

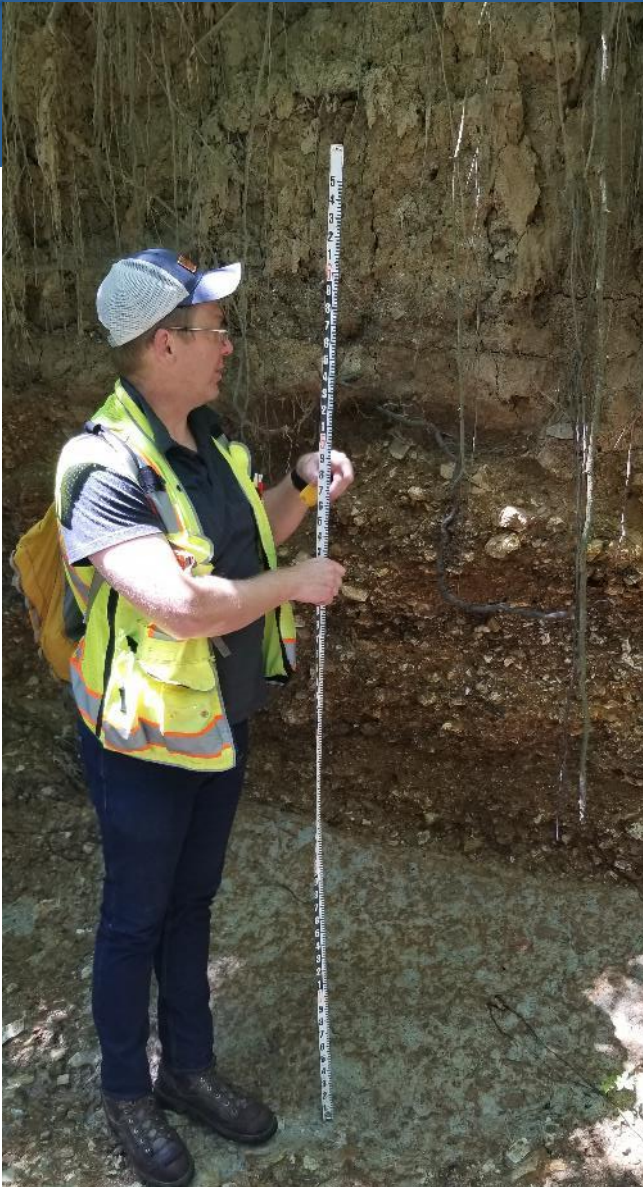
Overbanks over 5 feet from bed rock on left bank.

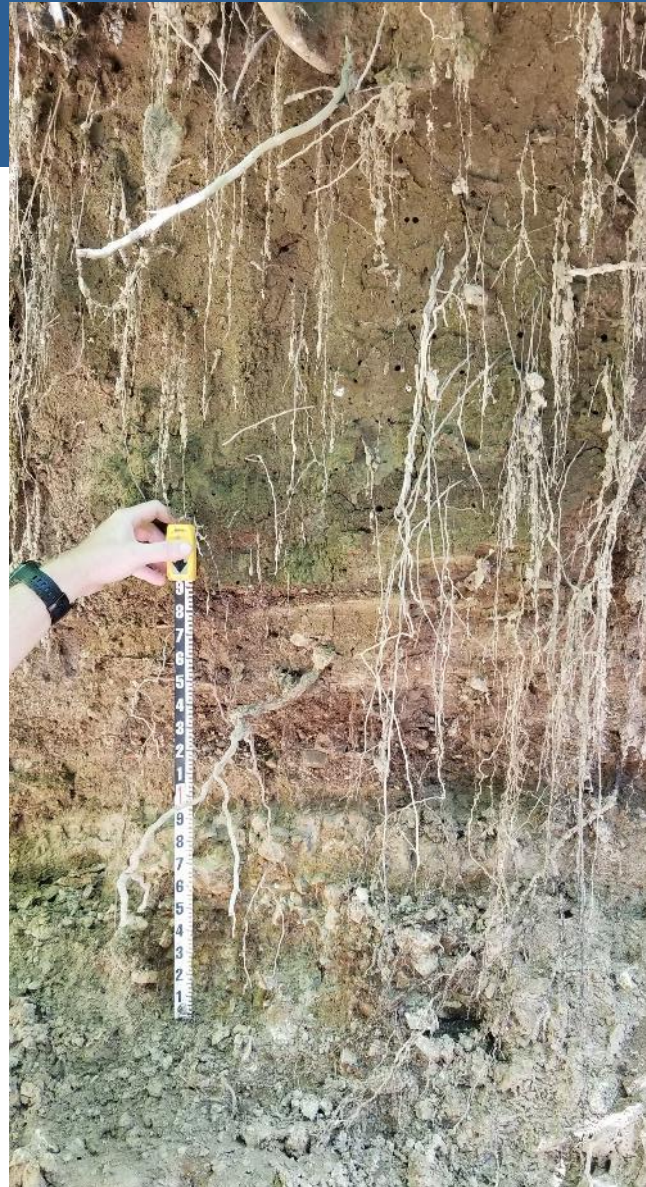
Stratification observed on right bank.

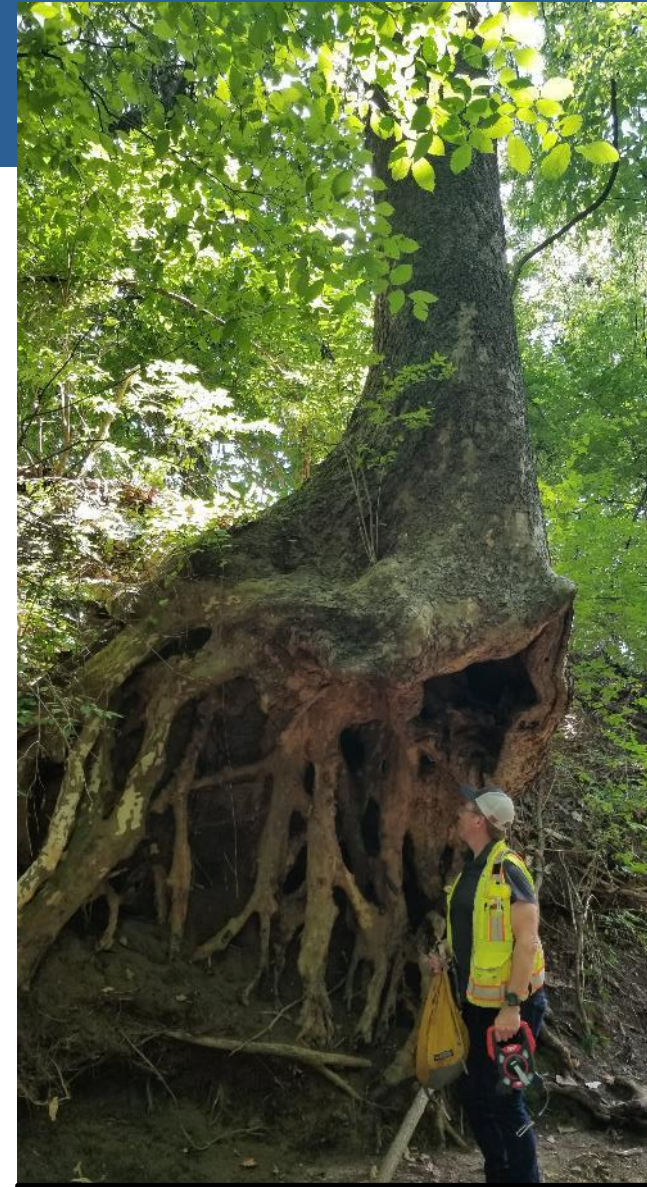
Exposed root system on the right bank.

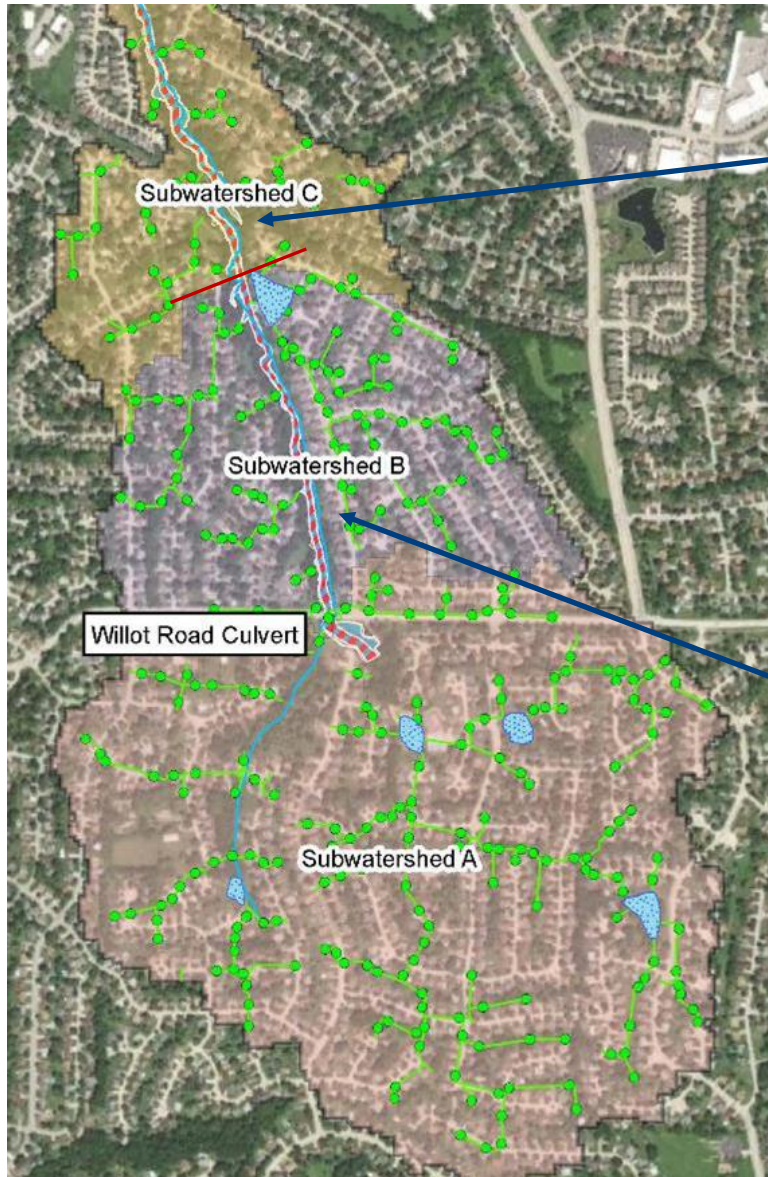
Class IV
downstream of
pedestrian bridge

Class III
upstream of
pedestrian bridge
