Butterfield Country Club Stream Restoration Project

Christopher B. Burke Engineering, Ltd
Michael D. Cothard, PE, CFM
Donald R. Dressel, PE, CFM
Casey D. Perry

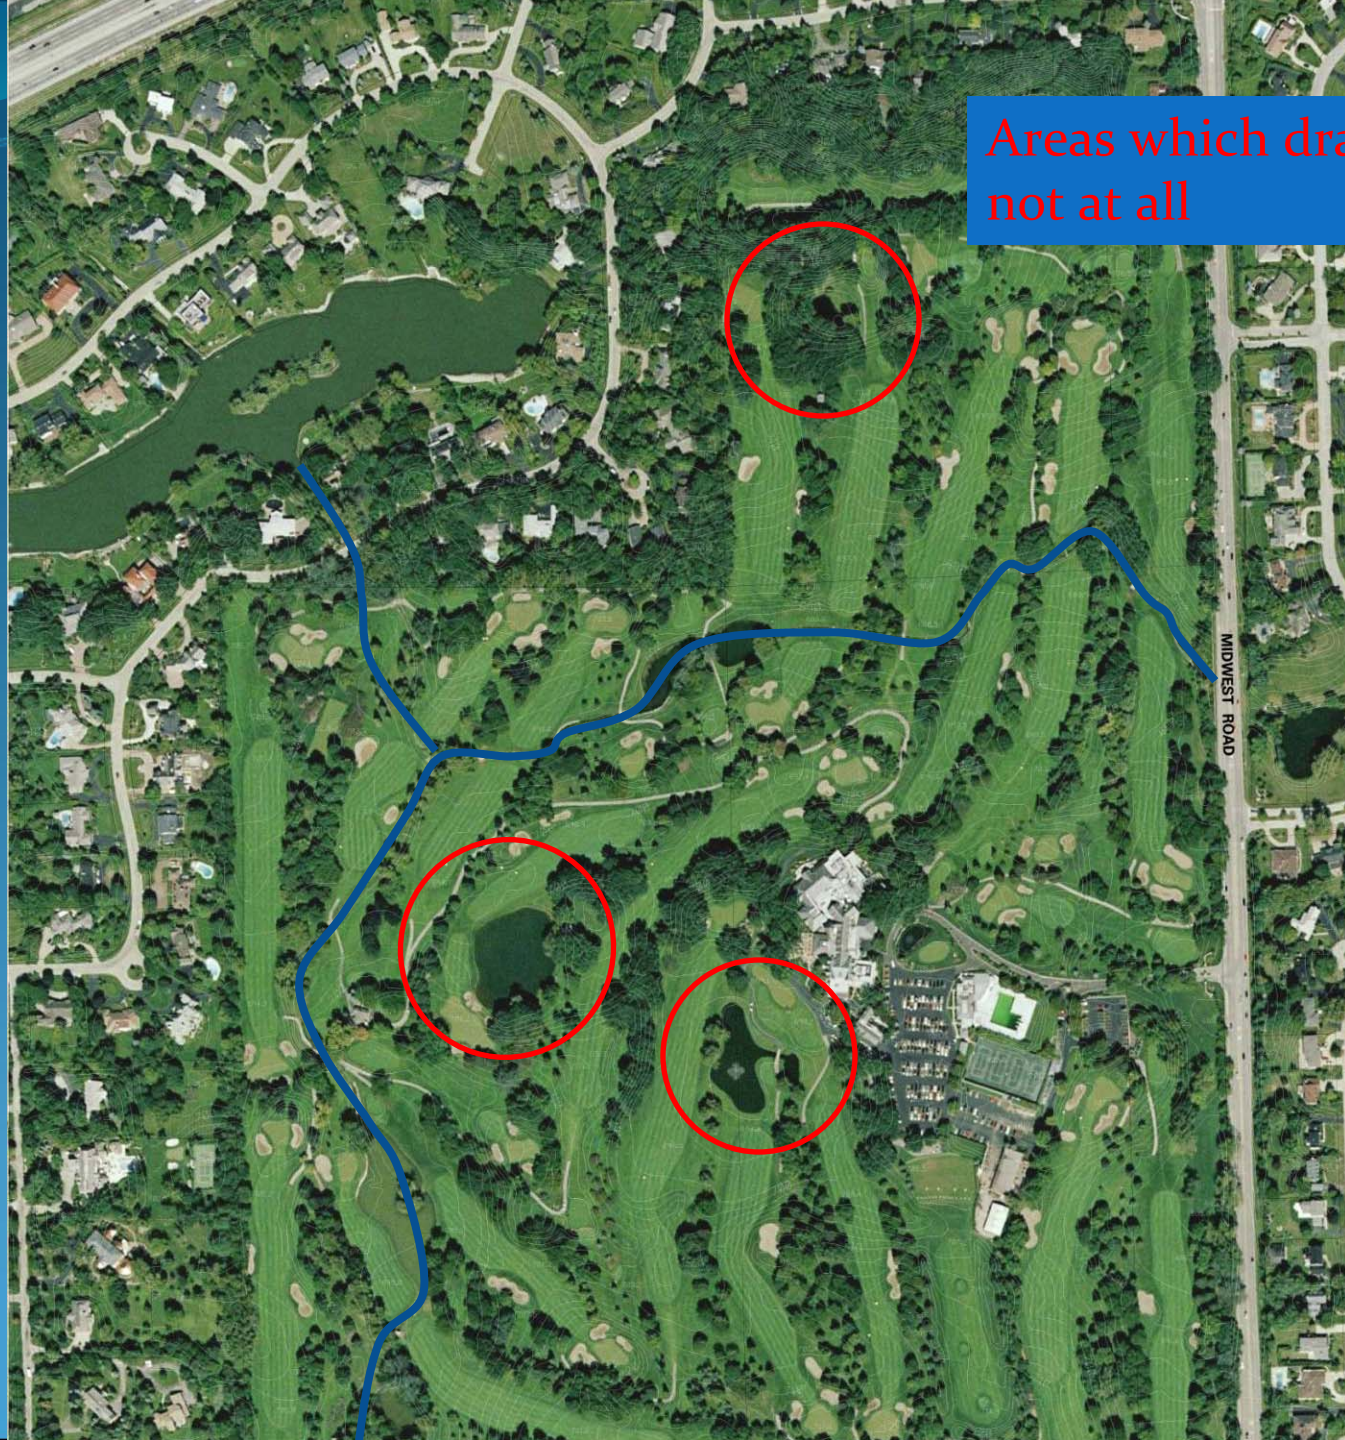
Eroding banks are undercutting bridge abutments and removing fairways

Drainage system has had minimal up grading, thus resulting in difficult golf course maintenance

Areas which drain poorly or not at all

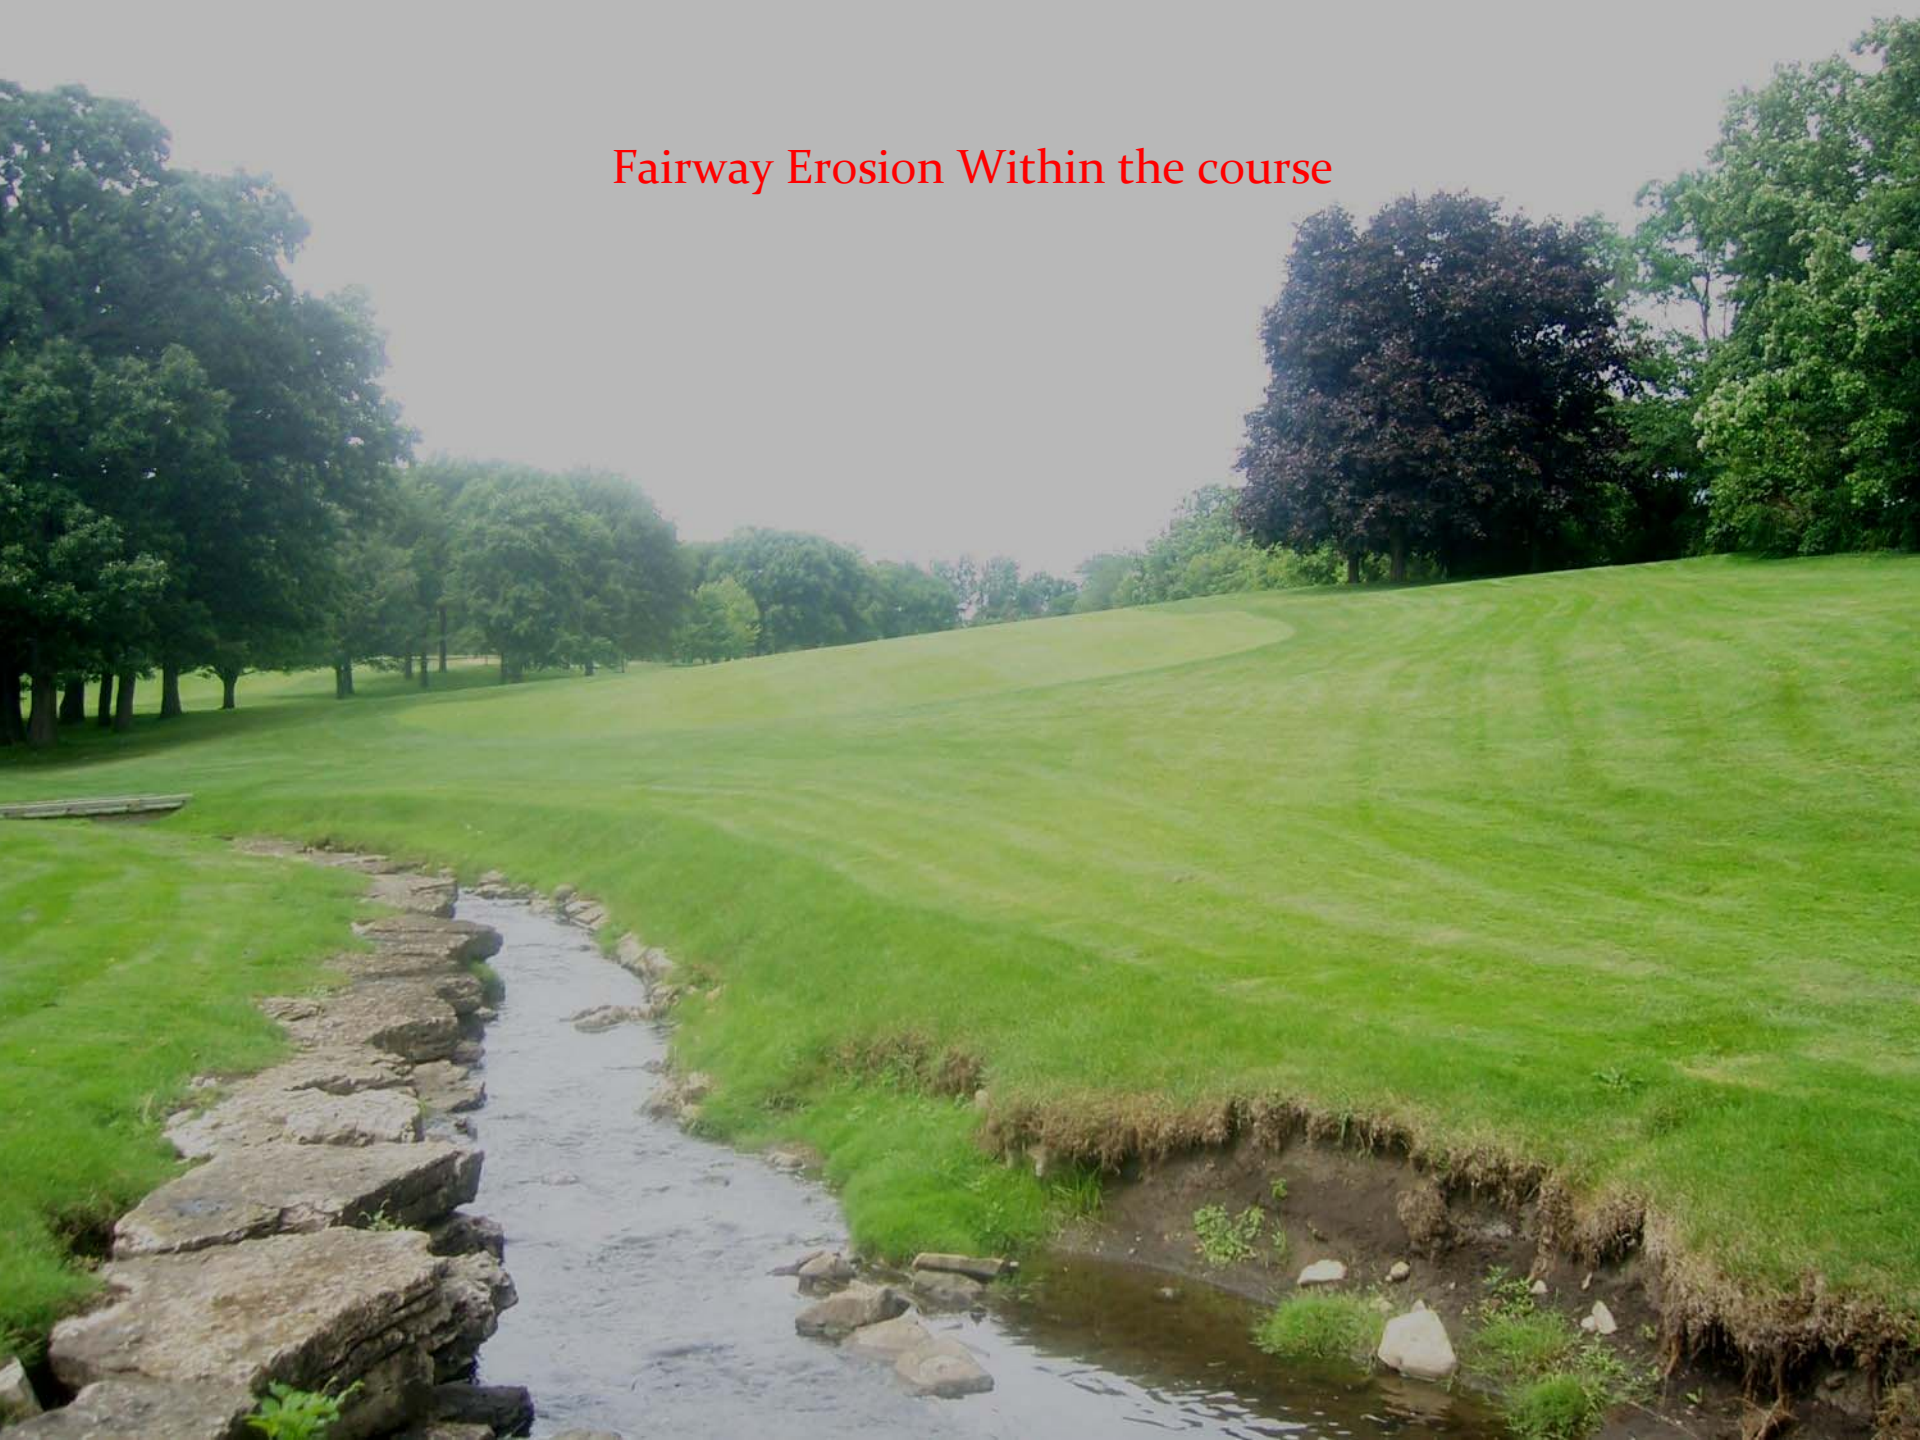
Fairway Erosion Within the course

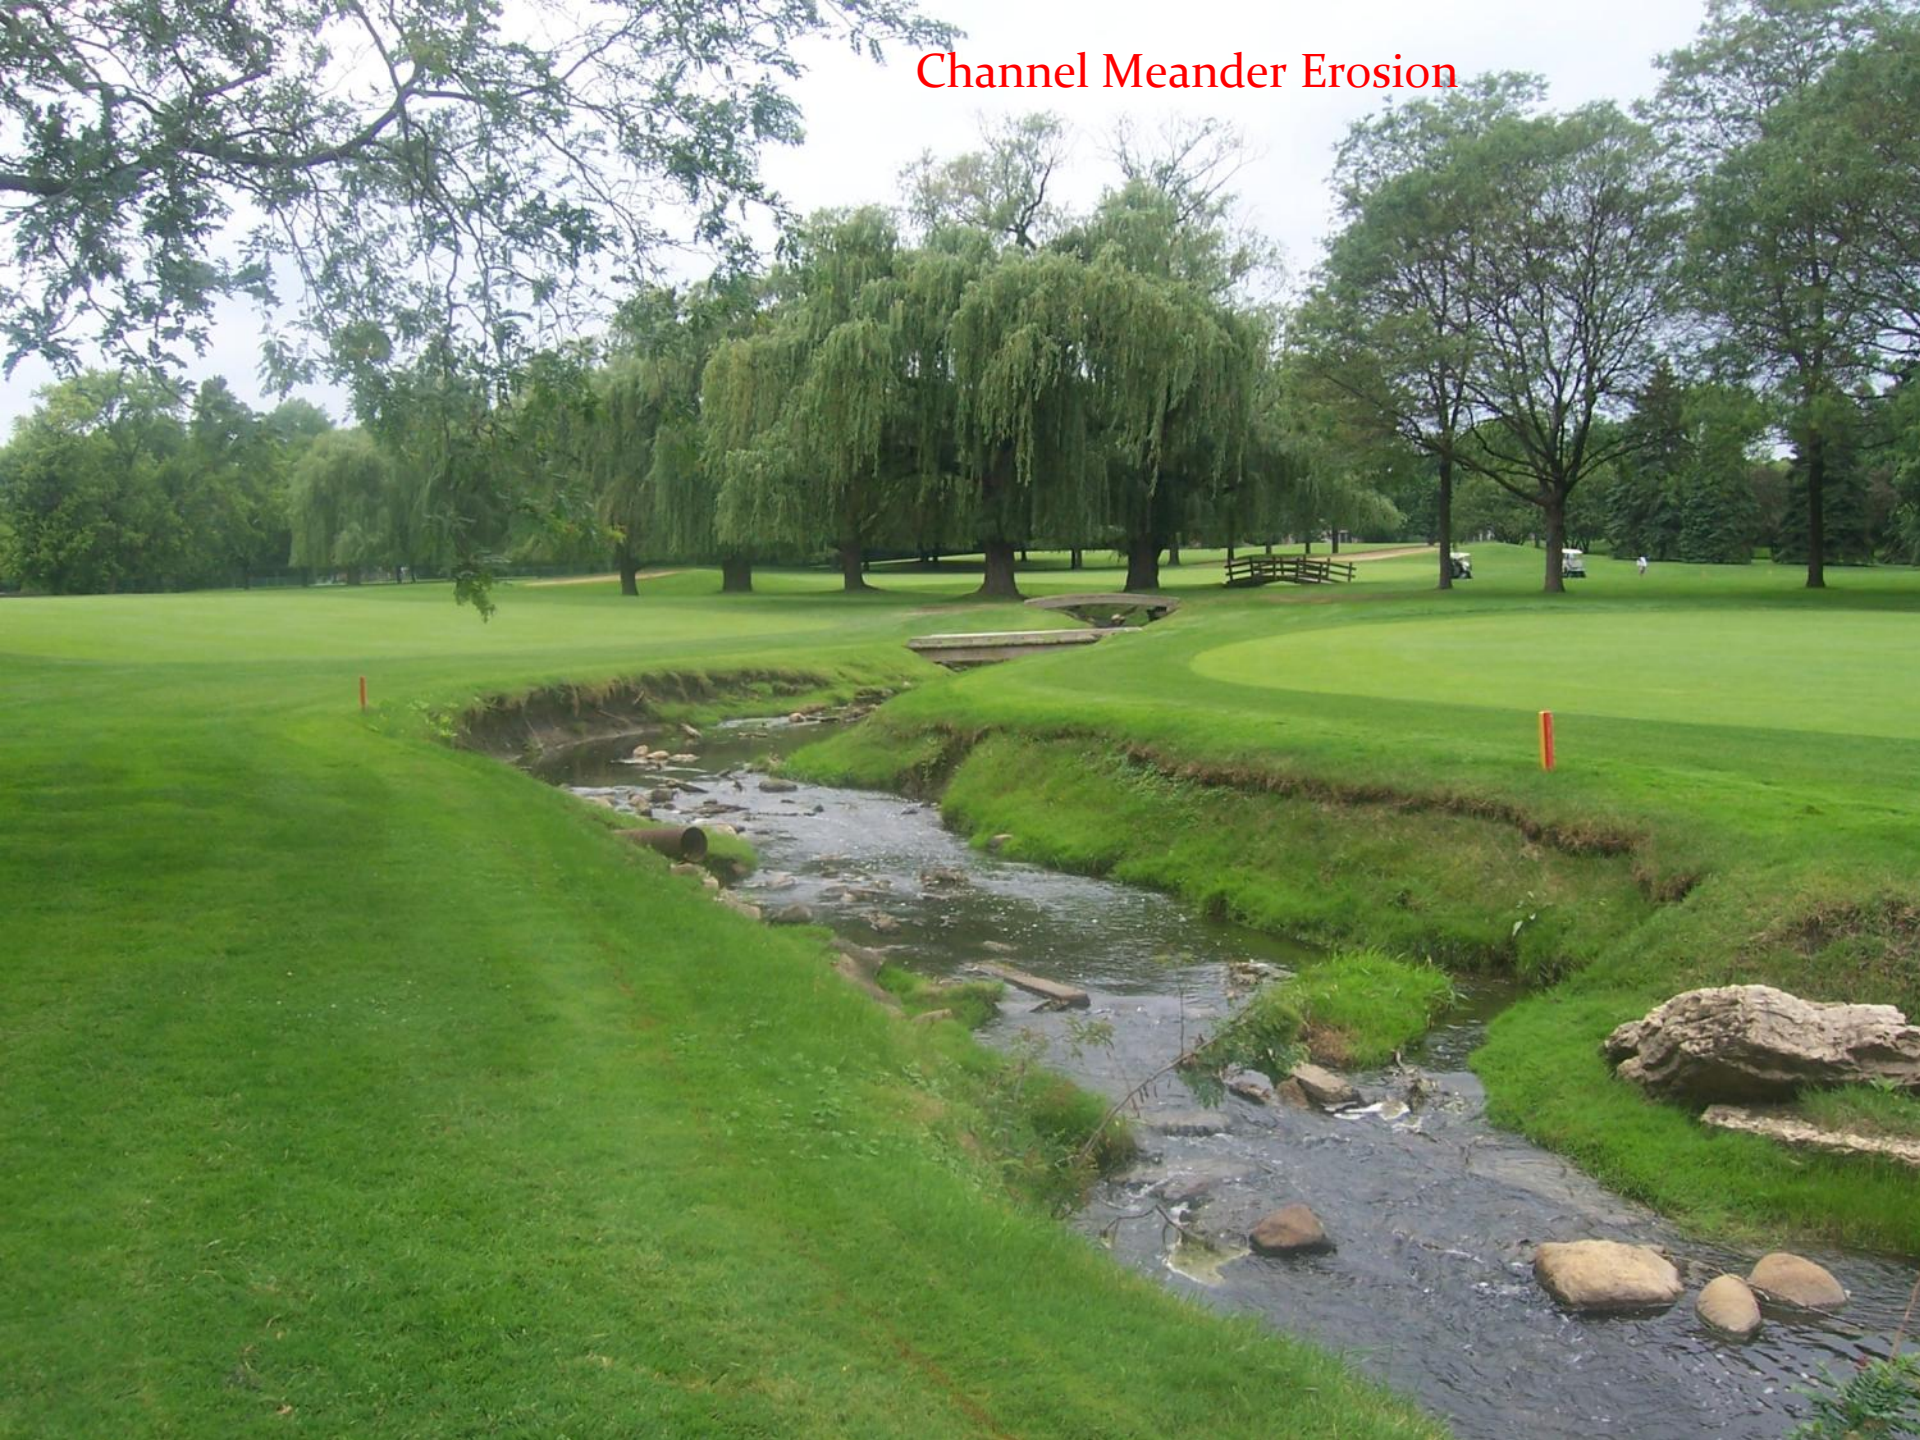
Channel Meander Erosion

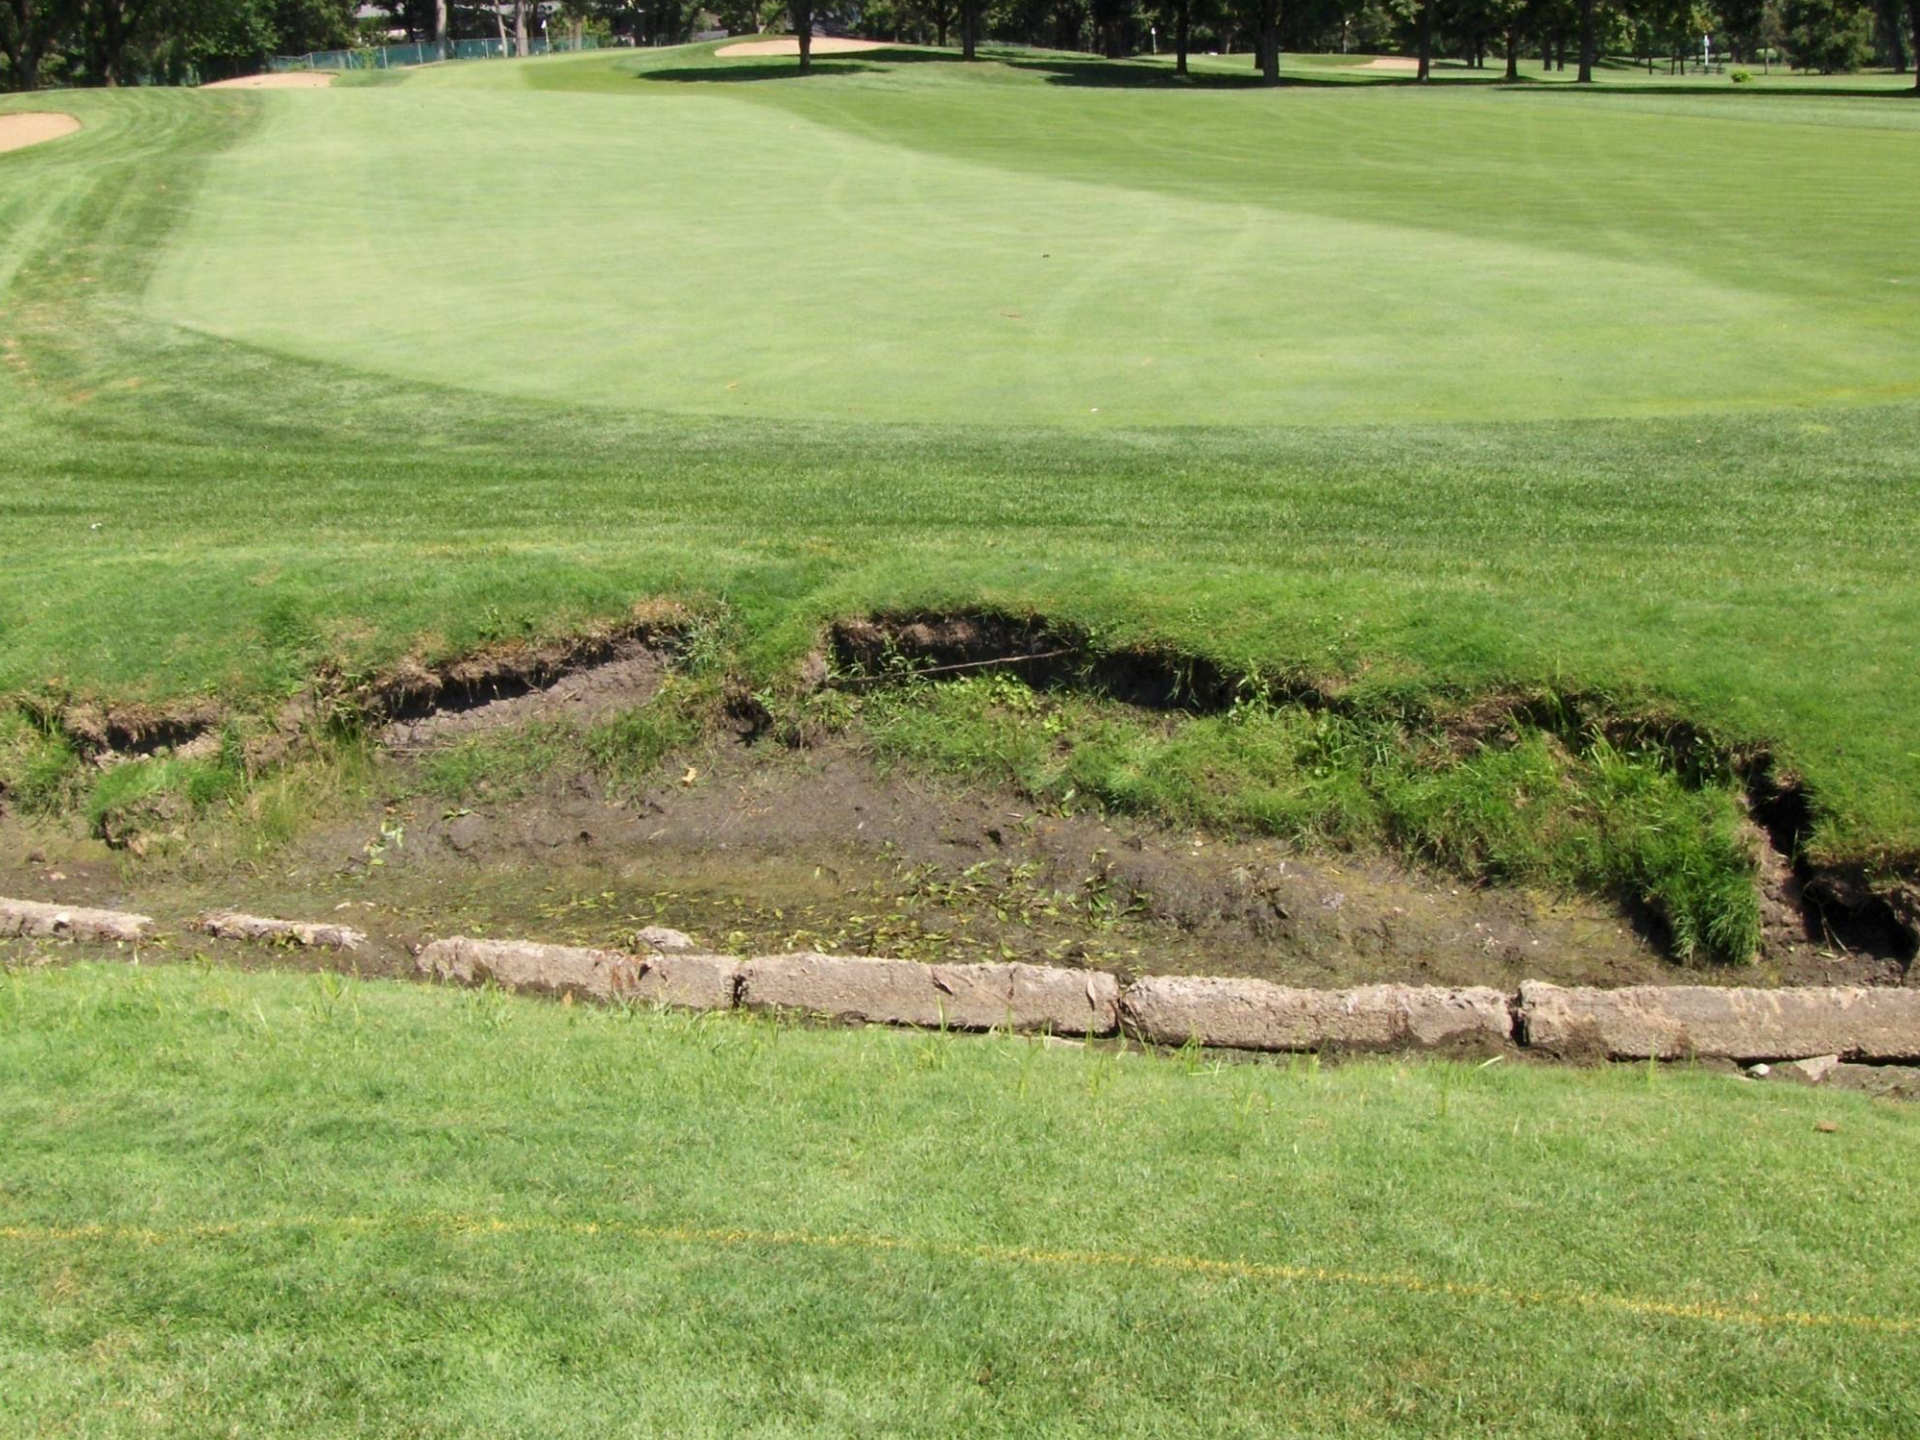
Tree and Bush Undercut
