Conducting BMP Inspections During the Pandemic

Saya Hickey, PE, Jacob Cantor, PE, Madison Gleason, EI

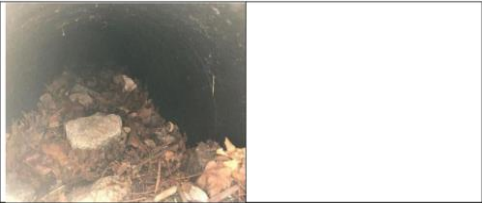
a. Principal Spillway Pipe No. 1

Blockage	3 - Low Priority / Functional
Blockage Description/Dimensions	Blocked by rip rap but functioning
Spalling/Deterioration Score	X - No Priority / Continue Routine Maintenance
Spalling/Deterioration Description/Dimensions	X - No Priority / Continue Routine Maintenance
Separation/Misaligned Joints Score	X - No Priority / Continue Routine Maintenance
Separation/Misaligned Joints Description/Dimensions	X - No Priority / Continue Routine Maintenance
Photos

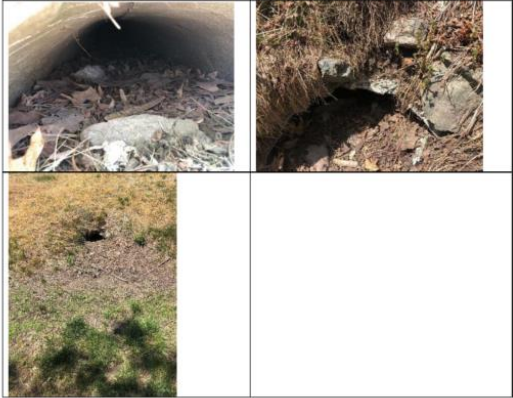
1. Upstream Inflow Pipe No. 1

End Type/Overland	Pipe End
Pipe Material	Concrete
Pipe Size	12 in
Blockage Score	2 - Moderate Priority / Approaching Non-functional
Obstruction Score	X - No Priority / Continue Routine Maintenance
Erosion/Undermining Score	X - No Priority / Continue Routine Maintenance
Spalling/Deterioration Score	3 - Low Priority / Functional
Separation/Misaligned Joints Score	X - No Priority / Continue Routine Maintenance
Overgrown Vegetation/Tree Removal Score	X - No Priority / Continue Routine Maintenance
Handrail Status Score	NA - Not Applicable
Downstream Channel Condition Score	X - No Priority / Continue Routine Maintenance
Other Score

Inflows: Debris, sediment and vegetation has built up inside and around the inflow pipes. Remove debris and clear the full length of the pipes (Moderate Priorityx2).

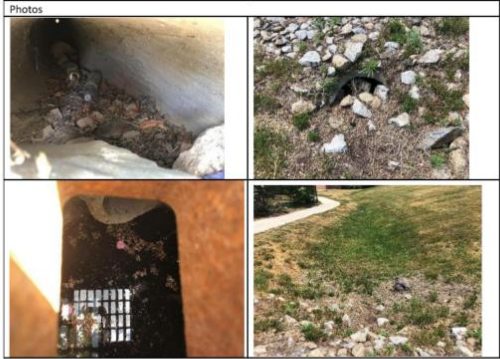
3. Upstream Inflow Pipe No. 3

End Type/Overland	Pipe End
Pipe Material	Concrete
Pipe Size	20in
Blockage Score	2 - Moderate Priority / Approaching Non-functional
Obstruction Score	3 - Low Priority / Functional
Erosion/Undermining Score	X - No Priority / Continue Routine Maintenance
Spalling/Deterioration Score	X - No Priority / Continue Routine Maintenance
Separation/Misaligned Joints Score	X - No Priority / Continue Routine Maintenance
Overgrown Vegetation/Tree Removal Score	X - No Priority / Continue Routine Maintenance
Handrail Status Score	NA - Not Applicable
Downstream Channel Condition Score	X - No Priority / Continue Routine Maintenance
Other Score	
Photos

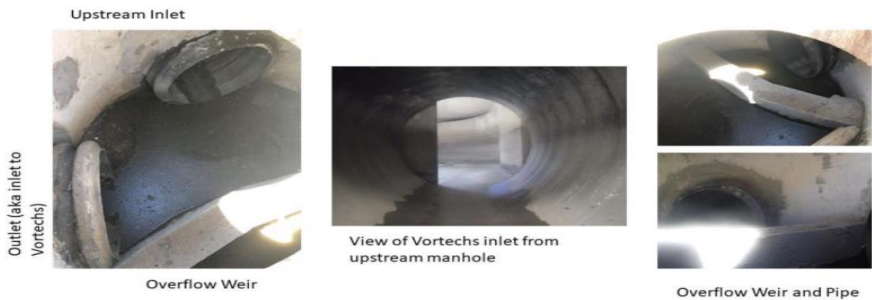
Manhole 1 – Upstream Inlet Manhole

Rim to Water Level	4.8'
Inlet Pipe - Rim to Invert	4.8'
Inlet Pipe - Rim to Crown	3.2'
Outlet Pipe (to Vortechs) - Rim to Invert	4.8'
Outlet Pipe (to Vortechs) - Rim to Crown	2.7'
Overflow Pipe - Rim to Invert	No Measurement
Overflow Pipe - Rim to Crown	No Measurement
Rim to Overflow Weir	3.7'
Manhole Condition Score	X - No Priority / Continue Routine Maintenance
Inlet Pipe - Blockage Score	X - No Priority / Continue Routine Maintenance
Outlet Pipe - Blockage Score	X - No Priority / Continue Routine Maintenance
Overflow Pipe - Blockage Score	X - No Priority / Continue Routine Maintenance

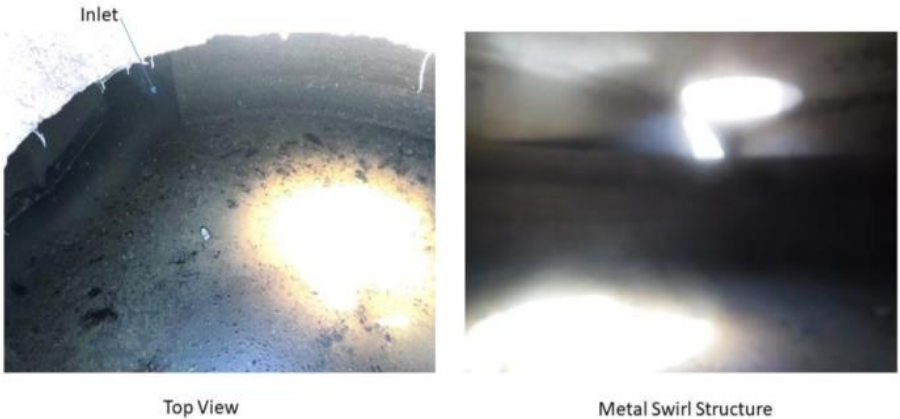
Manhole 2 – Swirl Chamber

Trash, debris and sediment was found inside the swirl chamber, floatables chamber and outlet chamber. It is recommended to removal these materials.

Rim to Sediment	6.3'
Rim to Water Level	4.4'
Sediment Score	1 - High Priority / Non-Functional
Manhole Condition Score	X - No Priority / Continue Routine Maintenance
Metal Structure Condition Score	X - No Priority / Continue Routine Maintenance

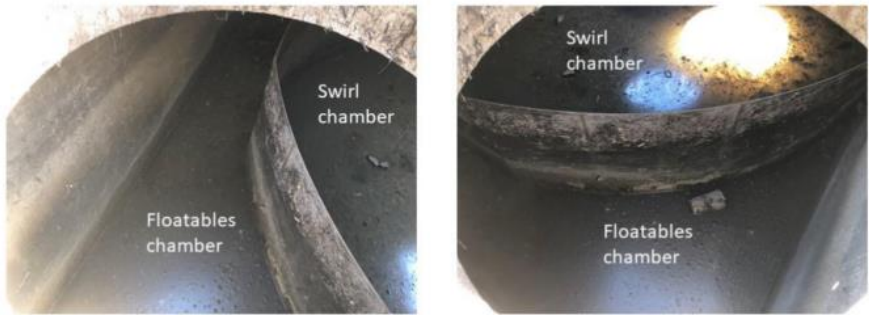
Manhole 3 – Floatables Chamber

Rim to Water Level	4.4'
Rim to Swirl Chamber Weir	2.4'
Rim to Bottom of Chamber	8'
Manhole Condition Score	X – No Priority / Continue Routine Maintenance
Sediment Score	3 Low Priority / Functional

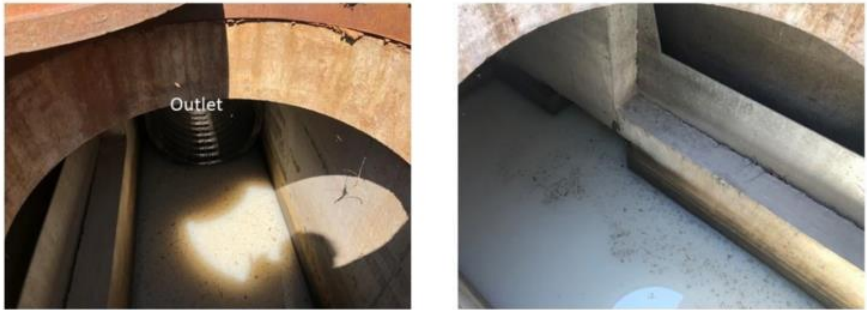
Manhole 4 – Outlet Chamber

Rim to Water Level	4.4'
Outlet Pipe – Rim to Invert	4.4'
Outlet Pipe – Rim to Crown	No Measurement
High Flow Weir	2.7'
Low Flow Orifice – Rim to Top	3.7'
Low Flow Orifice – Rim to Bottom	5.3'
Sediment Score	3 – Low Priority / Functional
Outlet Pipe Condition Score	X – No Priority / Continue Routine Maintenance
Outlet Pipe Blockage Score	X – No Priority / Continue Routine Maintenance
High Flow Weir Score	X – No Priority / Continue Routine Maintenance
Low Flow Orifice Score	X – No Priority / Continue Routine Maintenance
Manhole Condition Score	X – No Priority / Continue Routine Maintenance

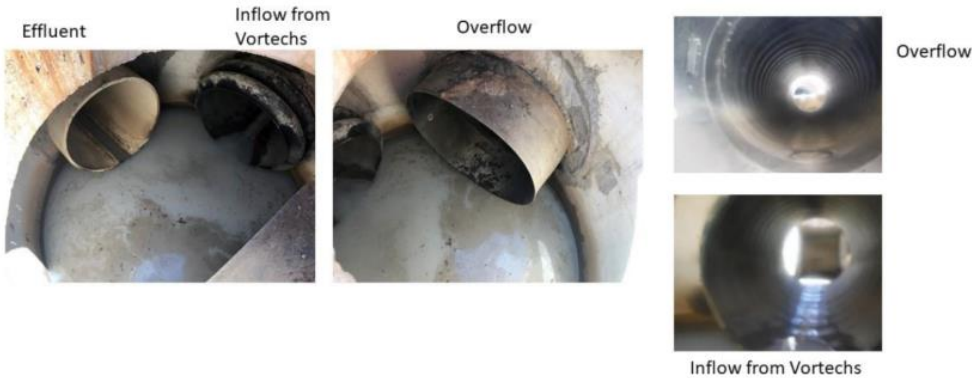
Manhole 5 – Downstream Effluent

Rim to Water Level	4.5'
Inlet Pipe (From Vortechs) - Rim to Invert	4.5'
Inlet Pipe (From Vortechs) - Rim to Crown	2.5'
Overflow Pipe – Rim to Invert	No Measurement
Overflow Pipe – Rim to Crown	No Measurement
Manhole Condition Score	X – No Priority / Continue Routine Maintenance
Inlet Pipe – Blockage Score	X – No Priority / Continue Routine Maintenance
Outlet Pipe – Blockage Score	X – No Priority / Continue Routine Maintenance
Overflow Pipe – Blockage Score	X – No Priority / Continue Routine Maintenance

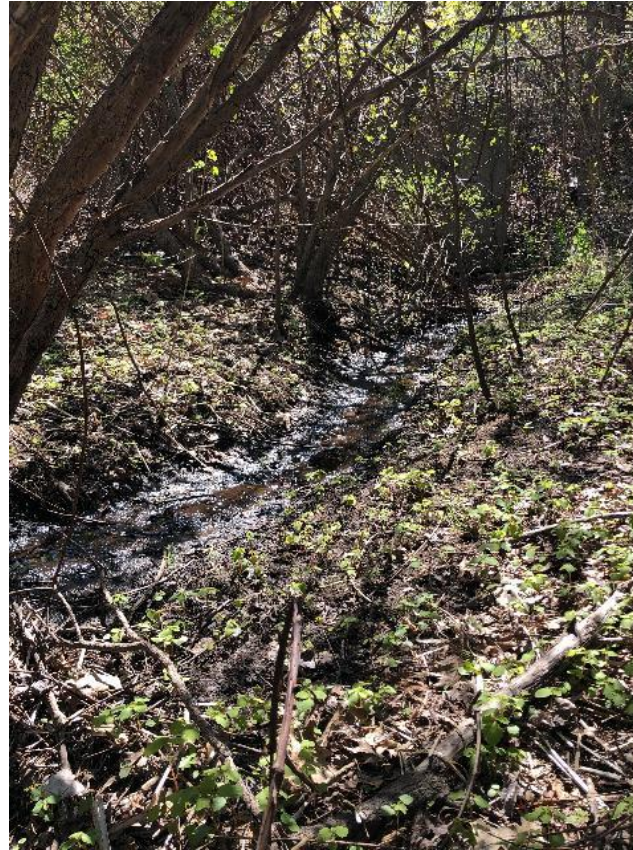
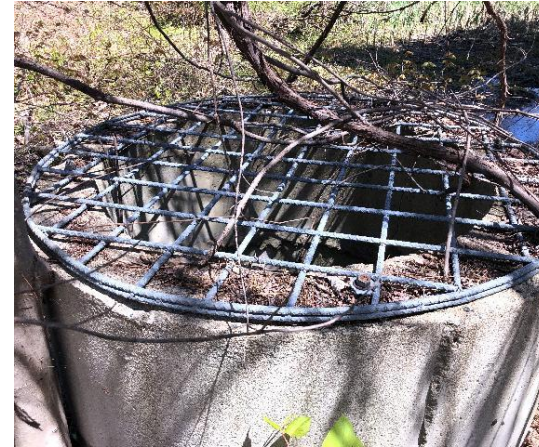
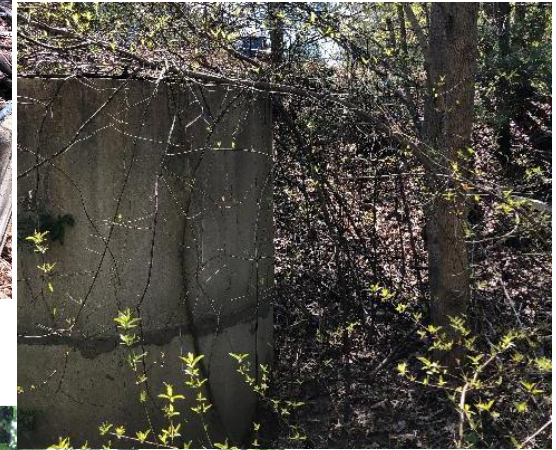
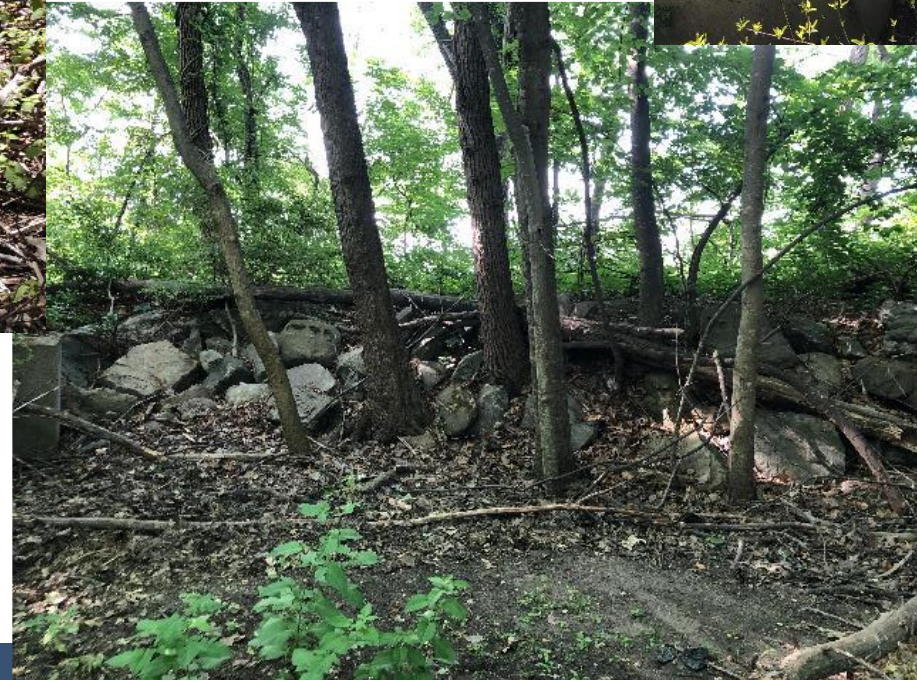
- Common Defects
 - Overgrown Vegetation
 - Blockages
 - Structural issues
 - Alterations/Encroachment
 - Erosion

- Remove vegetation (39 BMPs)
- Restore flow channels (19 BMPs)
- Repair Structures (16 BMPs)
- Remove debris and regrade pond floor (15 BMPs)
- Mitigate erosion (5 BMPs)
- Retrofits to remove ponds from jurisdictional waters (4 BMPs)
- Investigate potential illicit discharges (2 BMPs)

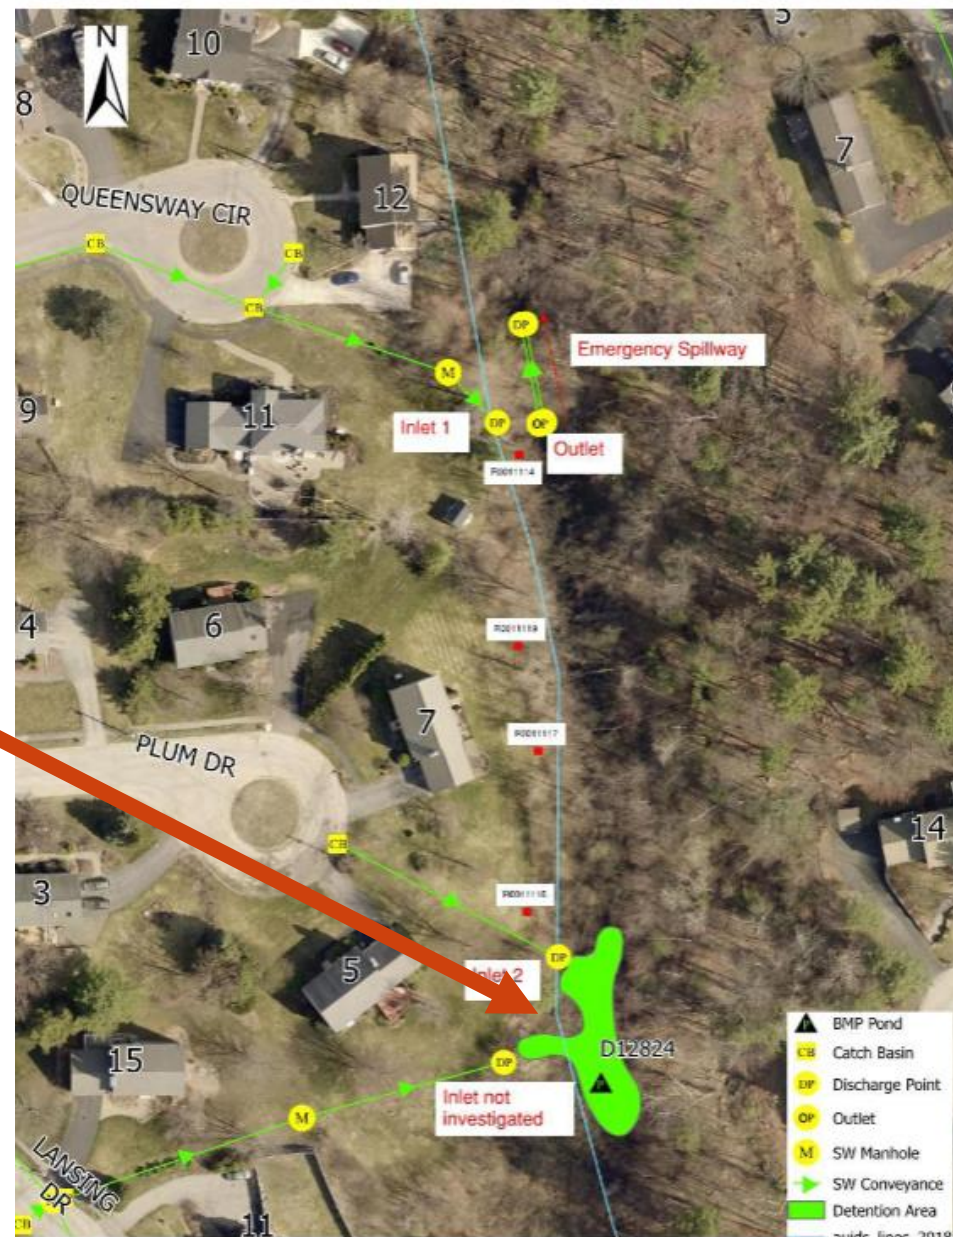
- Four ponds were found to be installed in jurisdictional waters
 - D12824** 77 Plum Dr
 - D12826 Alford Ln
 - D12827 11 Greenock Ln
 - D12828 23 Elaine Dr

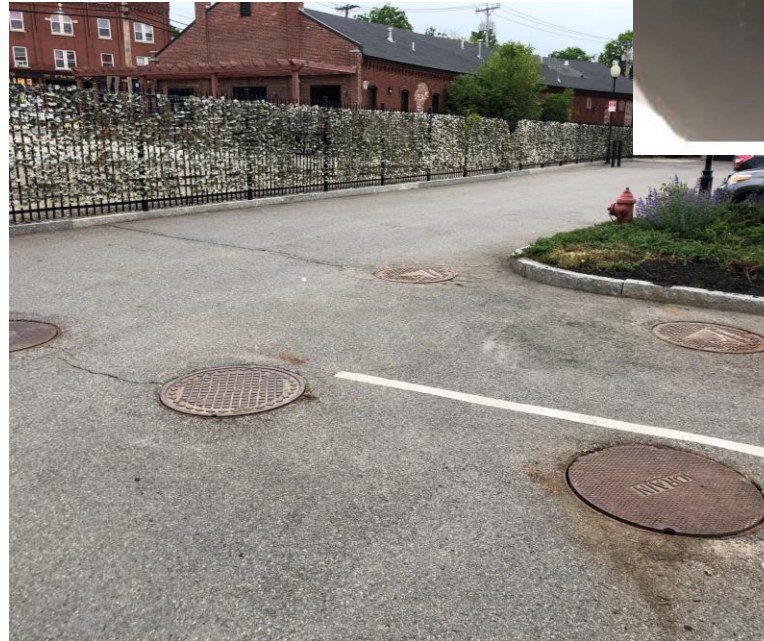
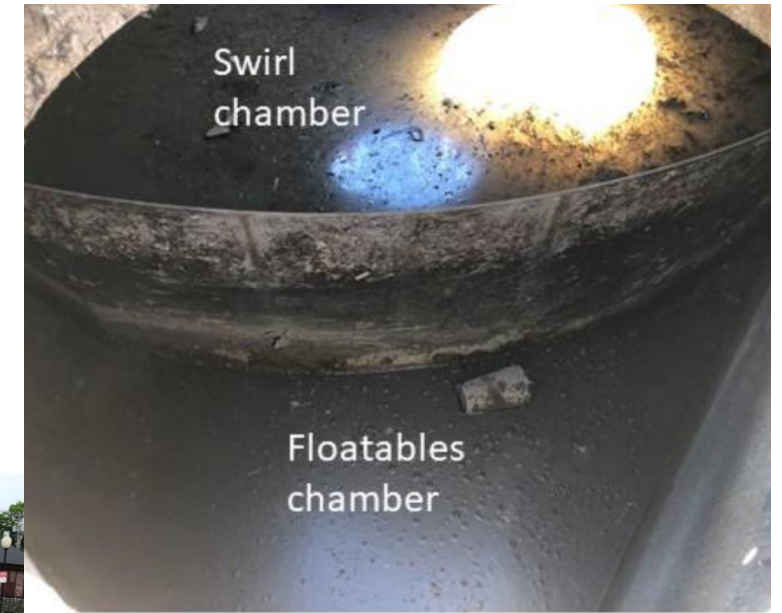
- Observed build up of sediment and floatables
- Most structural components appear sound
- Some manhole covers damaged and/or rusted

- Remove Sediment, Debris, Blockages (5 BMPs)
- Replace Rim and Covers (1 BMP)
