# VILLAGE OF ORLAND PARK, COOK COUNTY, IL

## POND EVALUATIONS

**Jedd M. Anderson - PWS, CPESC, CWS**  
**Vice President – Environmental Resources Dept**

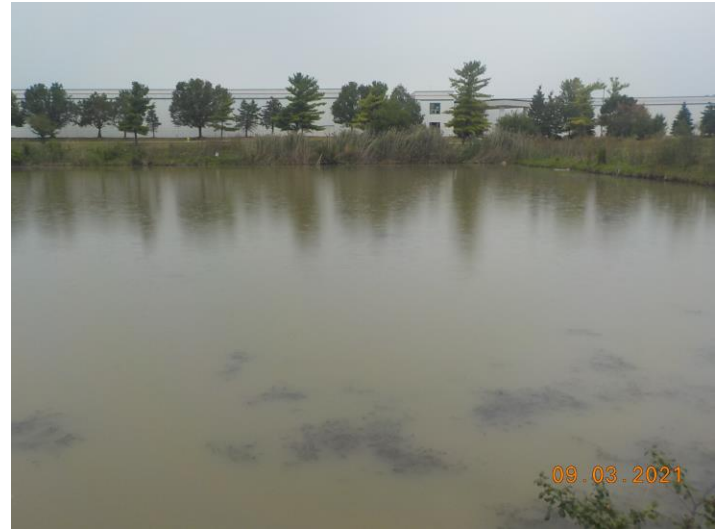
DSCN5778

Muskrats

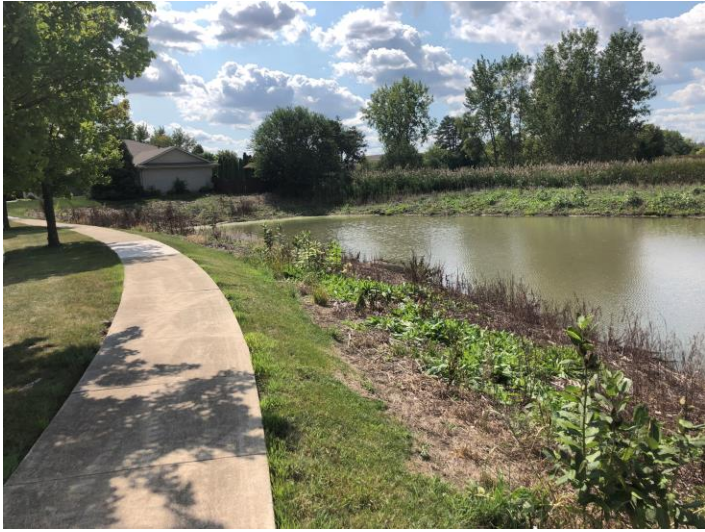
IMG\_7008

Management was completed but nothing installed to replace the weeds. Needs to be supplemental seeded.

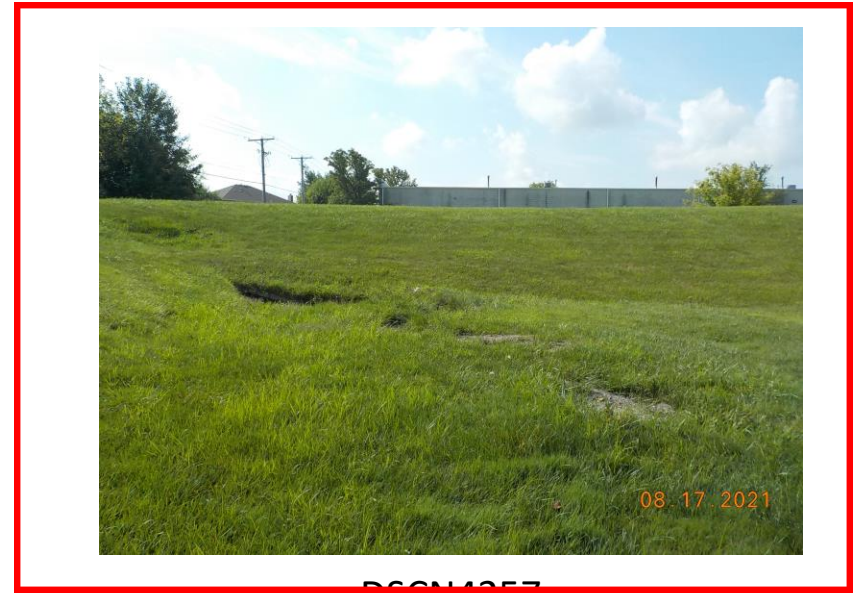
DSCN4257

Sediment 3' deep

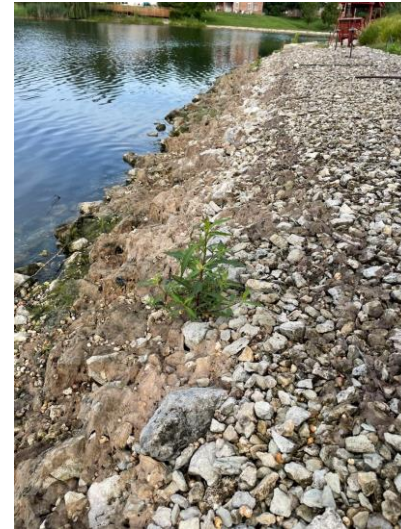
8

Voids from pipe separation  
Safety hazard
