Geosyntec Consultants

Cascading Dam Breach Analysis

- Need for Dam Breach Analysis
 - Edenville (MI)
- Case Study of 3 Dams in Series
- Lessons Learnt

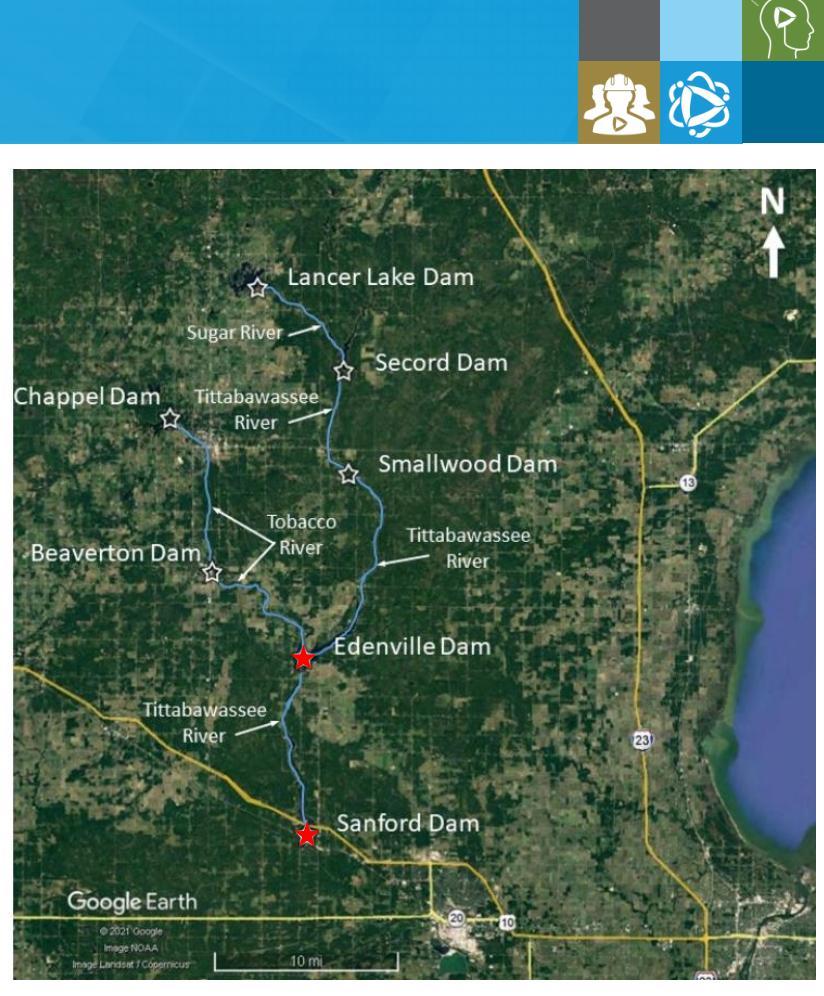
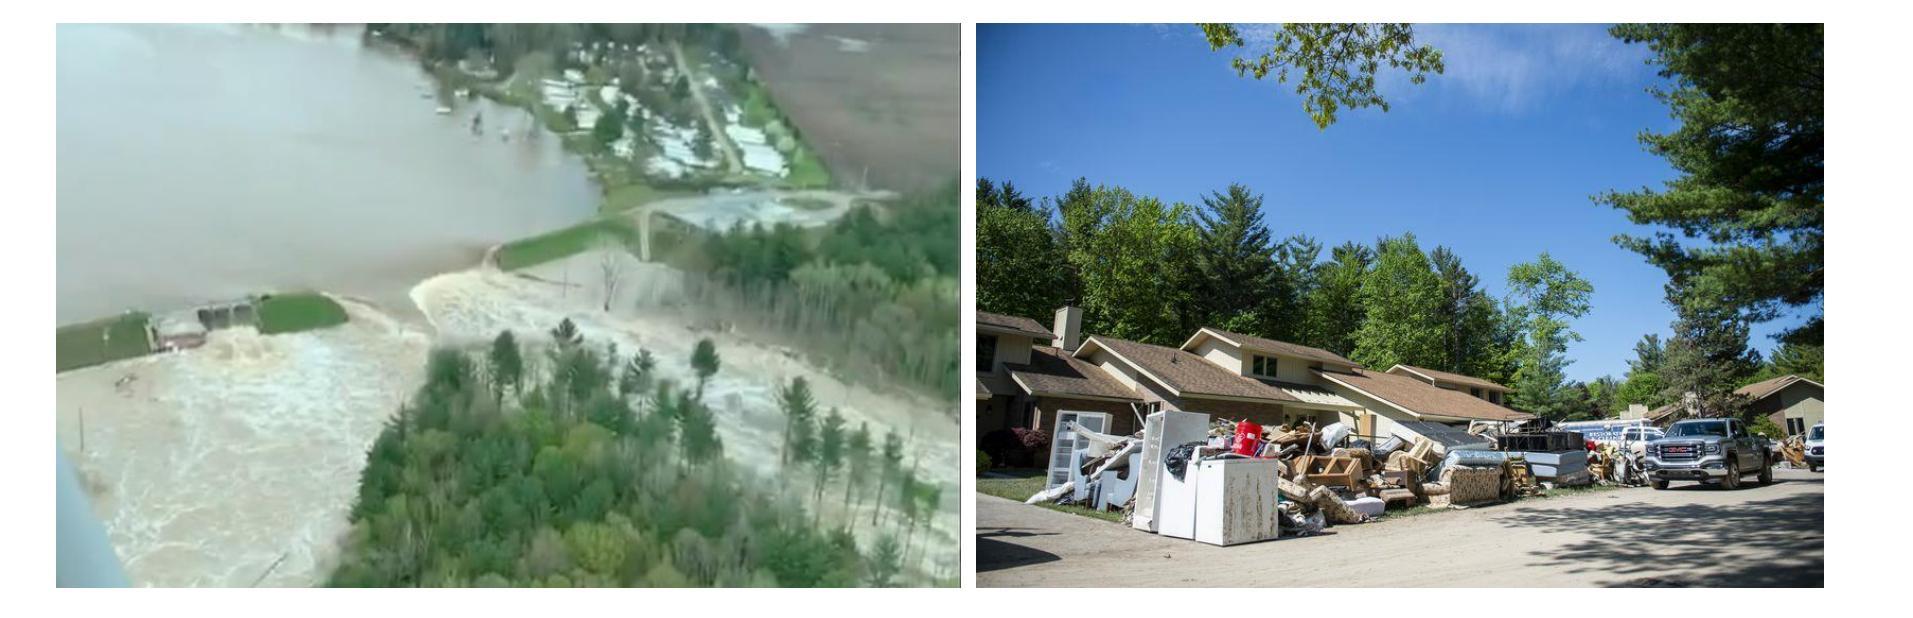
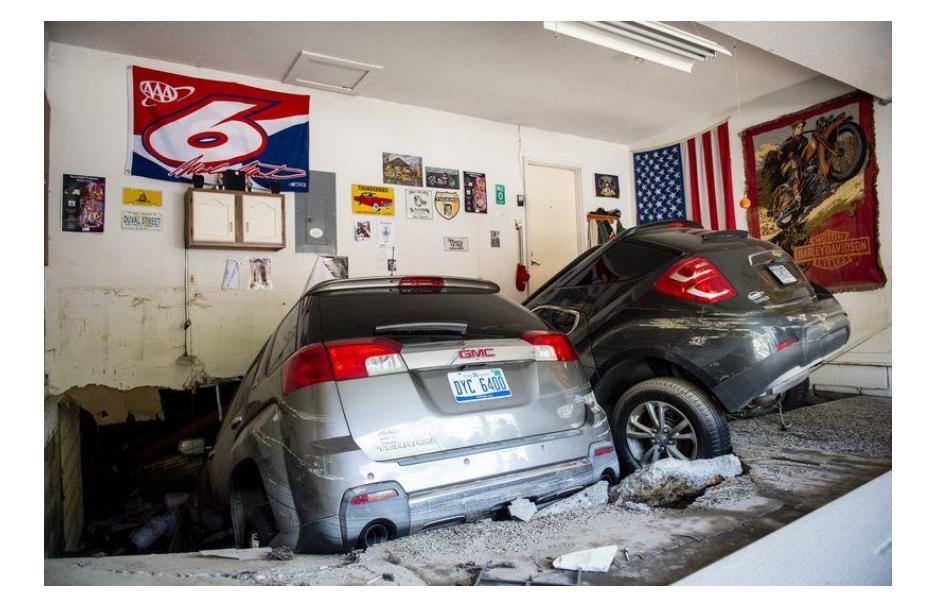
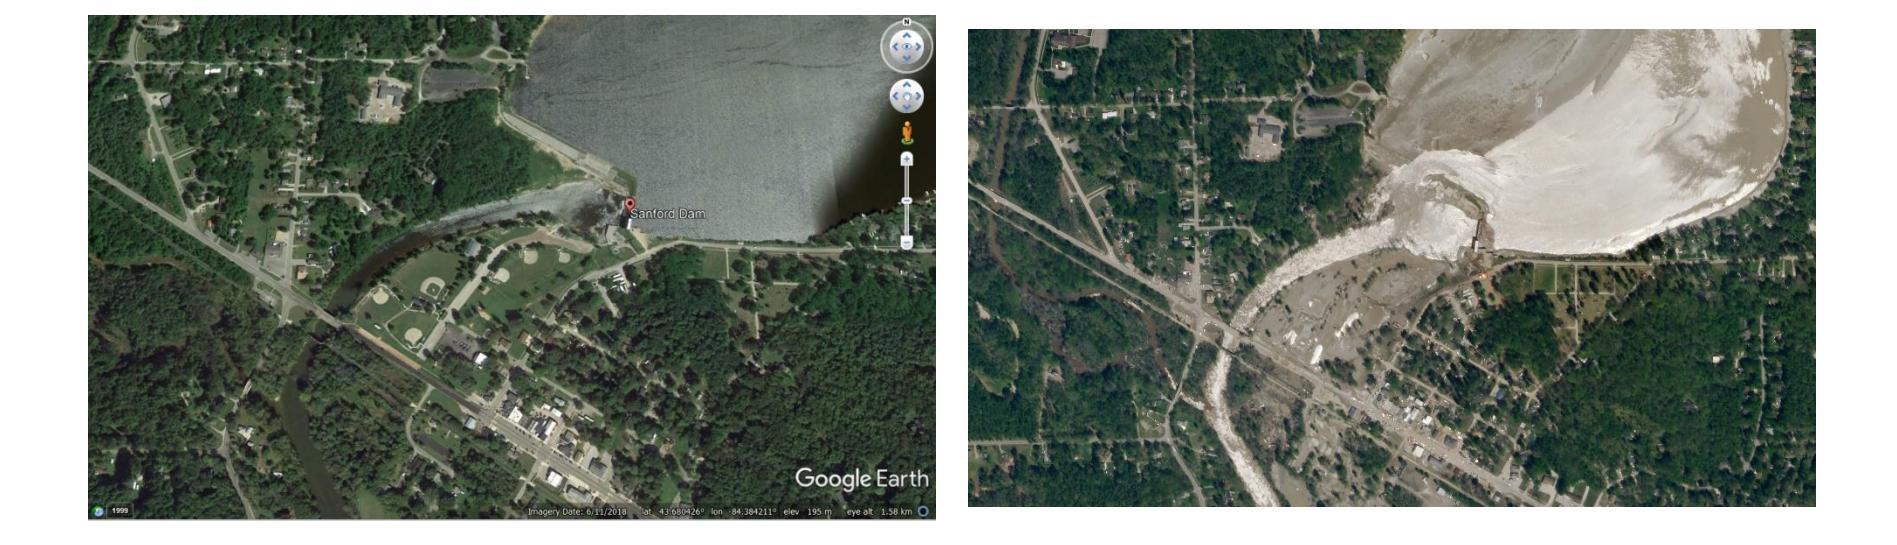
Edenville Dam Failure

- 5:35 p.m. on May 19, 2020
- Static Liquefaction
 - failure of loose, saturated sands in the downstream section of the dam which led to embankment instability
 - Rare type of failure

- 7:46 p.m. on May 19, 2020
- Embankment overtopping
- Breach outflows from Edenville Dam Breach

- More than \$200 million in estimated damages
- Temporary evacuation of about 10,000 people in two counties

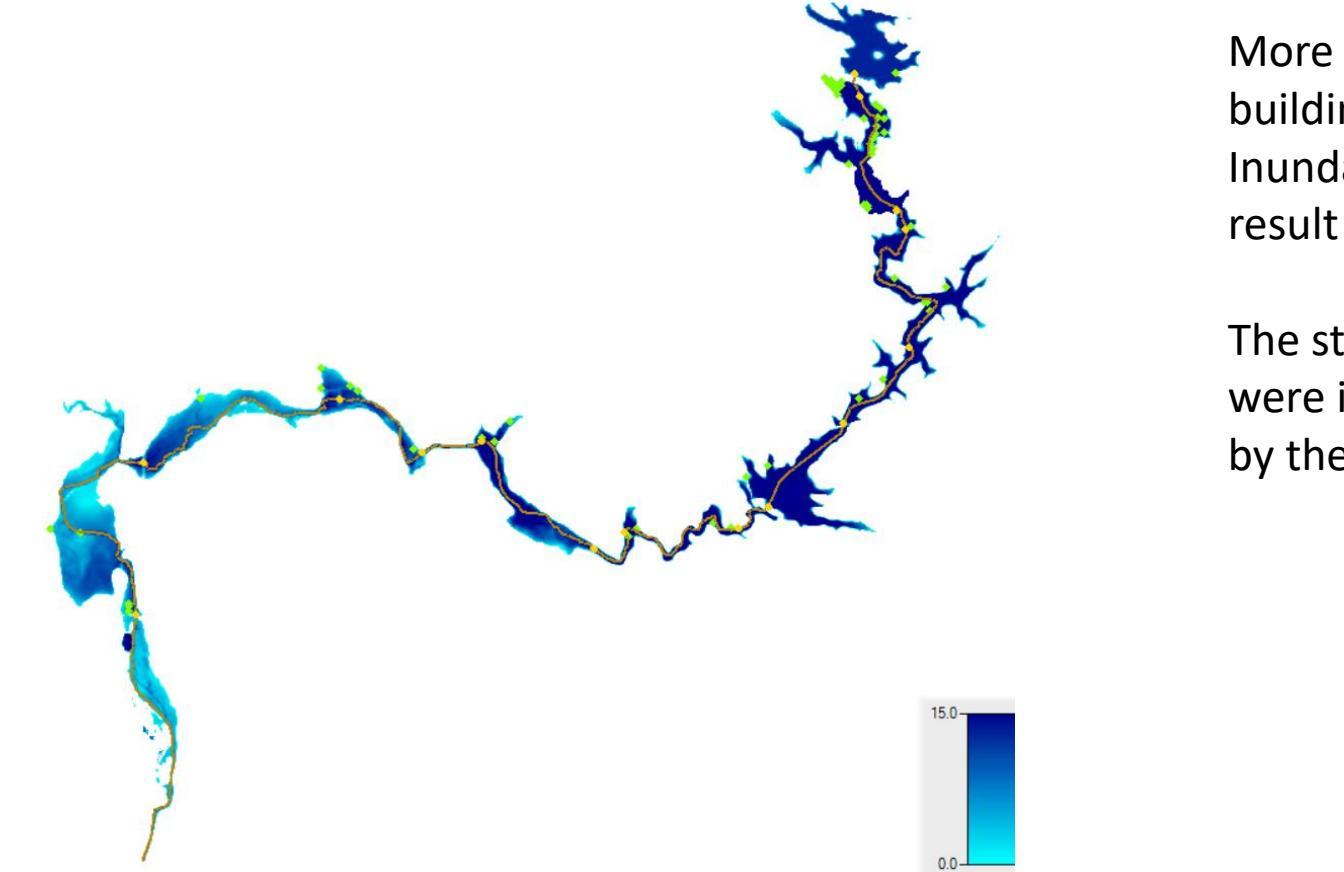
Inundation Map

More than 70 buildings were Inundated as a result!

The structures were identified by the regulator.
