# Internal Phosphorus Loading: What is it and how do we manage it?

*IAFSM Annual Conference March 12, 2024*

**Dendy Lofton, PhD, CLM**

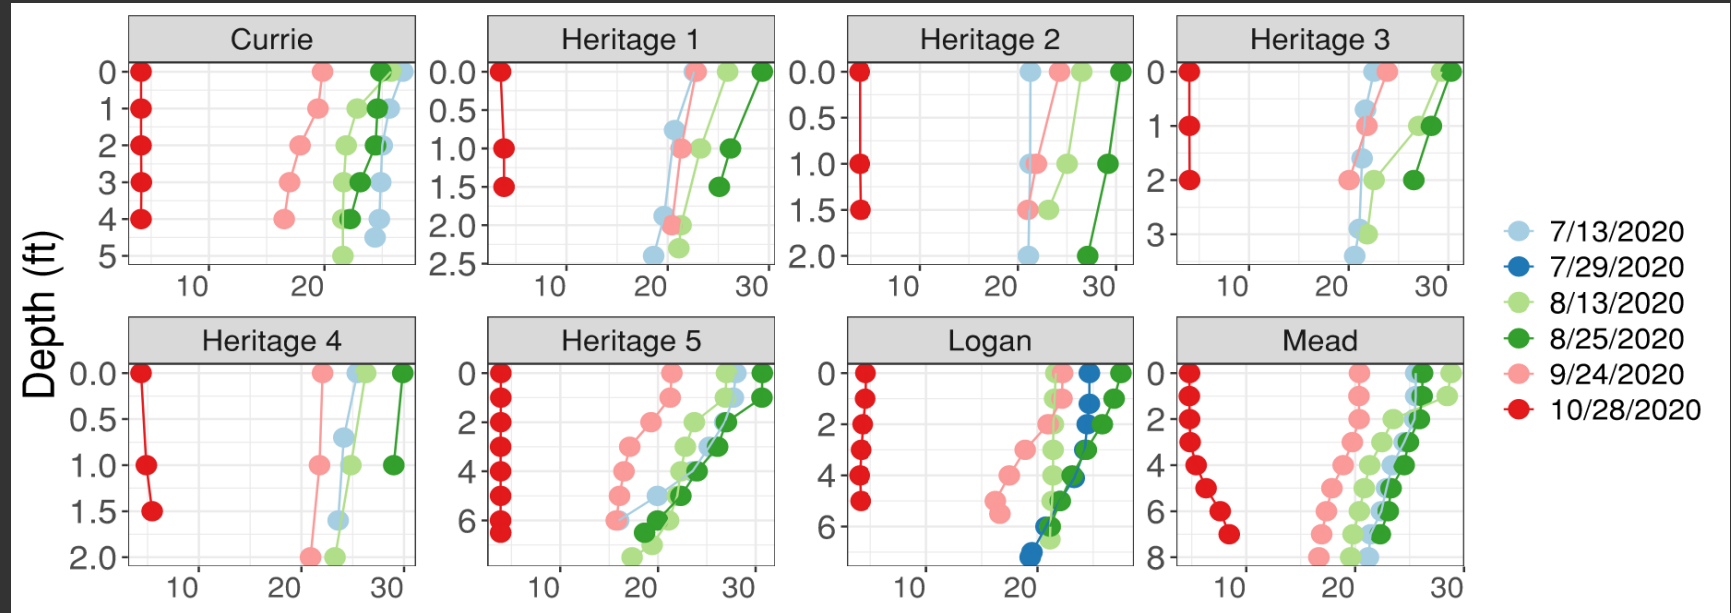
Temperature

# Misconceptions with Shallow Pond Mixing

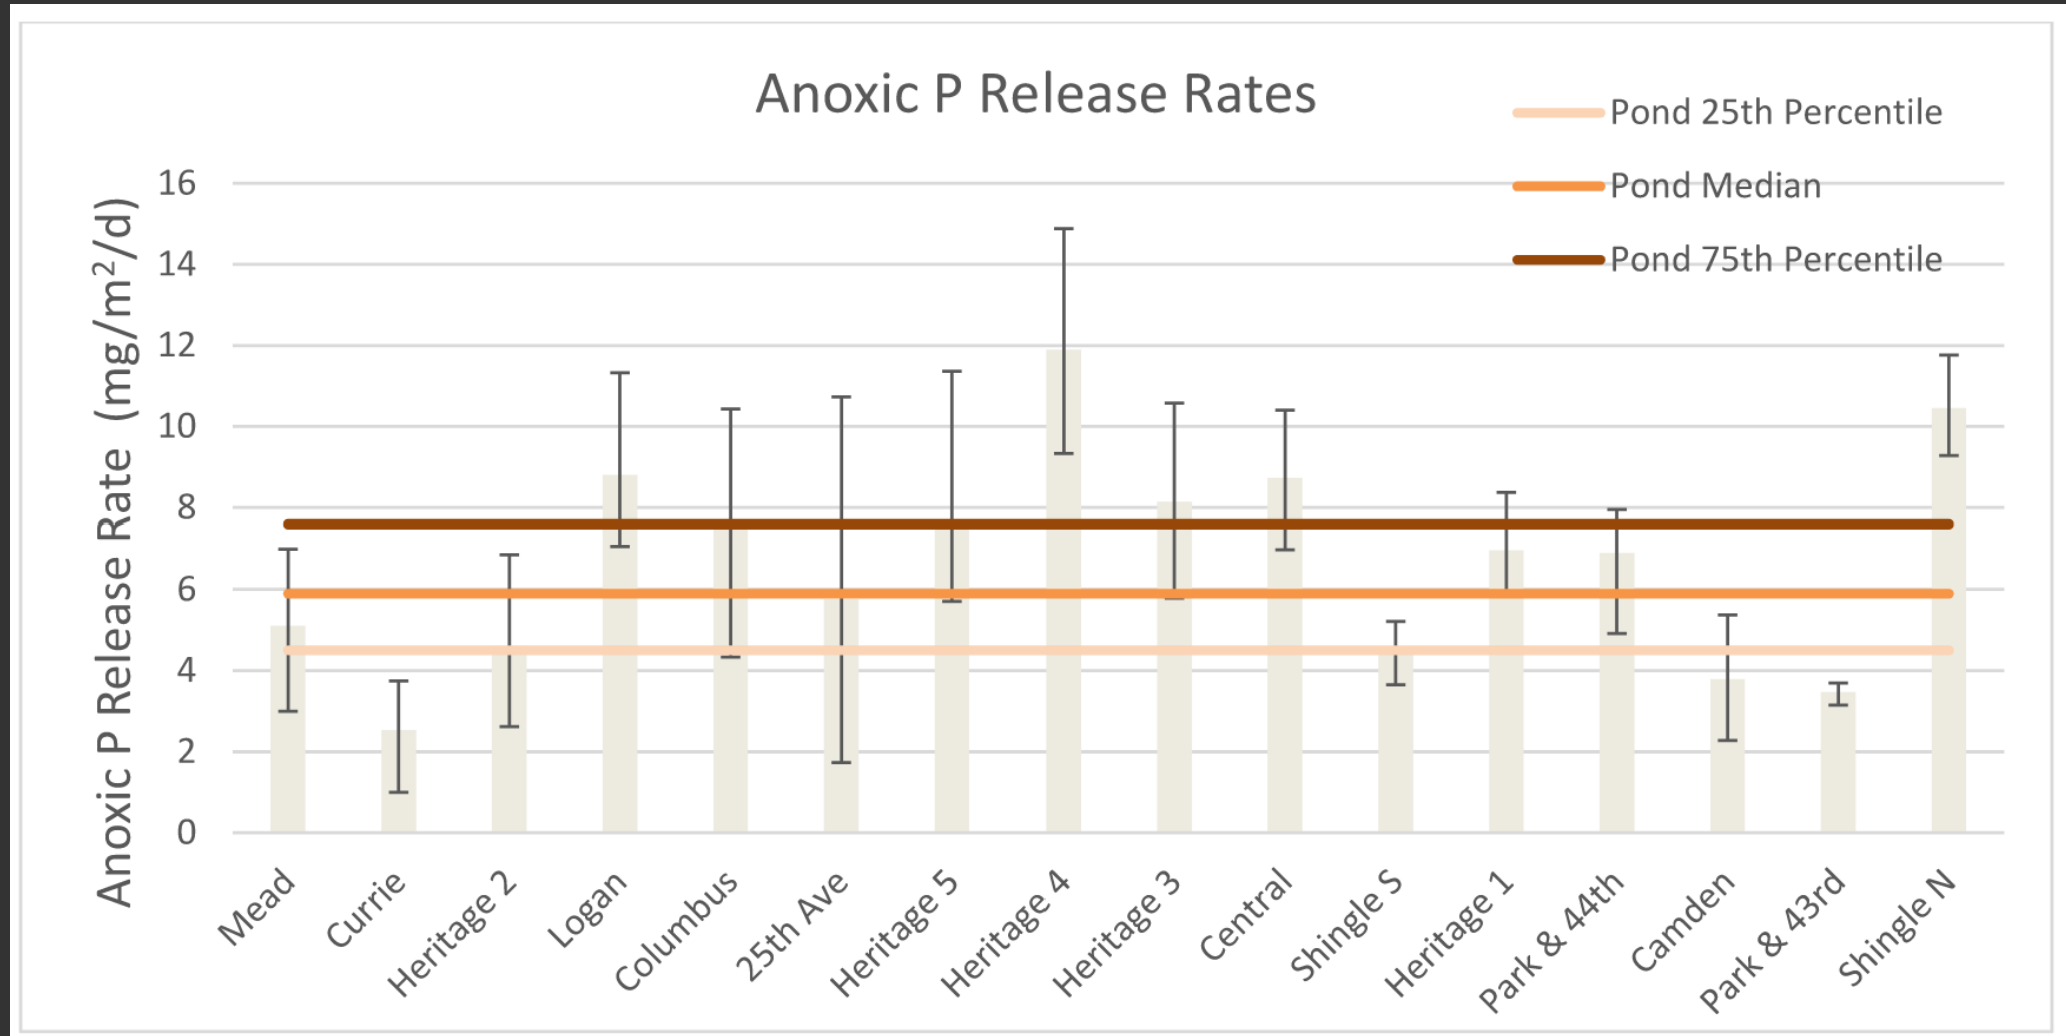
# Sediment P Release – Minneapolis Ponds

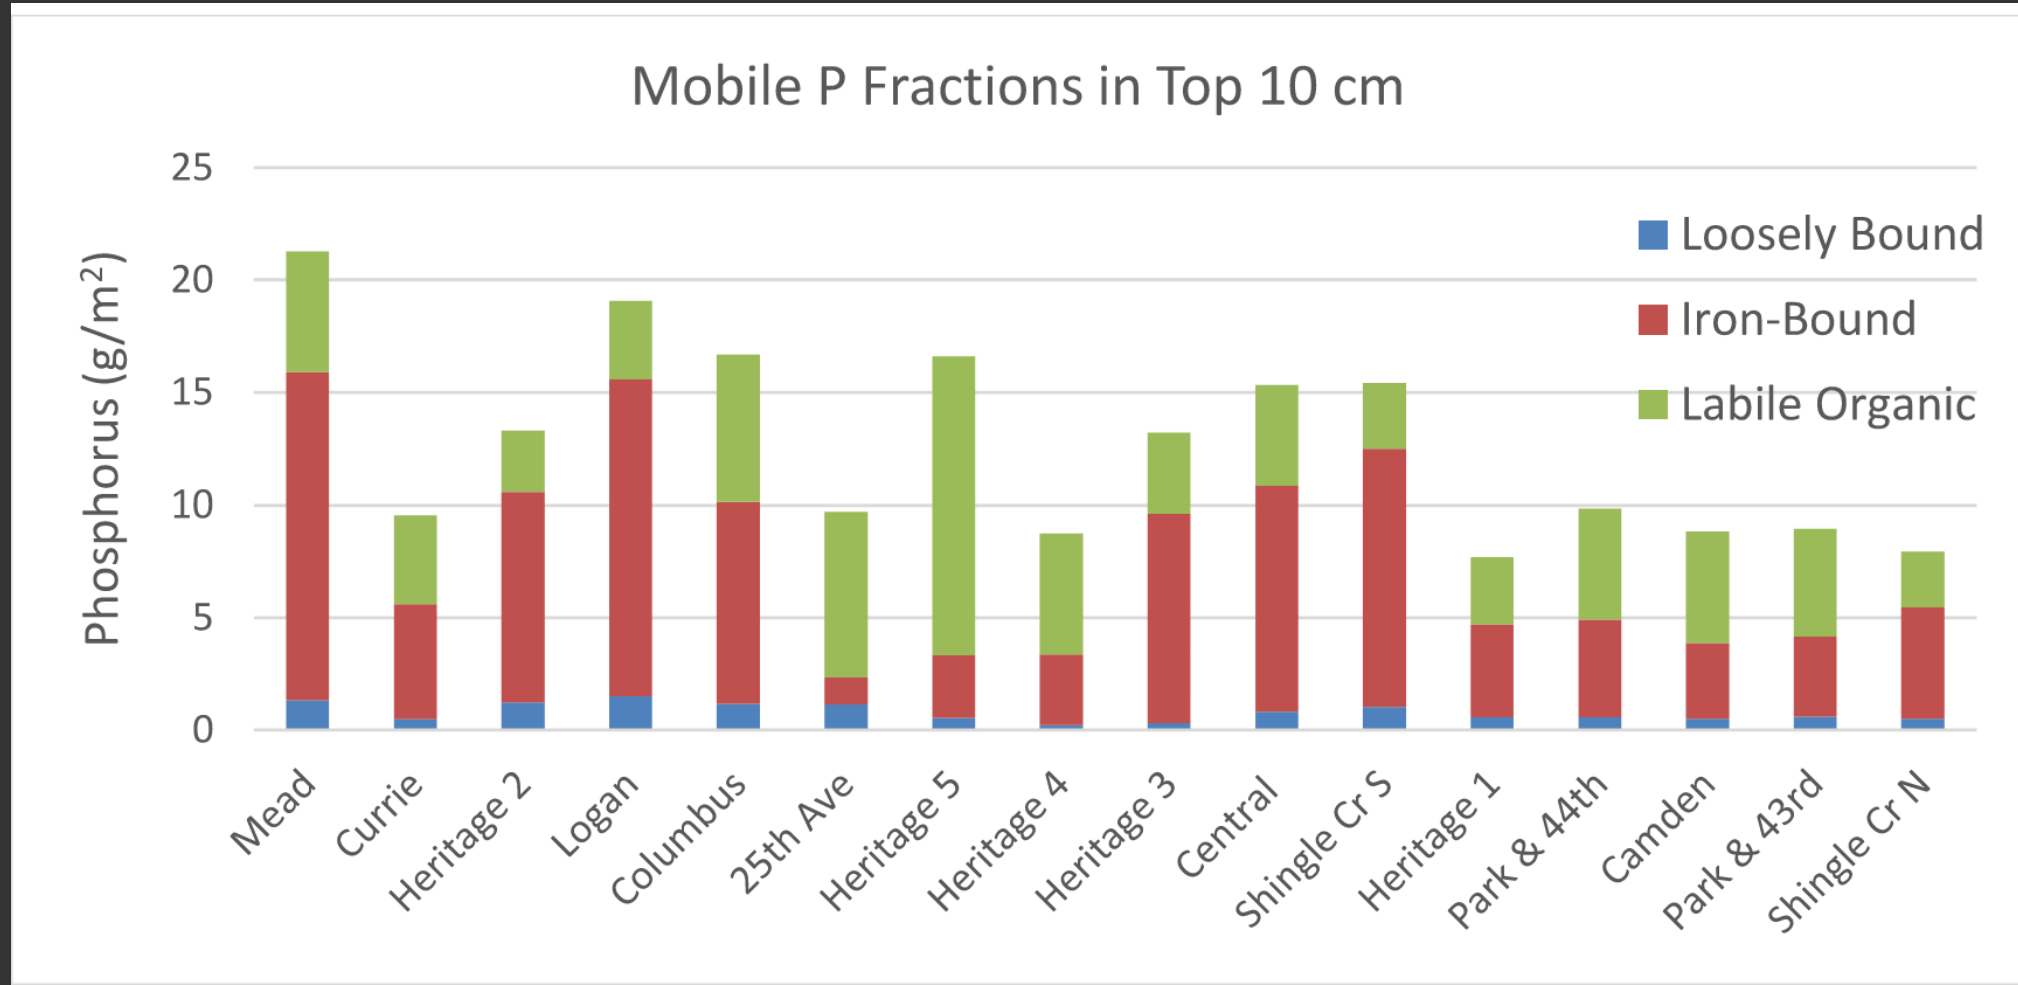
# Sediment P Fractions – Minneapolis Ponds

Operational Grouping	P Fraction	Recycling Potential
<b>Mobile P pool</b>	Iron-bound P	Biologically-labile and subject to mobilization through biogeochemical and geochemical reactions.
	Loosely-bound P	
	Labile organic P	
<b>Non-mobile P pool</b>	Aluminum-bound P	Biologically-refractory and subject to burial; not readily available for biological uptake.
	Calcium-bound P	
	Refractory P

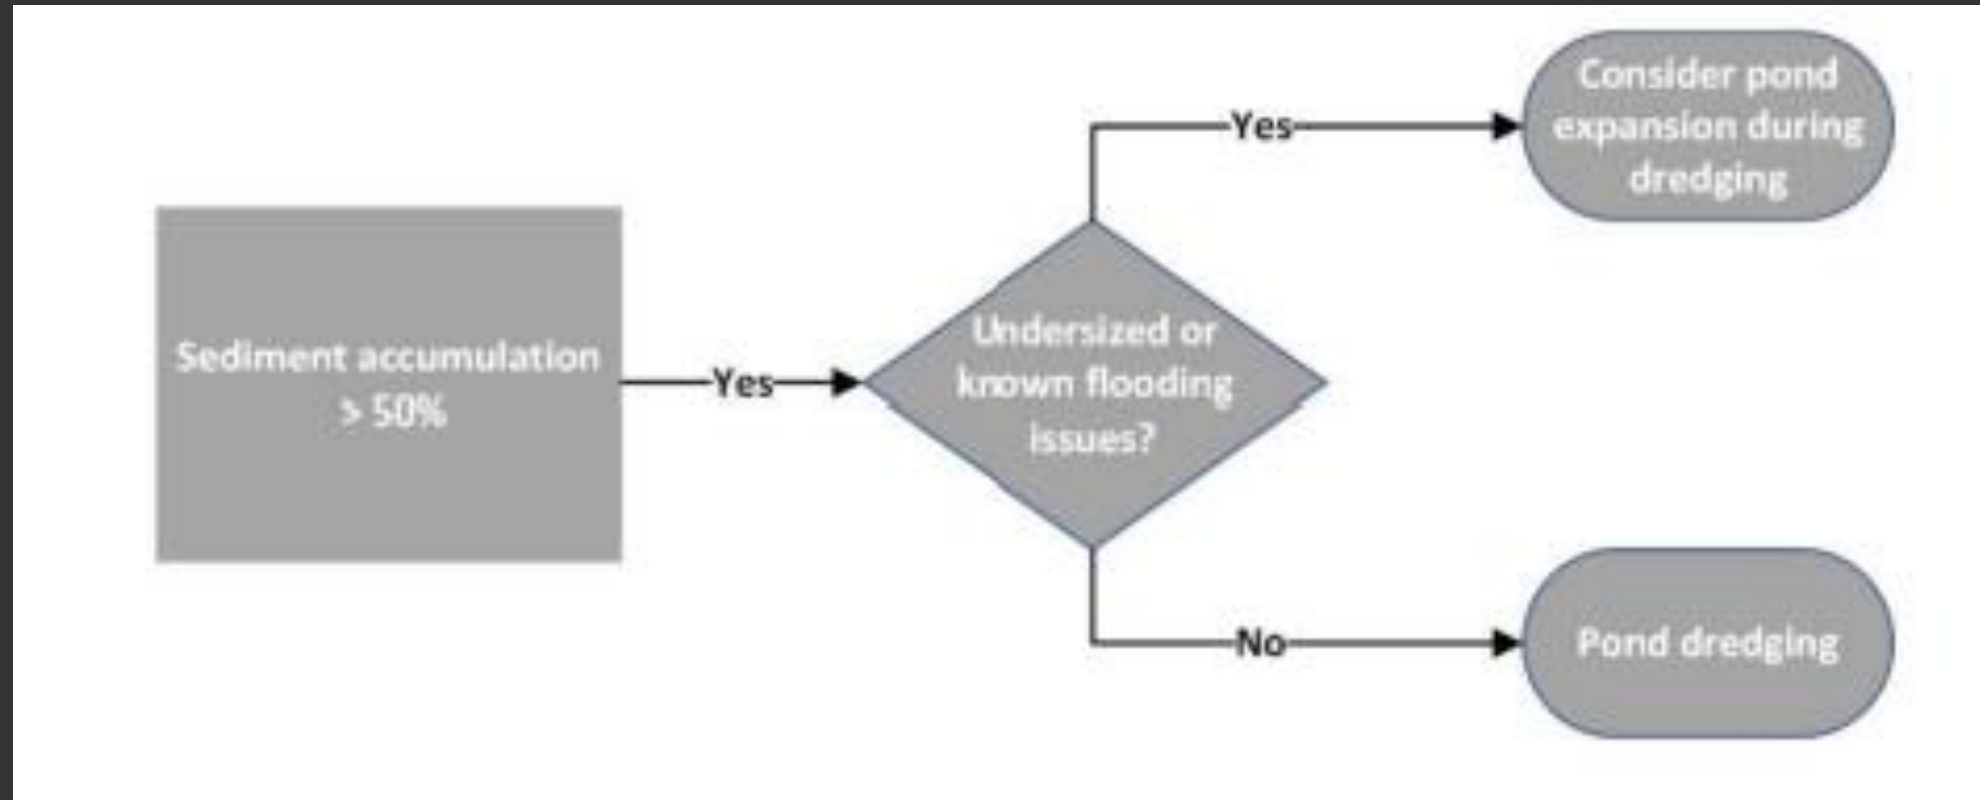
# Management Decision Tree

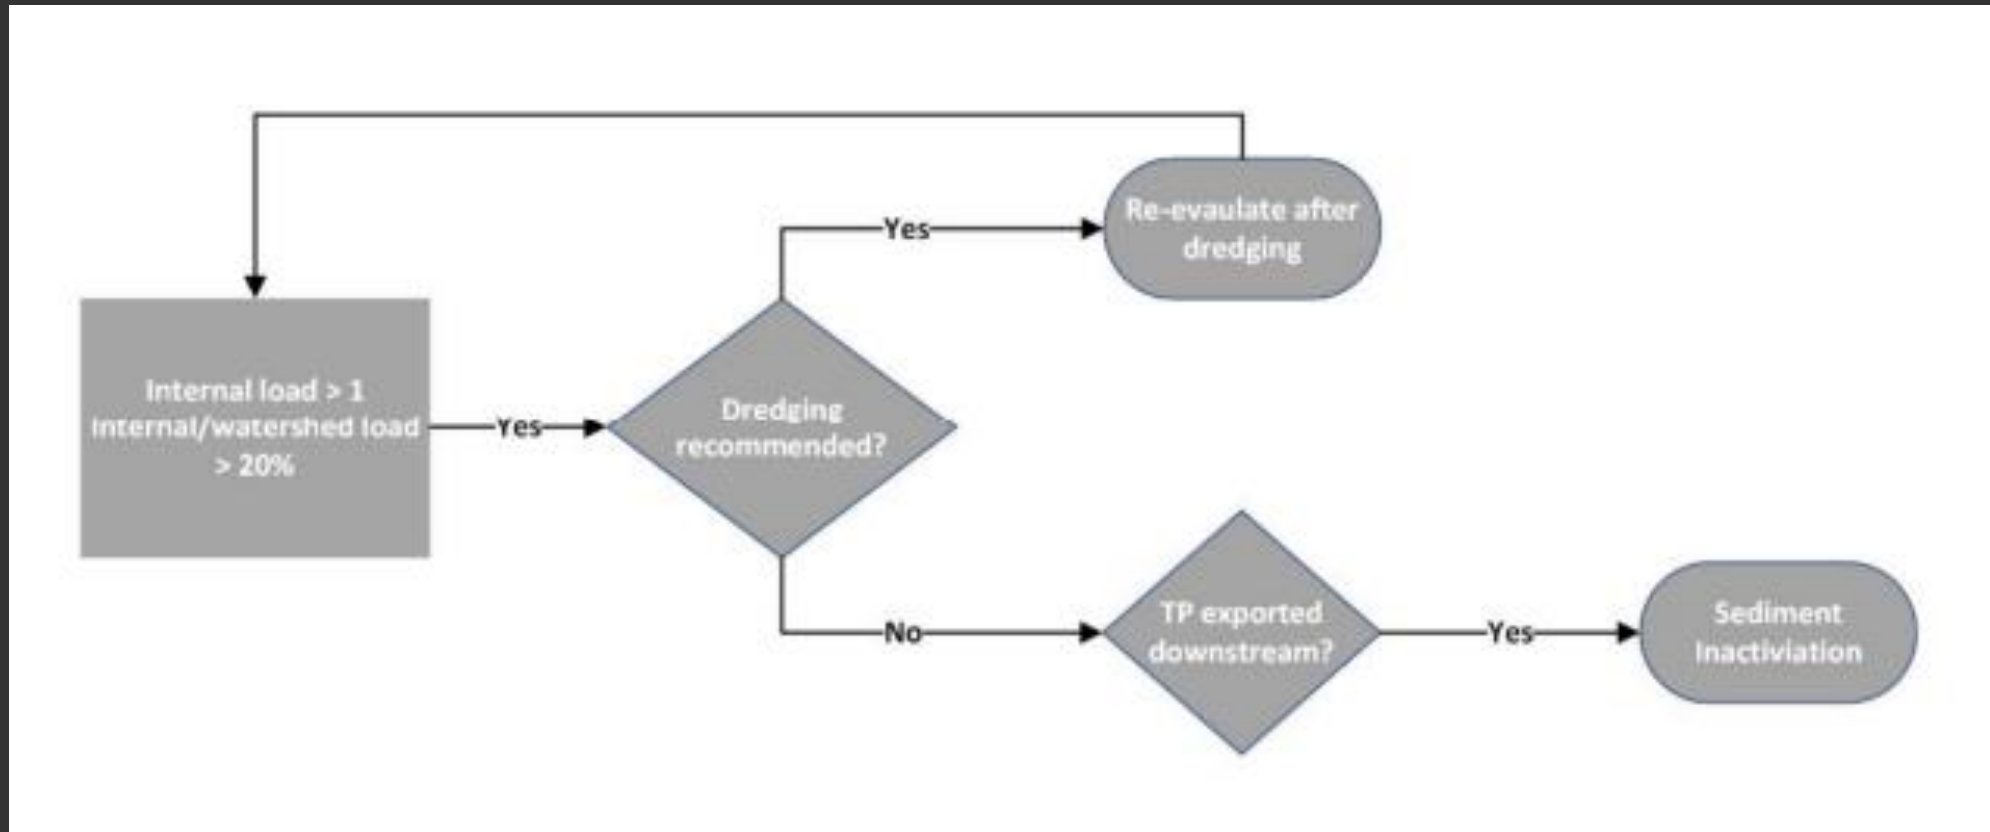
# Management Decision Tree

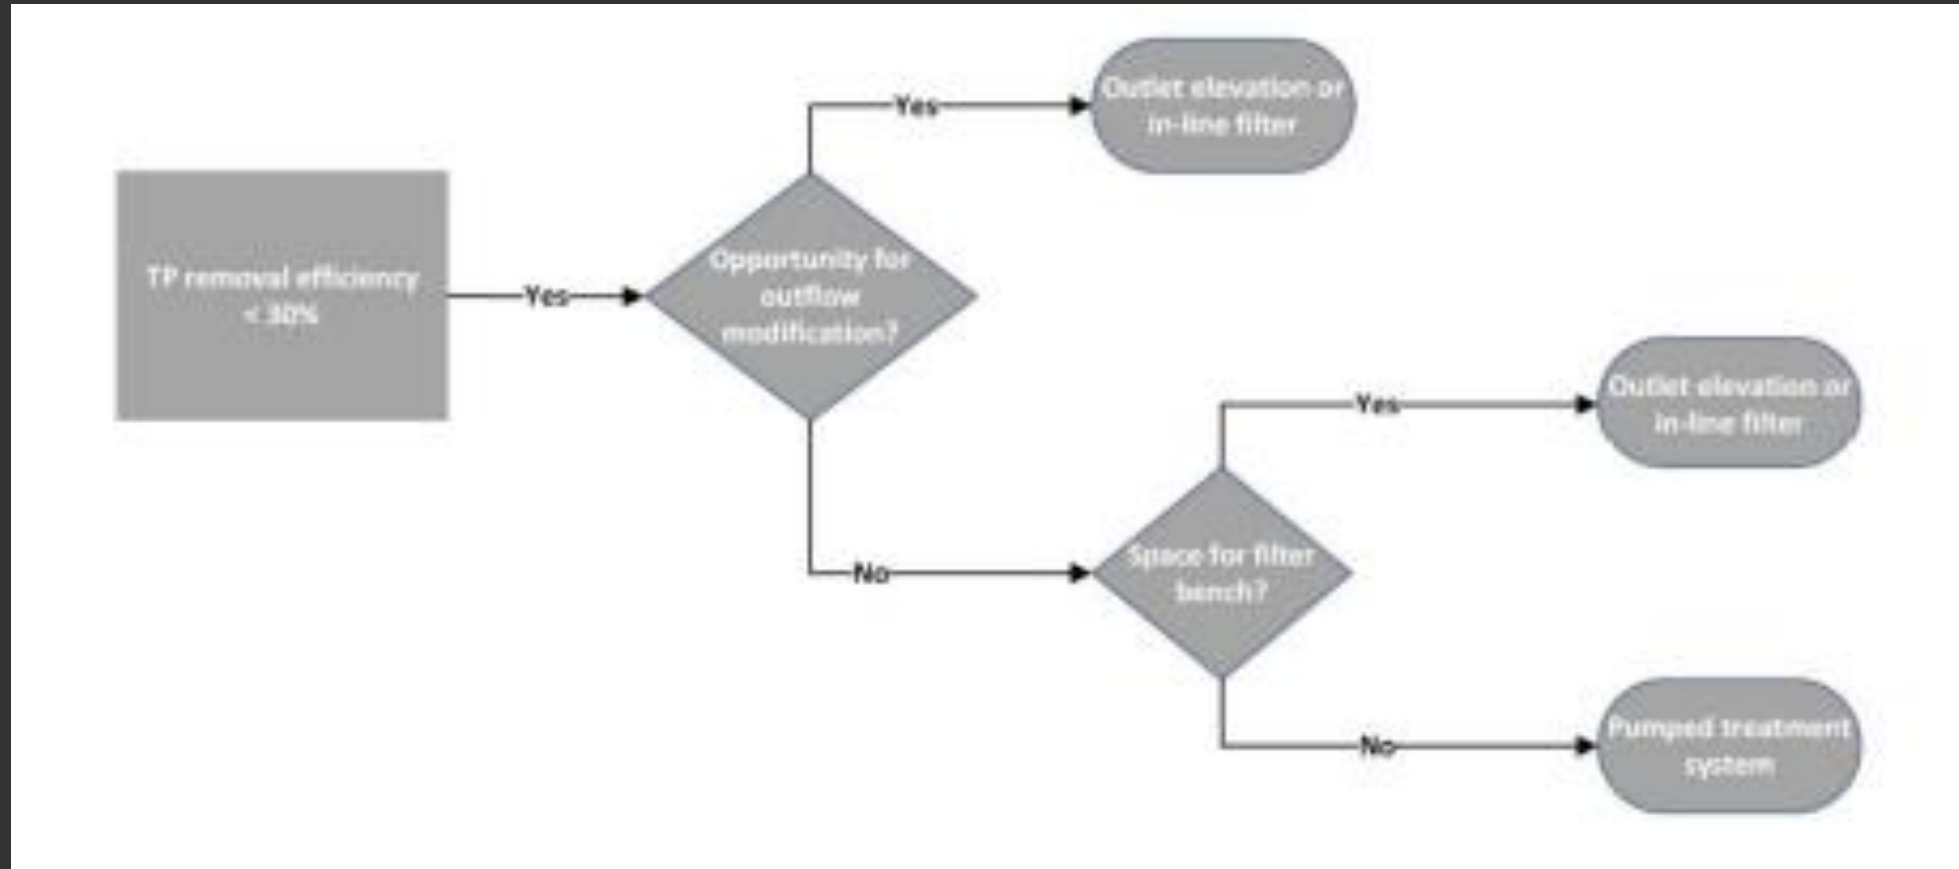
# Management Decision Tree

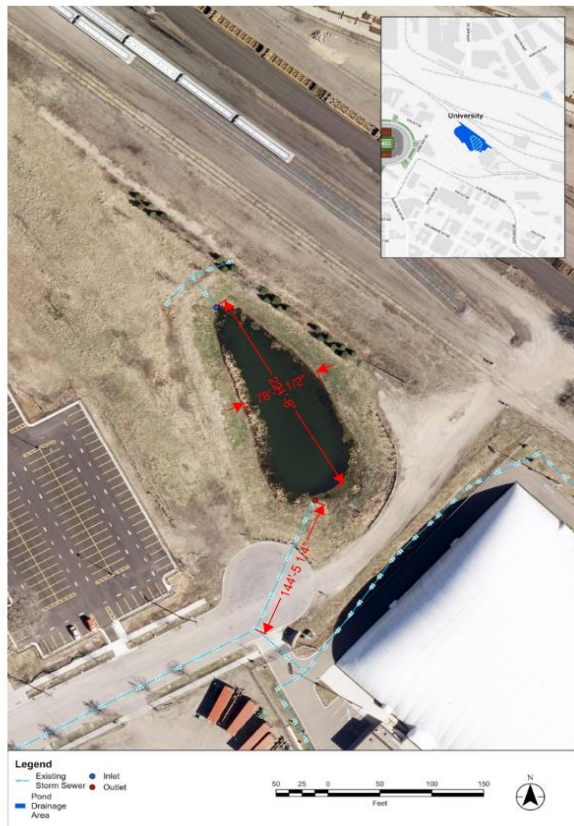
### Phosphorus Budget

NURP Ratio: 2.34  
 Sedimentation: 3.3%  
 TP Removal Efficiency: 43%  
 TP Removed: 1.5 lbs/yr  
 TSS Removal Efficiency: 81%  
 TSS Removed: 726 lbs/yr  
 Internal/Watershed Load: 47%

**Recommendations:** Candidate for sediment in-activation.

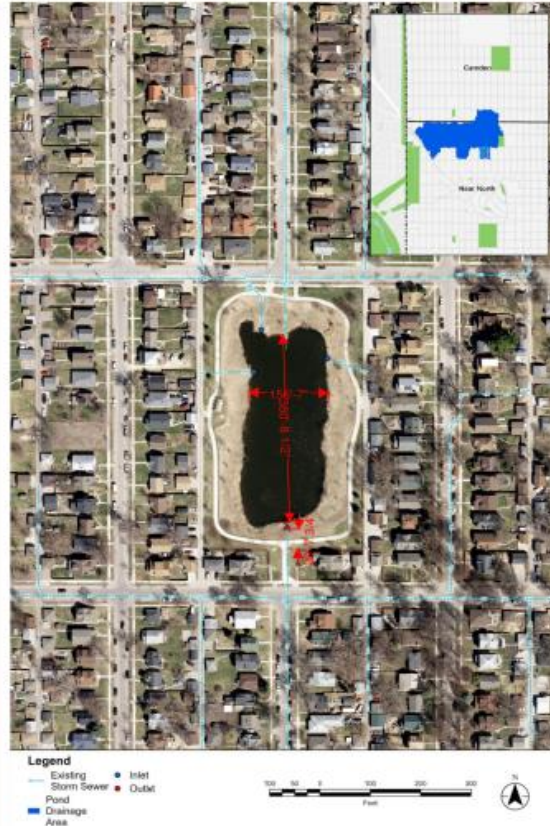
### Phosphorus Budget

NURP Ratio: 0.46  
 Sedimentation: 13.5%  
 TP Removal Efficiency: 57%  
 TP Removed: 38.4 lbs/yr  
 TSS Removal Efficiency: 84%  
 TSS Removed: 16,188 lbs/yr  
 Internal/Watershed Load: 14%

**Recommendations:** Candidate for sediment in-activation.

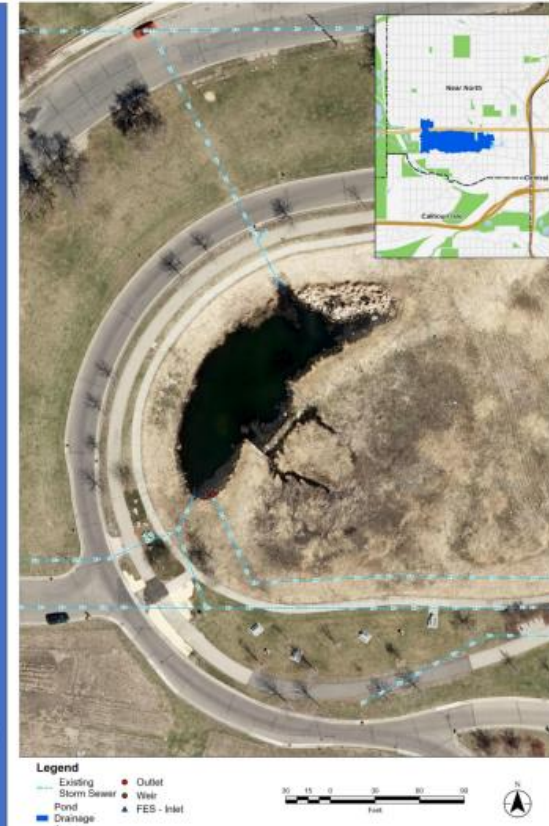
### Phosphorus Budget

NURP Ratio: 0.02  
 Sedimentation: 57.9%  
 TP Removal Efficiency: 4%  
 TP Removed: 2.5 lbs/yr  
 TSS Removal Efficiency: 7%  
 TSS Removed: 1,278 lbs/yr  
 Internal/Watershed Load: 3%

**Recommendations:** Full pond dredging.
