# Technology Applications for Environmental Fieldwork

*SAVE TIME IN THE FIELD AND THE OFFICE*

Caitlin Burke, CWS, DECI  
GHA, Inc.

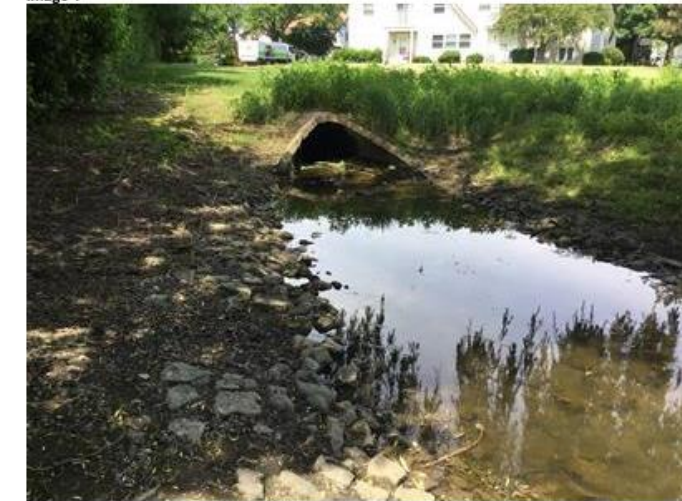
Image 1

Comments: View of Outfall 035

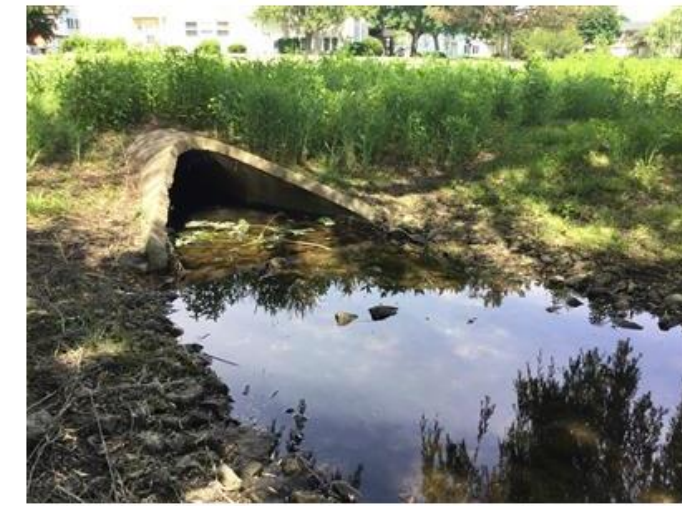
Image 2

Comments: View of Outfall 035
