REPLACEMENT OF THE NETTLE CREEK AQUEDUCT

AGENDA

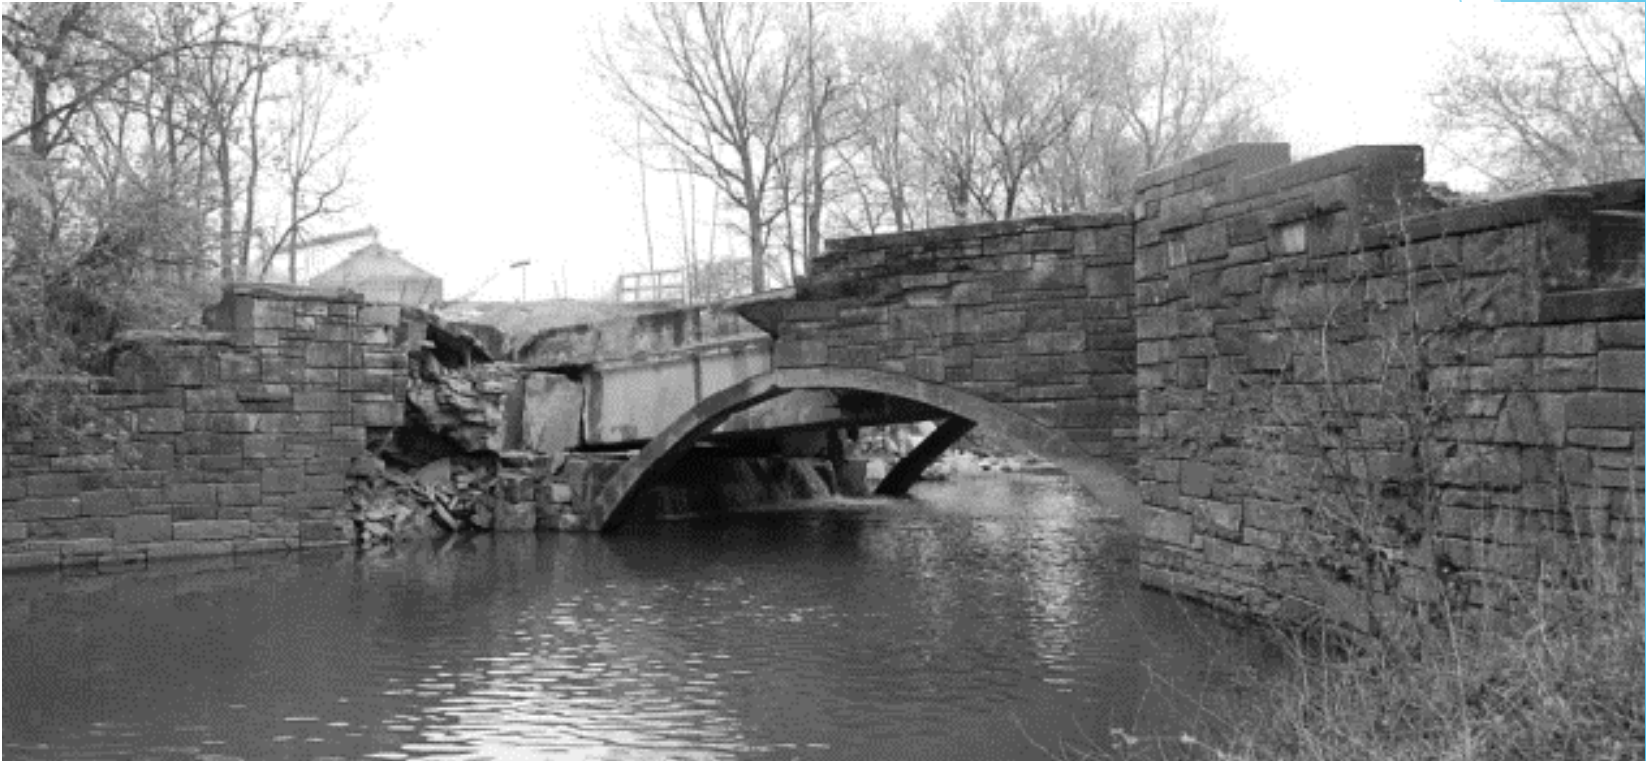
Nettle creek Aqueduct, after 2013 collapse.

In 2013, the last aqueduct at the crossing collapsed due to overtopping. The I&M Canal was capped at either side of this crossing and the remaining structure was removed. Only the west abutment of the aqueduct remained prior to this project

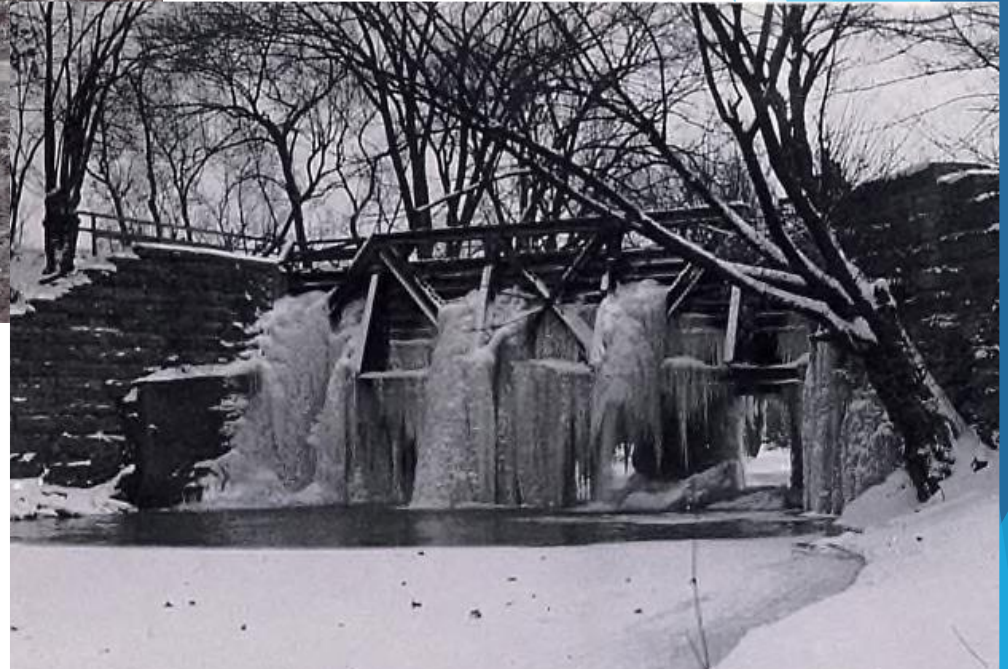
Nettle Creek Aqueduct showing the steel-frame structure that was installed in 1910.

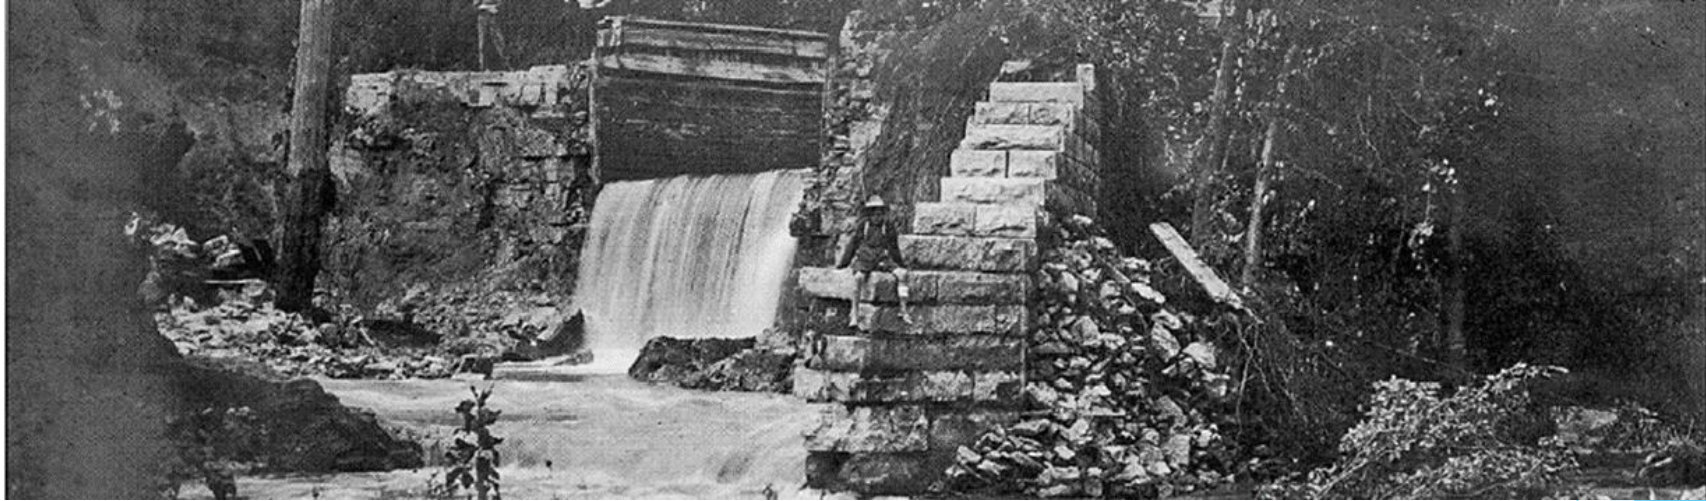
Nettle Creek Aqueduct after a break in the canal in the spring of 1910.

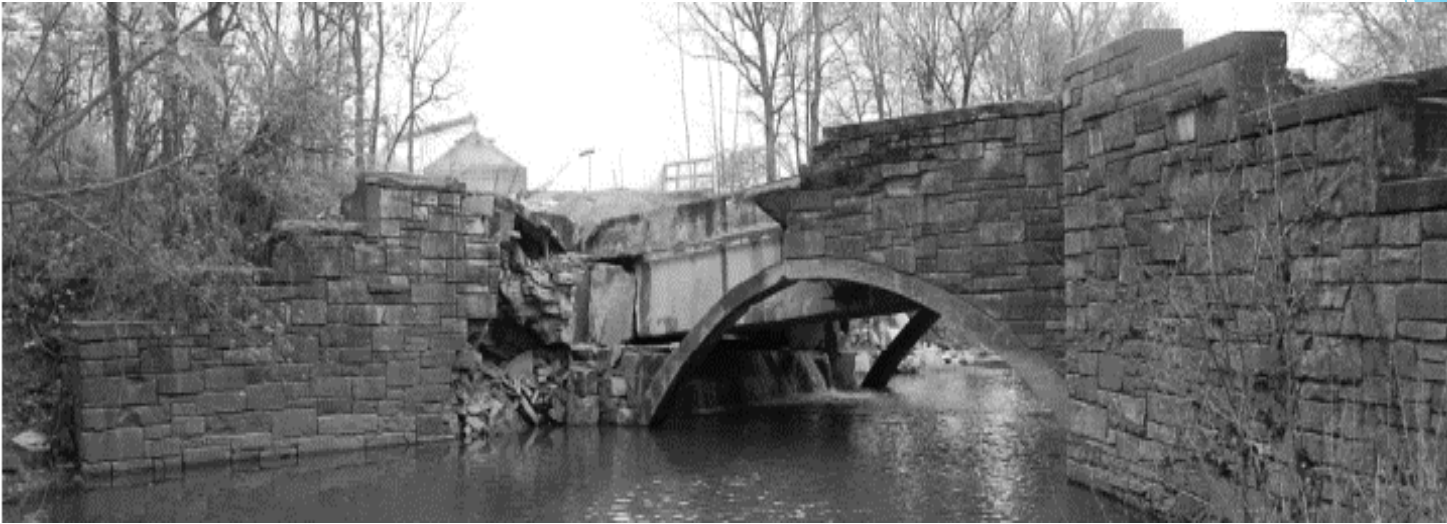
North elevation of aqueduct showing collapse from 2013 flood; taken from HAER report

- In April 2013, the aqueduct collapsed after a period of extreme flooding.

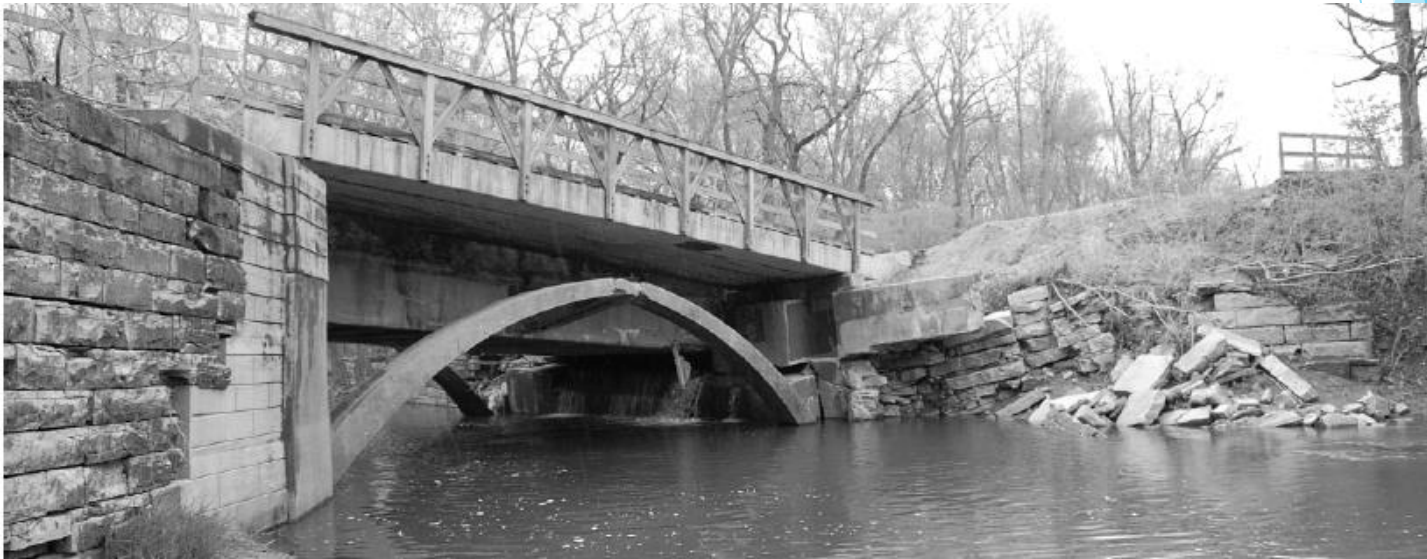
View of the rear side of the northern wing wall of the east abutment after collapse.

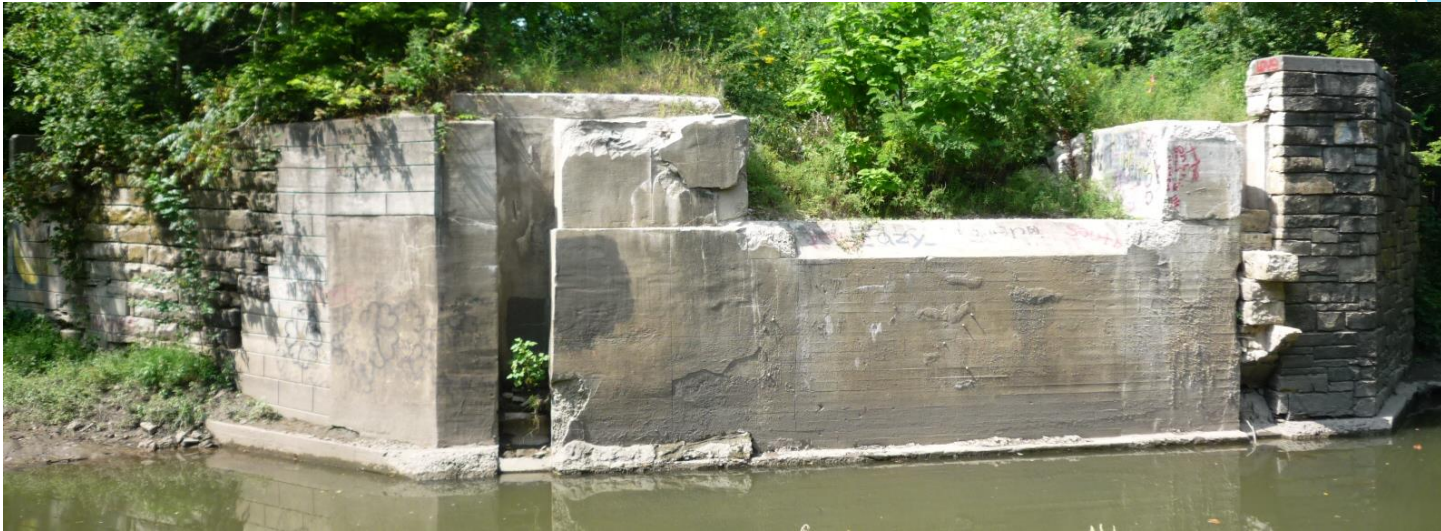
2020 condition of Nettle Creek Aqueduct.

- In 2017 the entire deck, prism, and eastern abutment were dismantled due to safety concerns. Only a partial west abutment remained.

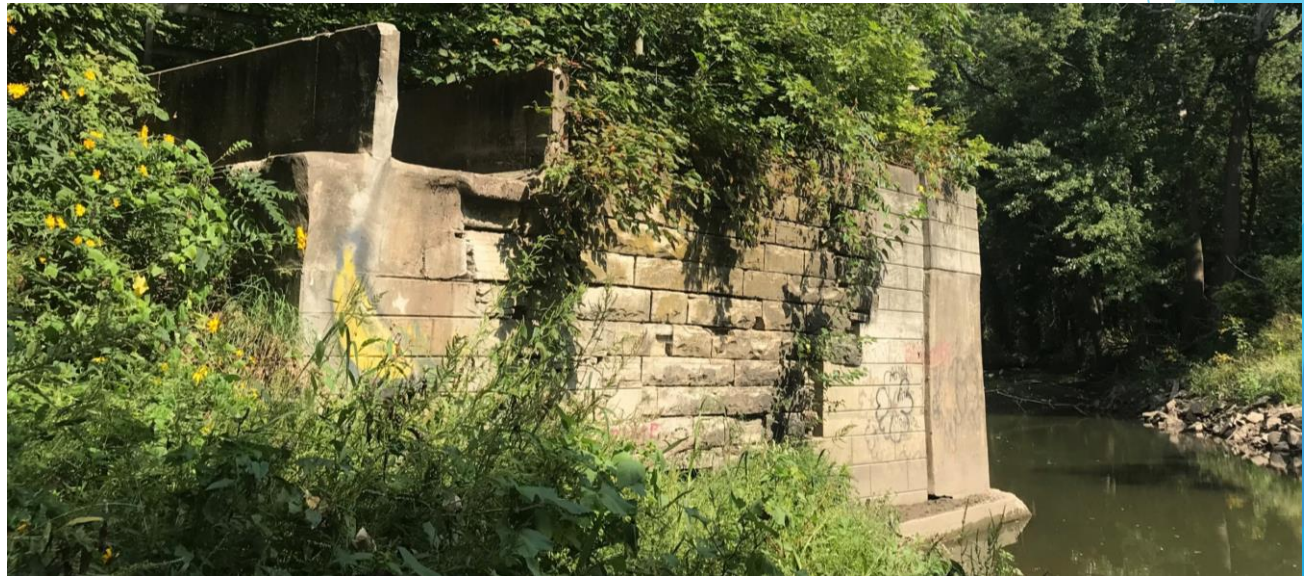
2020 condition of Nettle Creek Aqueduct (Wing-wall) .

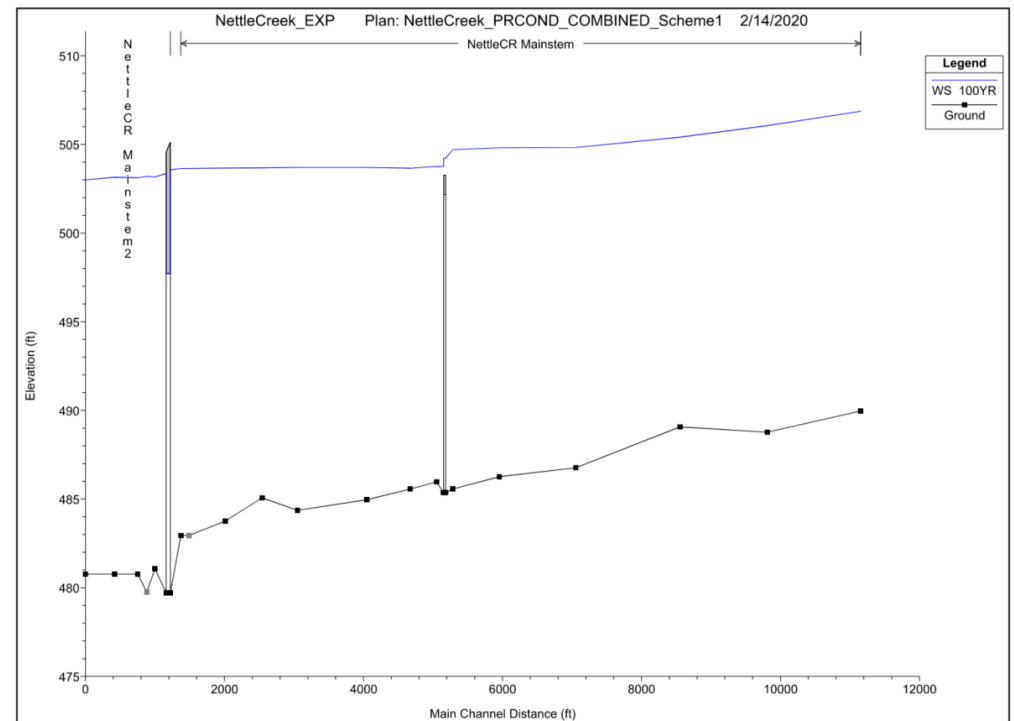
- Numerous proposed conditions model runs completed.
- Looked at increase in opening area width as compared to hydraulic results.
- A 140-foot width was ultimately chosen, as reductions in water surface elevations started to level off at greater widths.

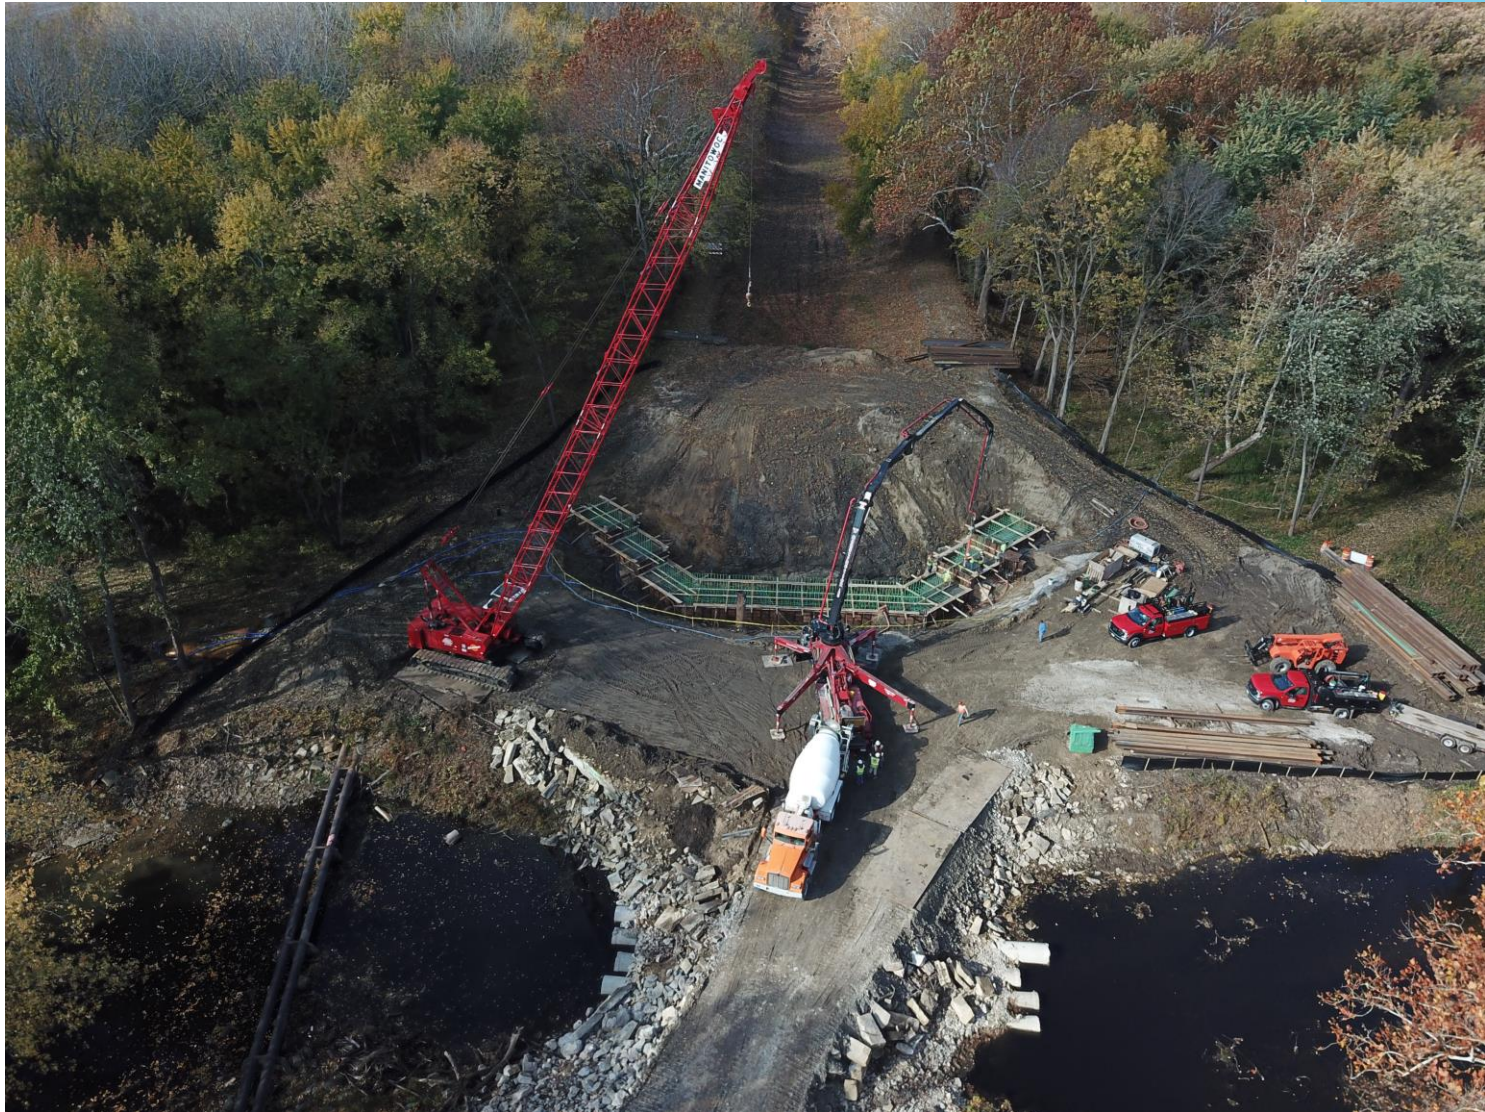
Under Construction: Framing to pour the west abutment

Construction drone photo: October 27, 2022.

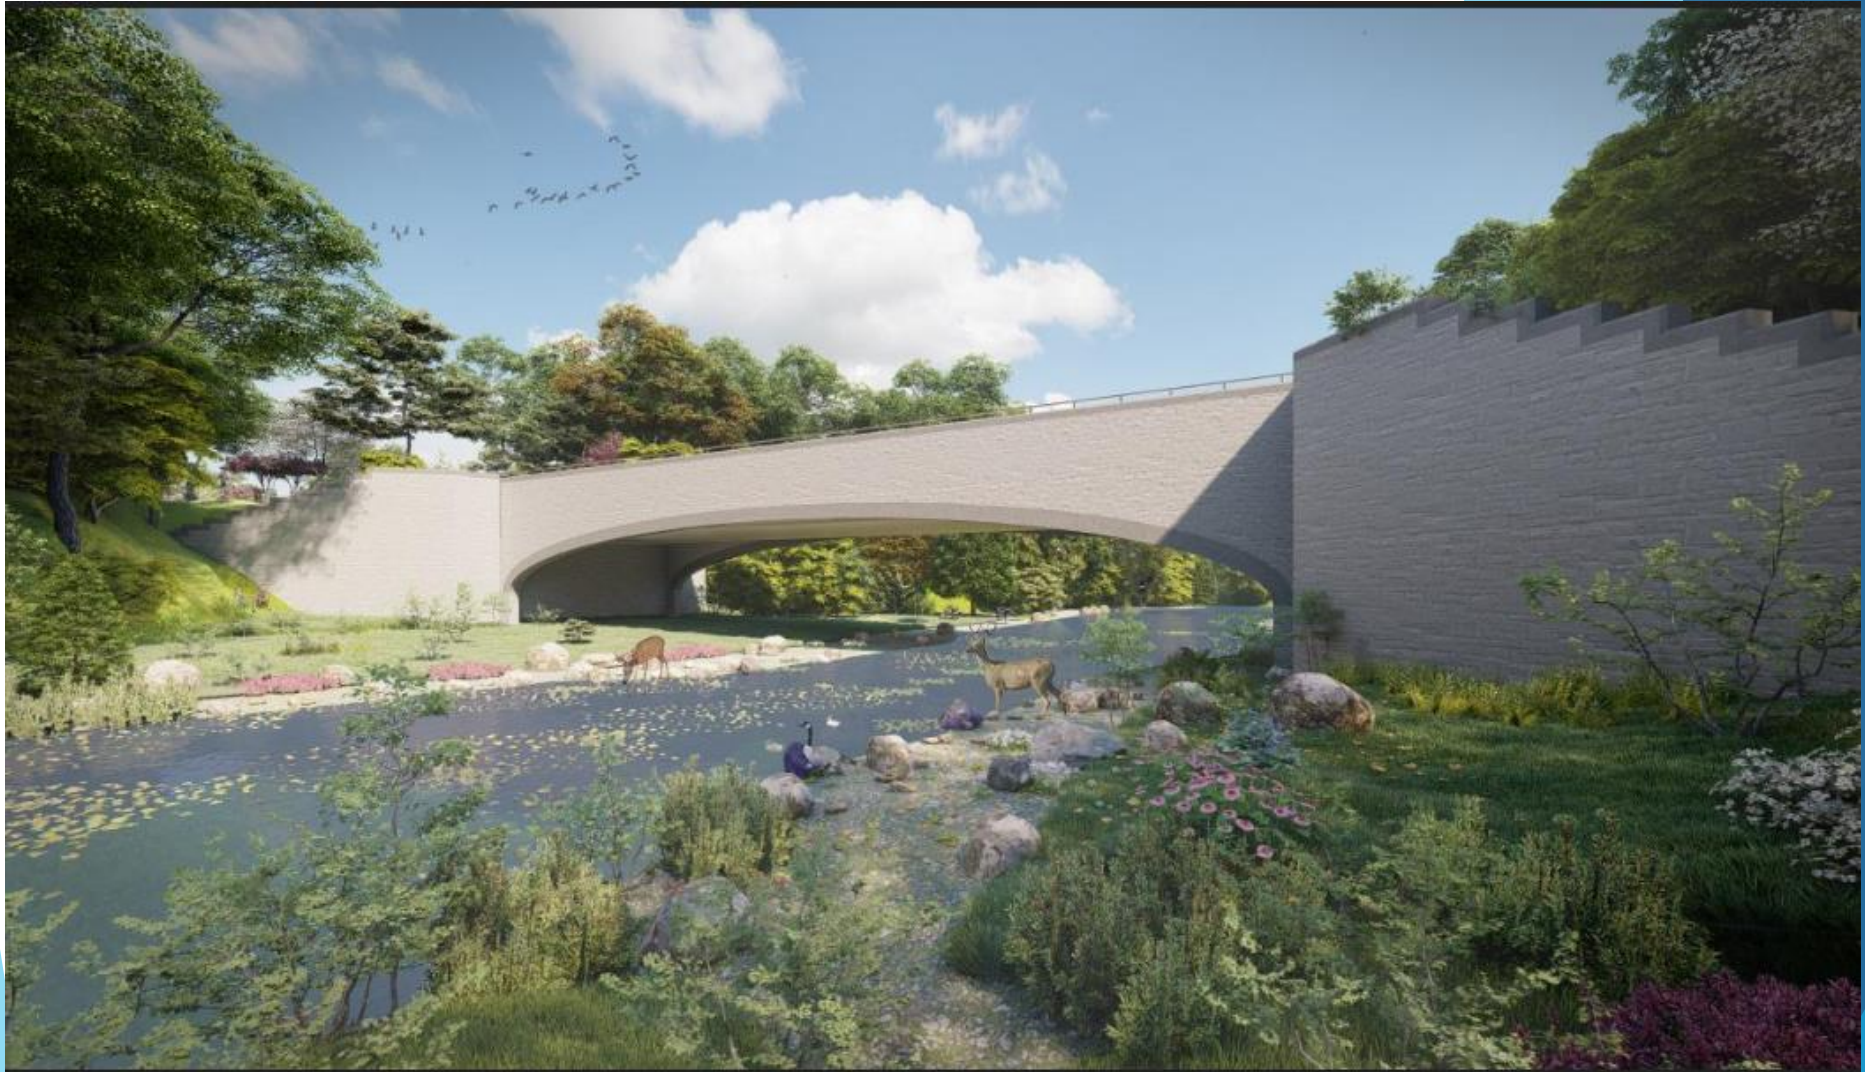
AQUEDUCT ELEVATION | SOUTH VIEW

Rendering prepared by JLK Architects.
