**Illinois Association of Floodplain & Stormwater Management
Annual Conference
March 14, 2023**

Stratton-Bolger Lock & Dam Improvements McHenry, IL

Stratton Lock & Dam Improvements

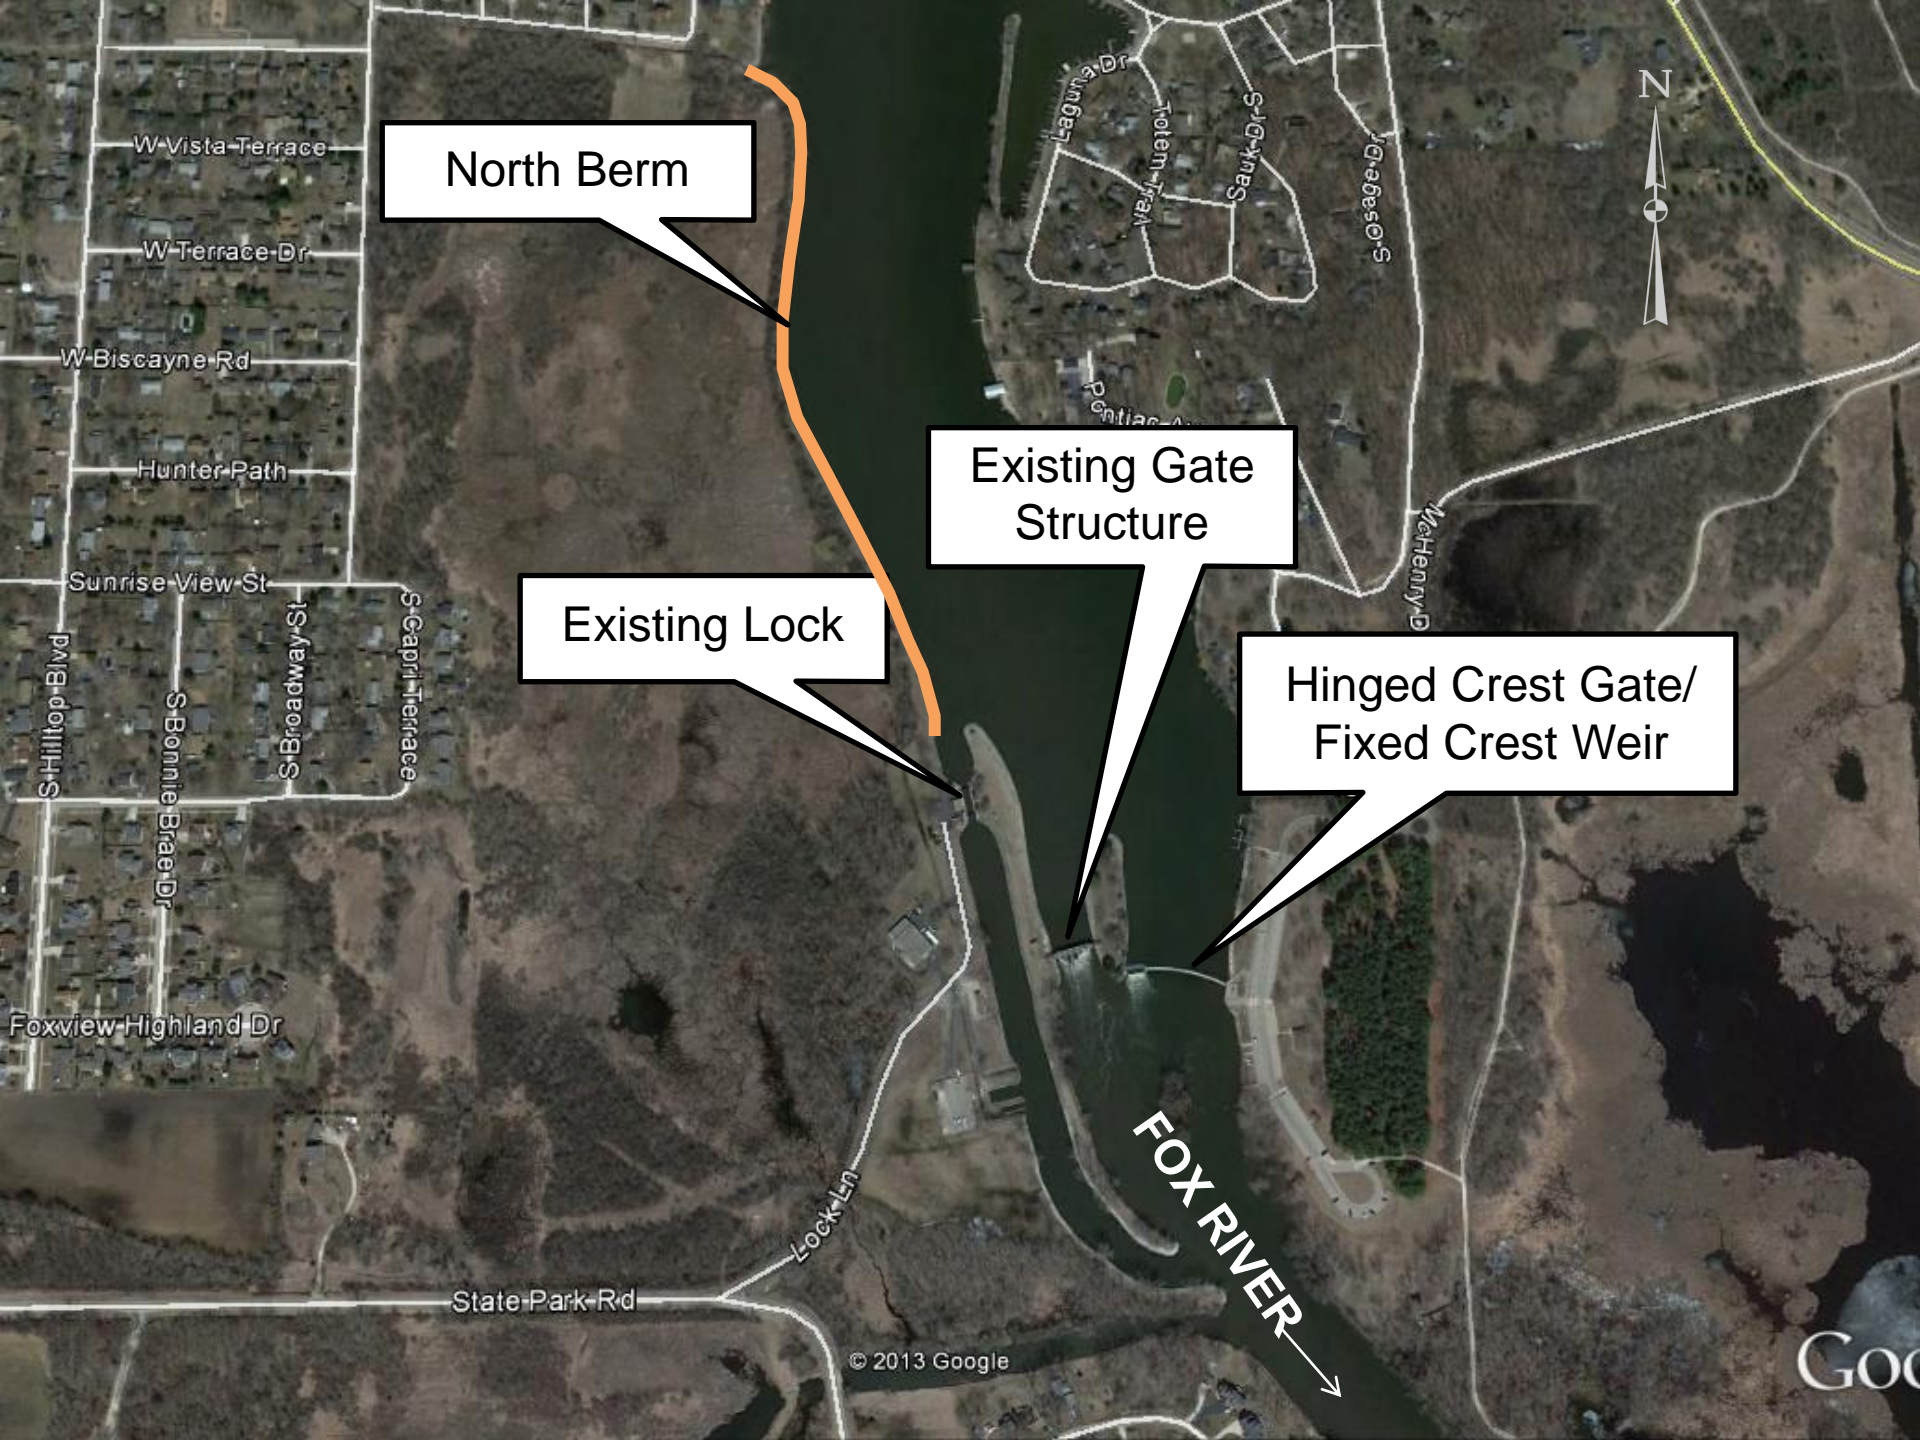
North Berm

Existing Gate
Structure

Existing Lock

Hinged Crest Gate/
Fixed Crest Weir

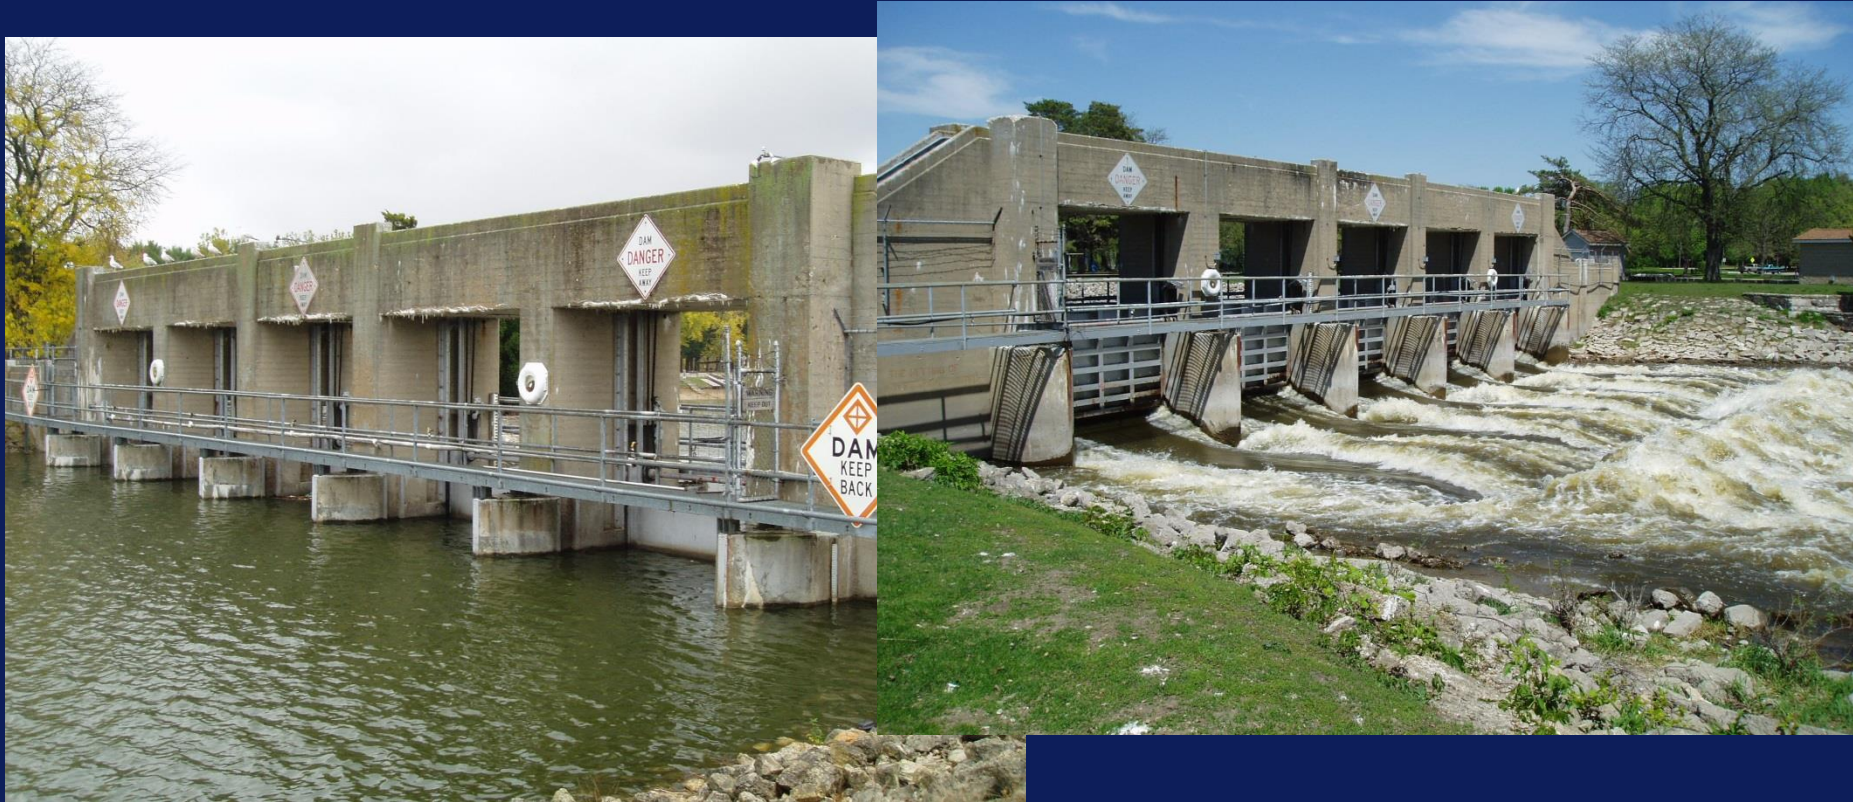
- Constructed 1938 – 1939
- 5–14-foot-wide sluice gates
- 4,500 – 5,500 CFS (normal pool)

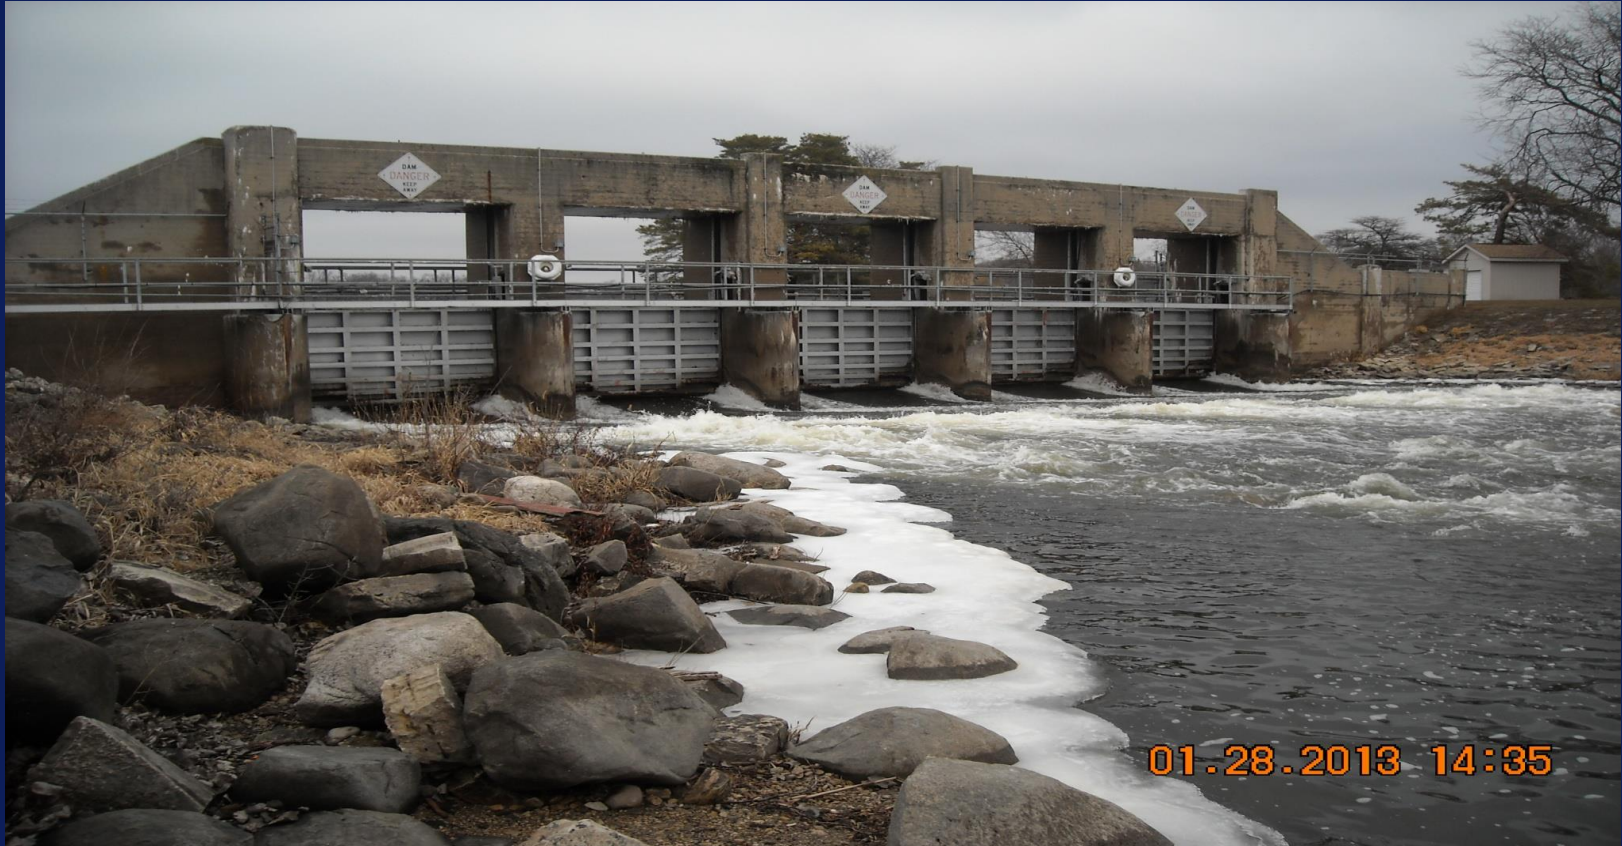
Gate Structure Replacement

Existing Structure with 5 Vertical Roller Gates

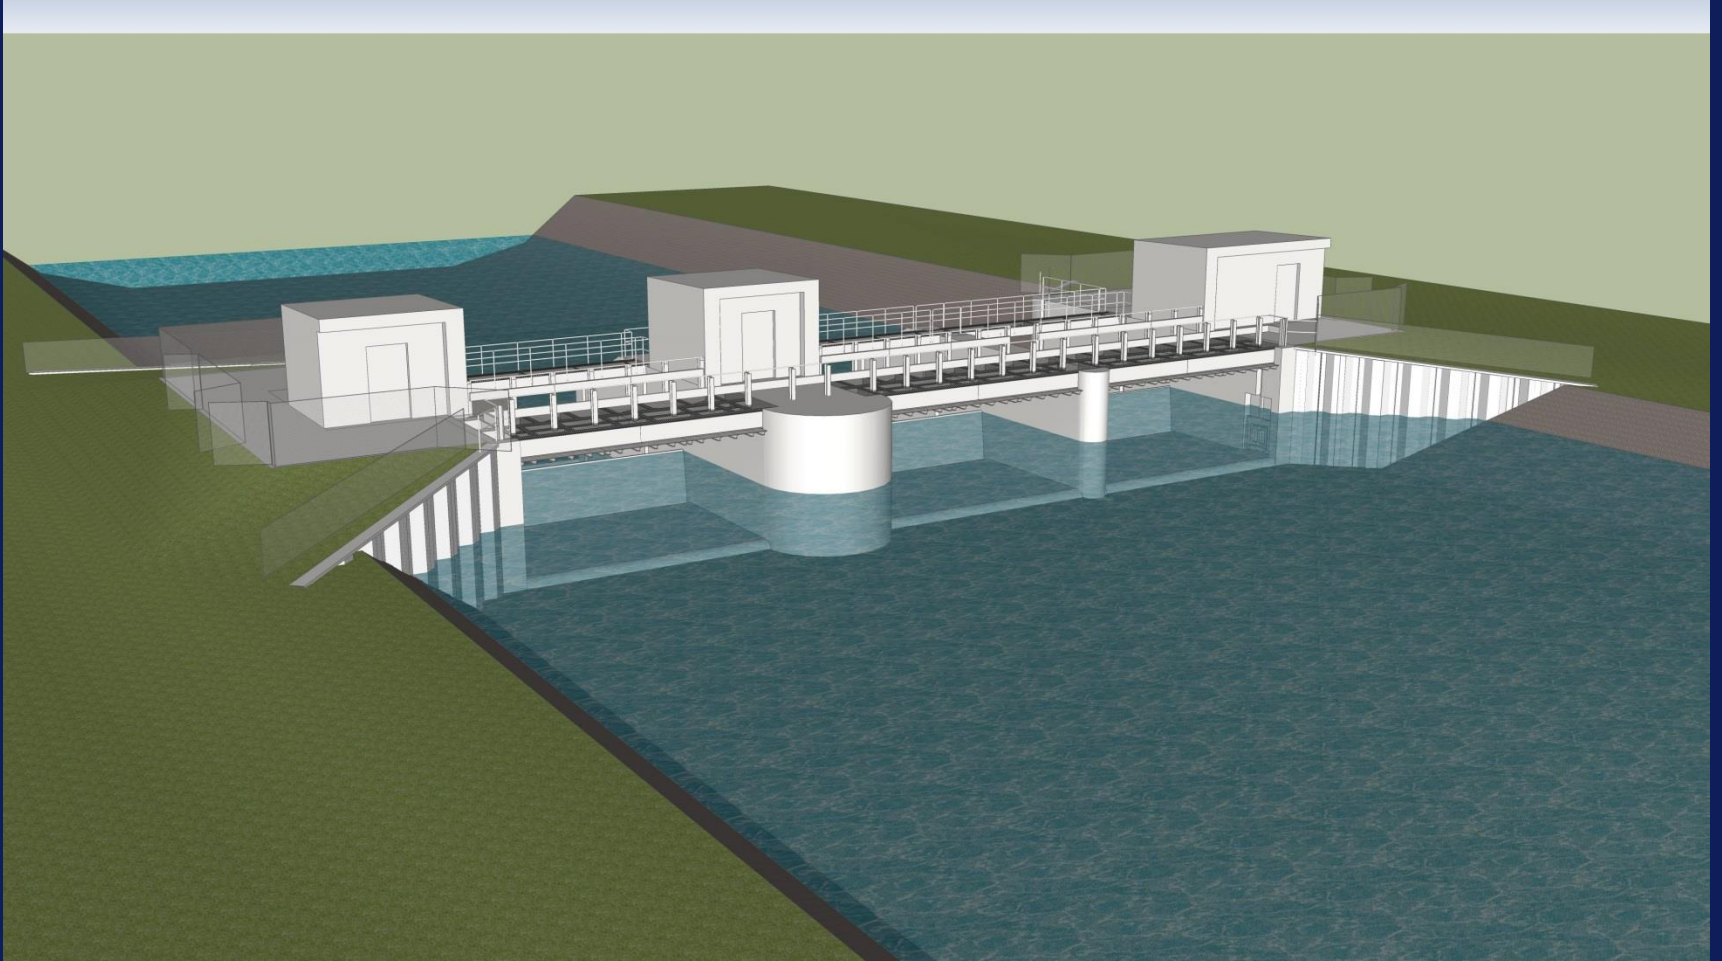
New Gate Structure with Three Torque Tube Gates

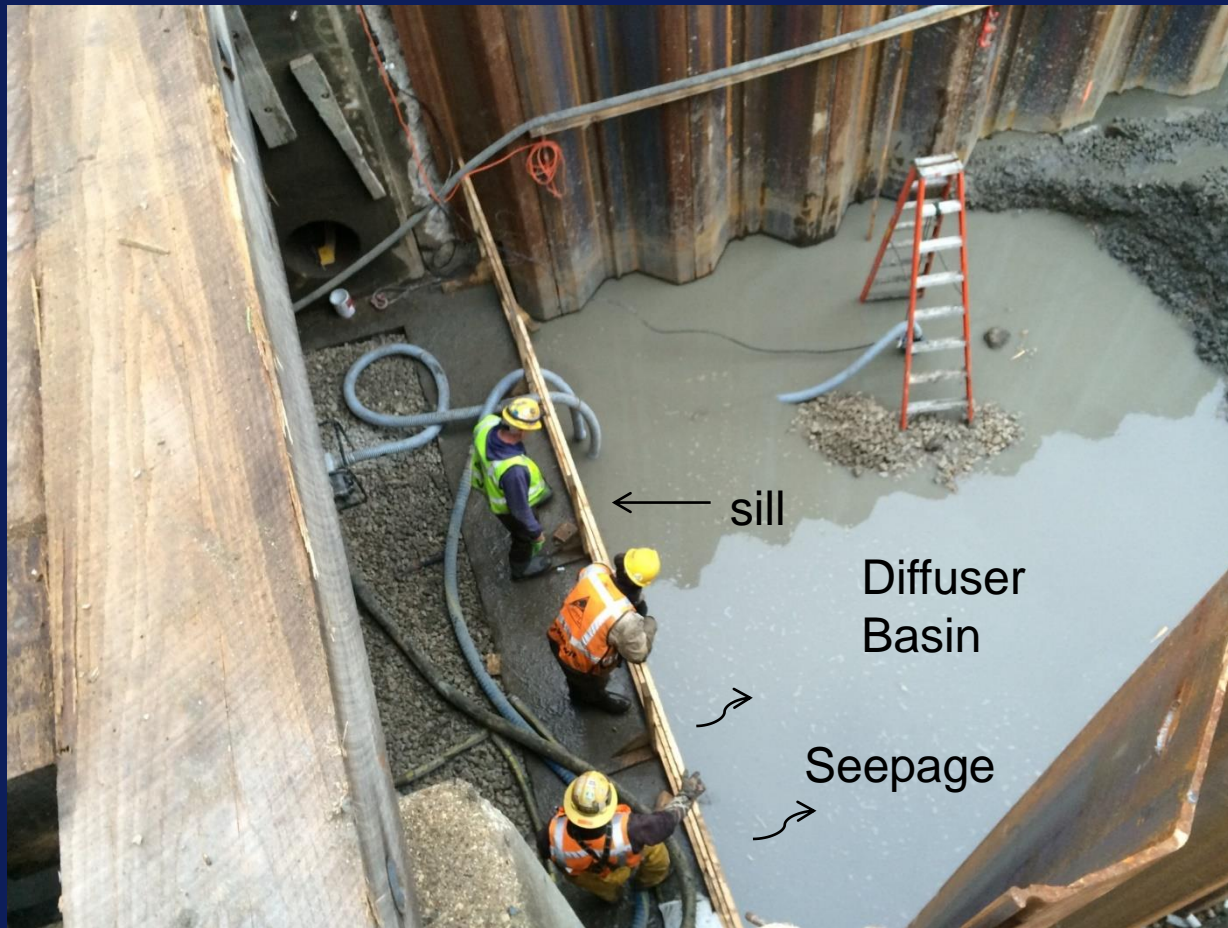
- Uncontrollable seepage under existing sill, existing cutoff wall missing, employed grouting, cured over xmas

- Grouting appeared to solve problem, but sprung a leak while excavating deeper for diffuser basin

- To arrest seepage, and save lock house, sheet piles were driven just downstream of existing sill

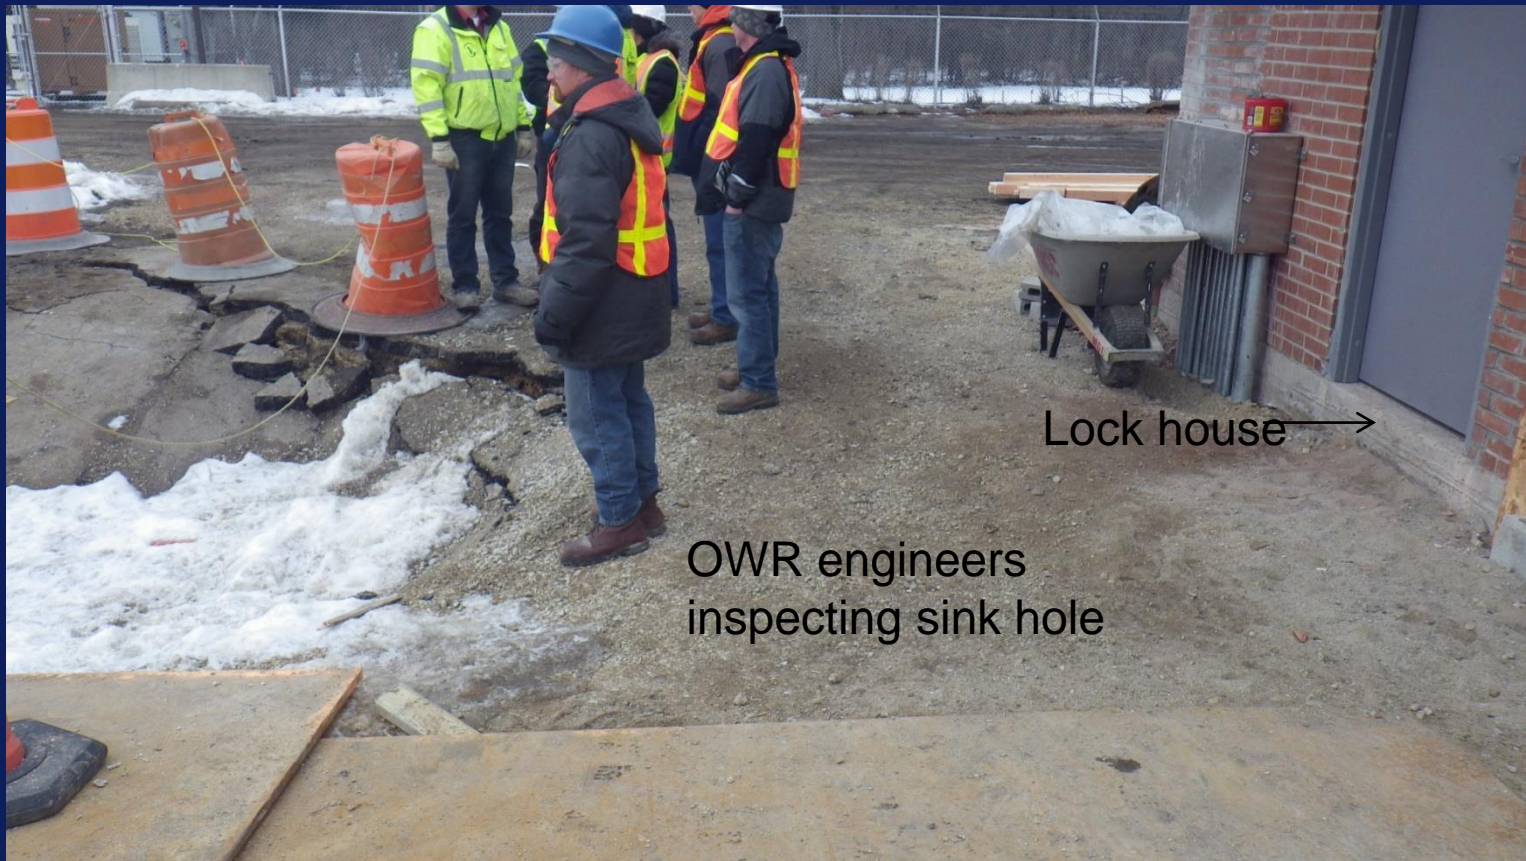
- Seepage suspected of causing large settlement within 10 feet of lock house

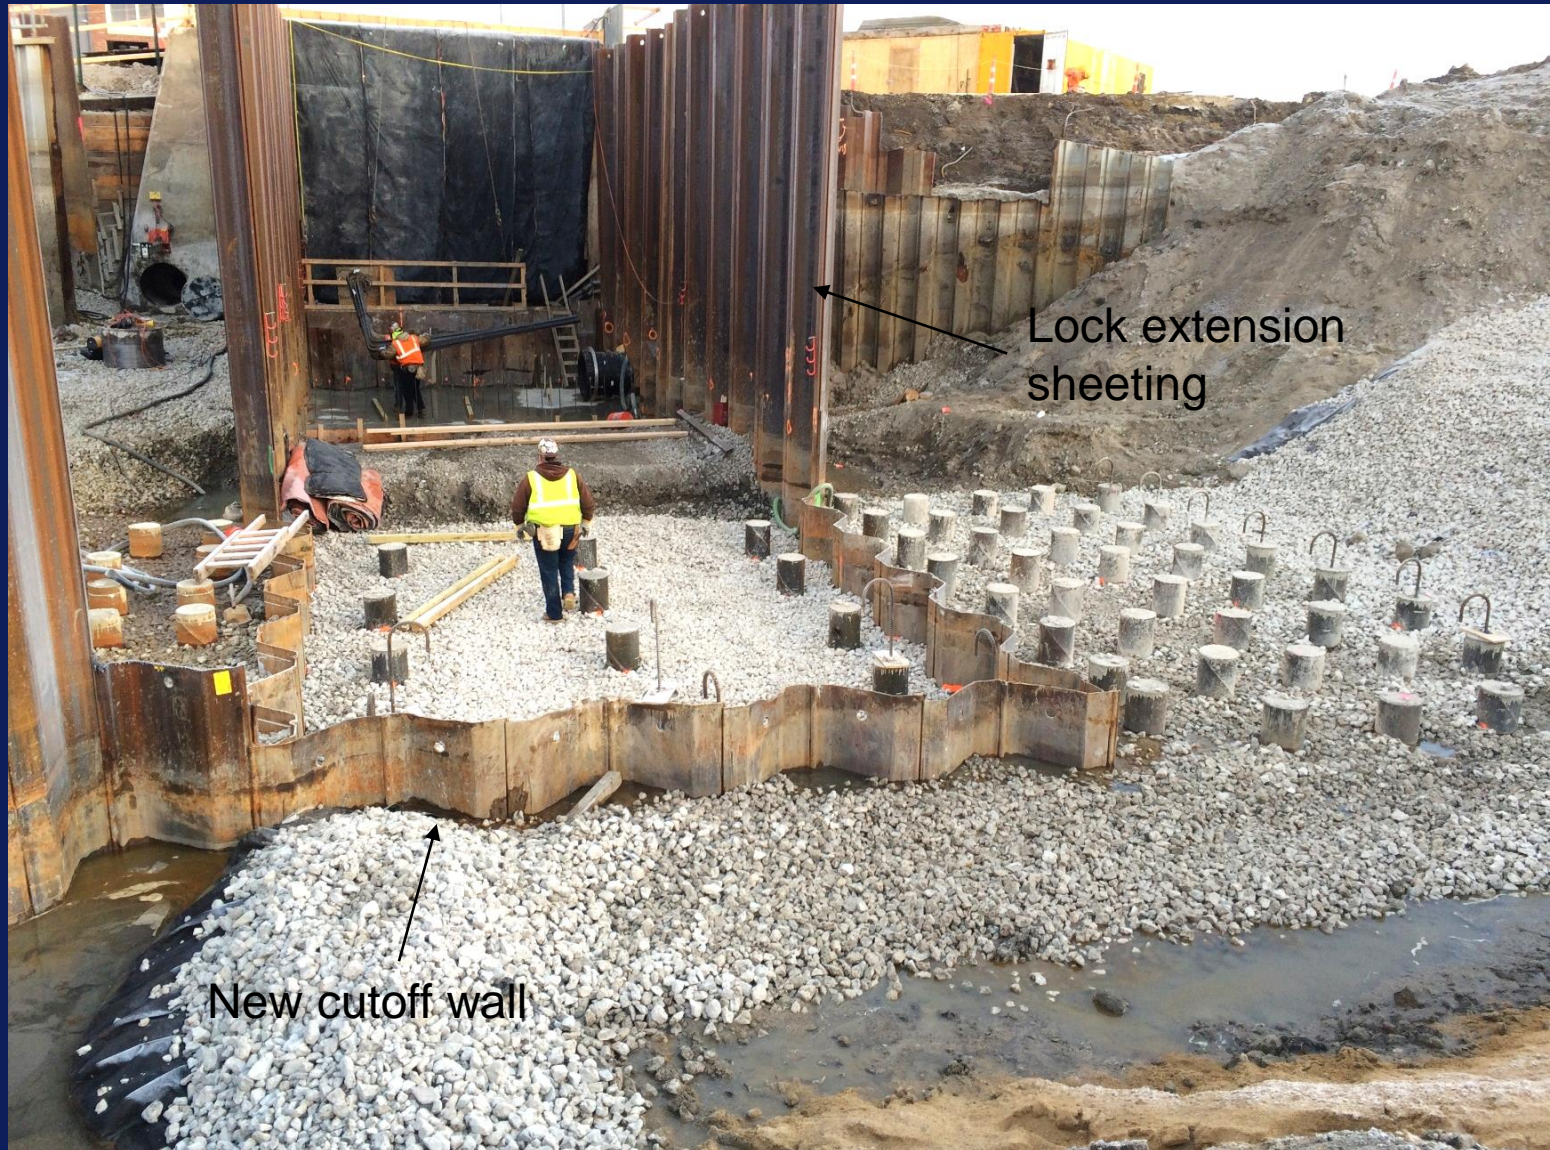
- Driving Metal Shell Piles for West Monolith footing

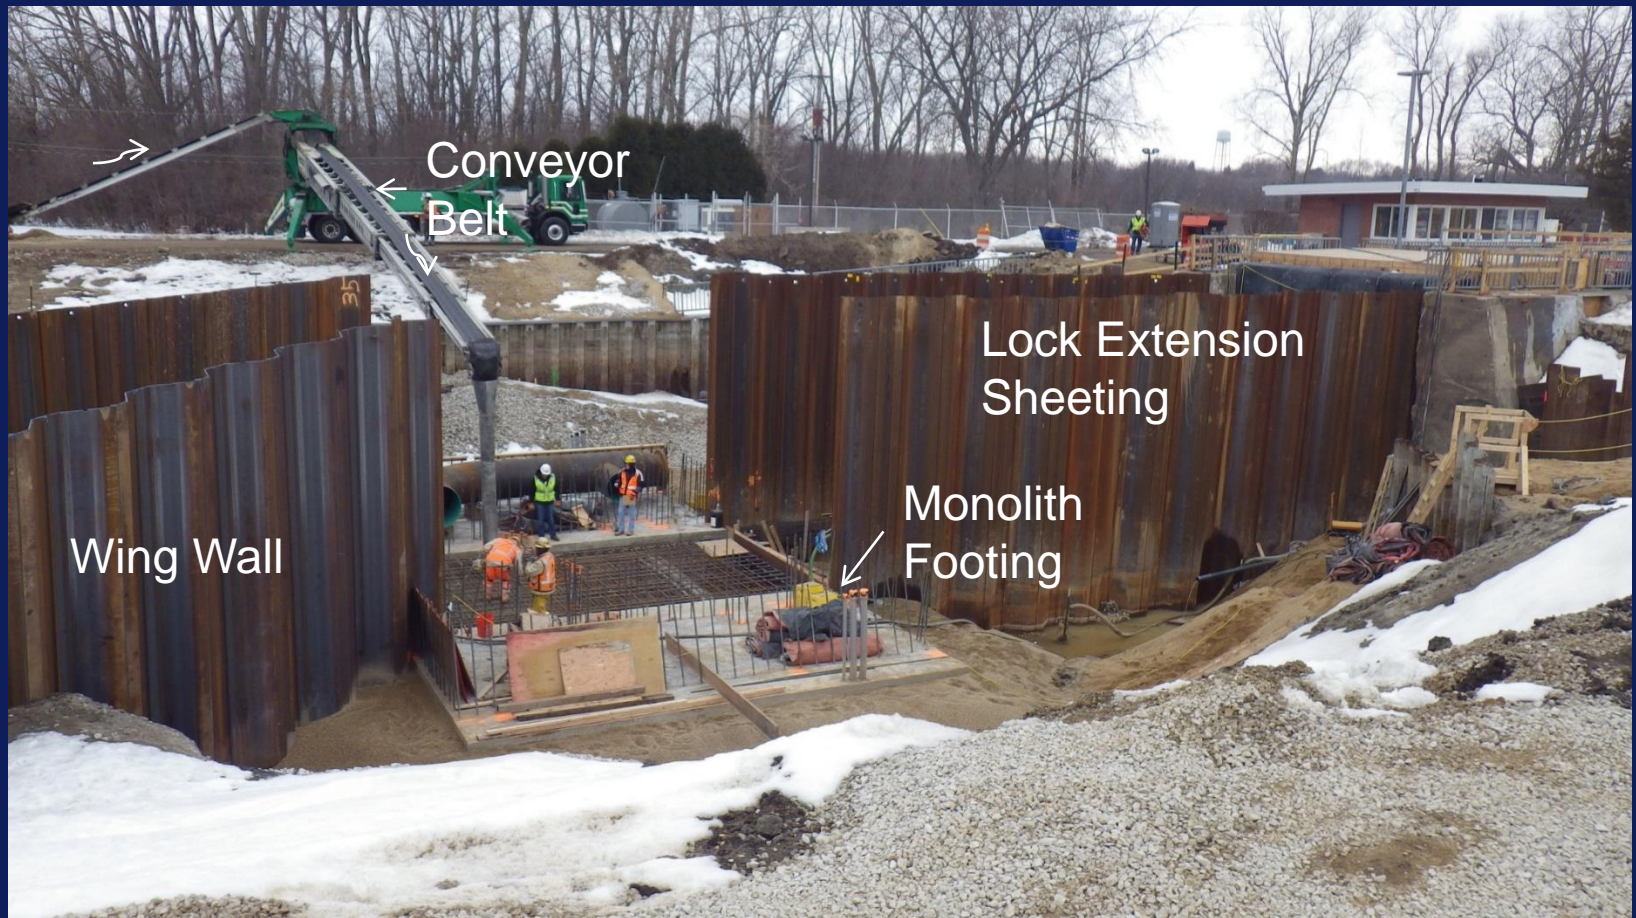
■ Emptying pipe (looking west)

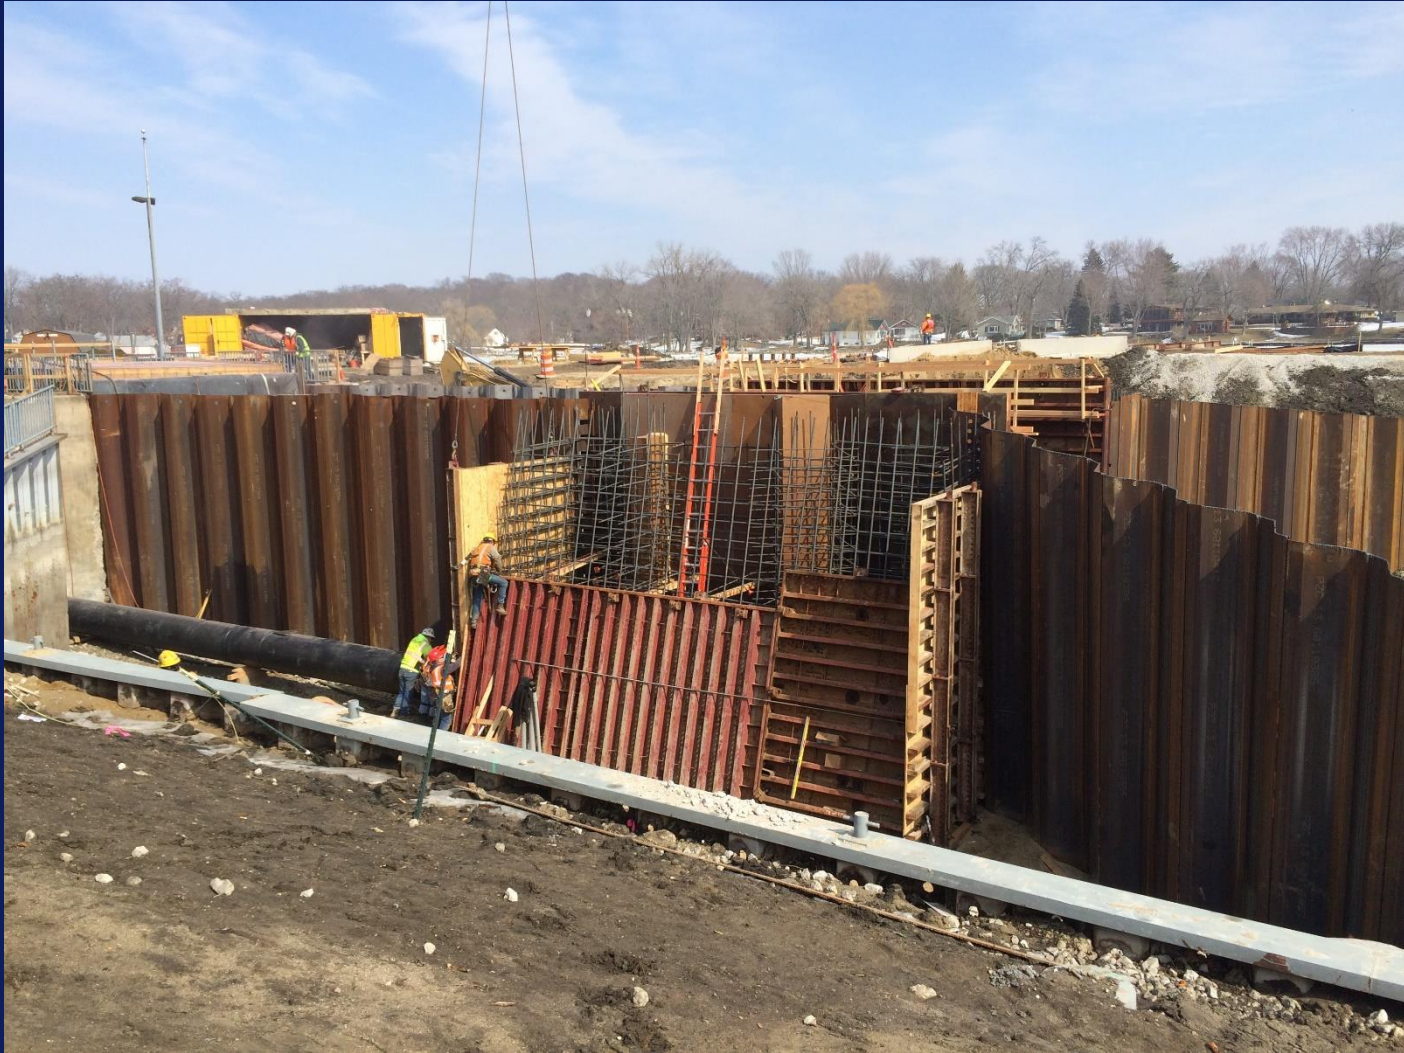
- Conveyor belt concrete delivery (looking west)

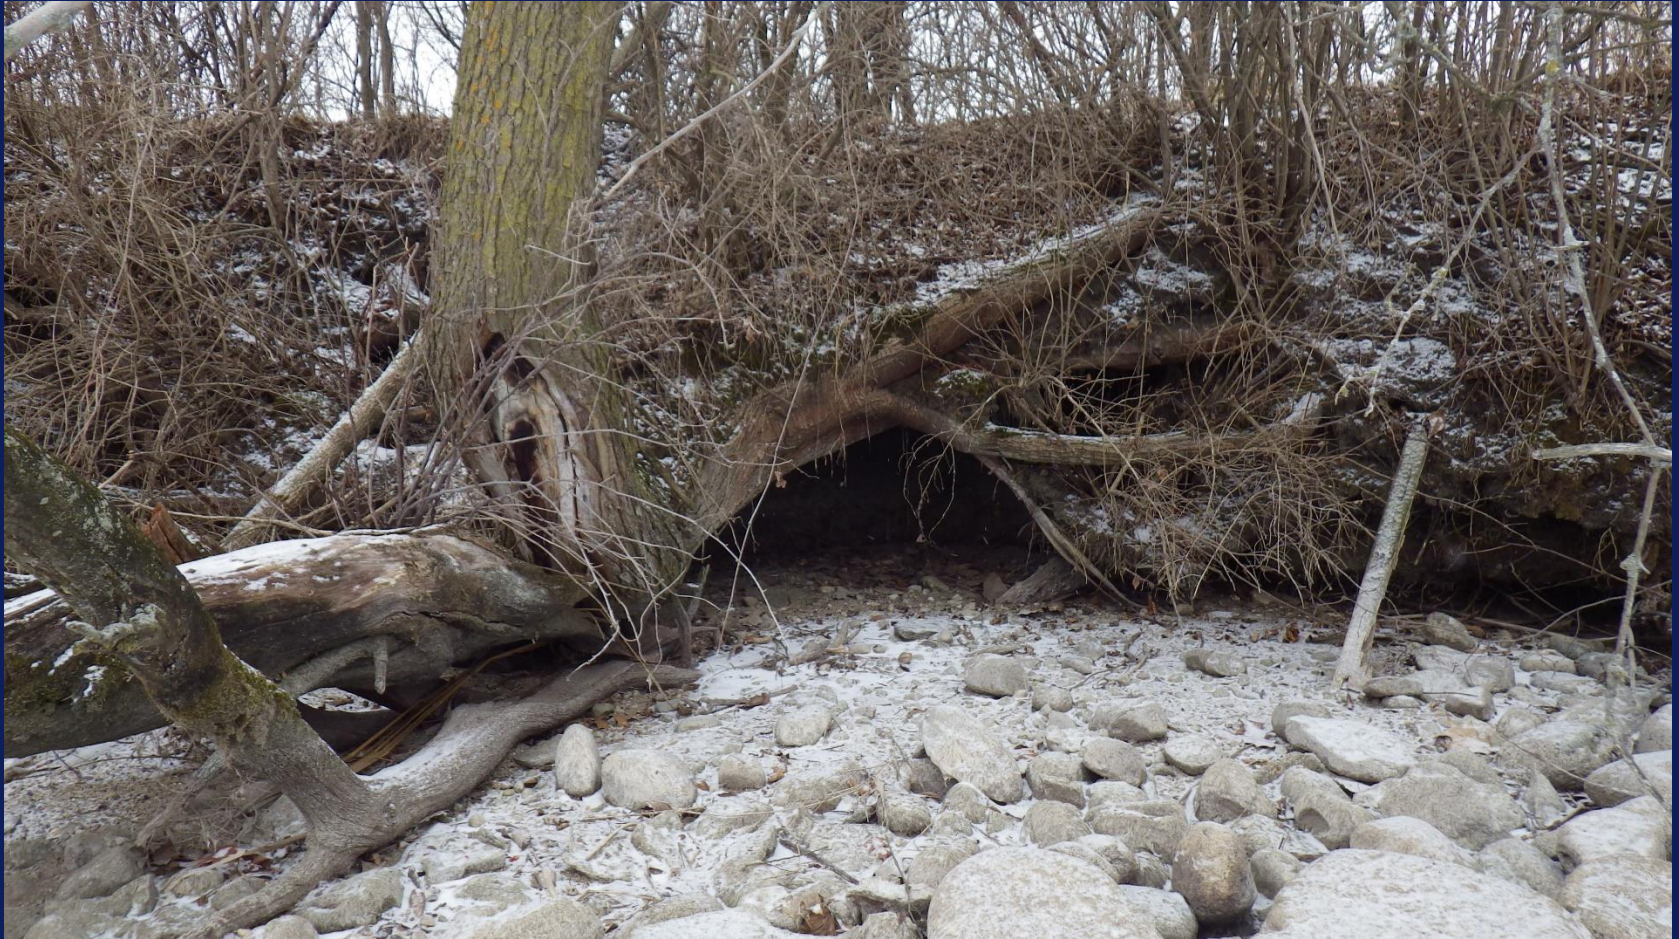
■ Clearing of North Berm/Levee

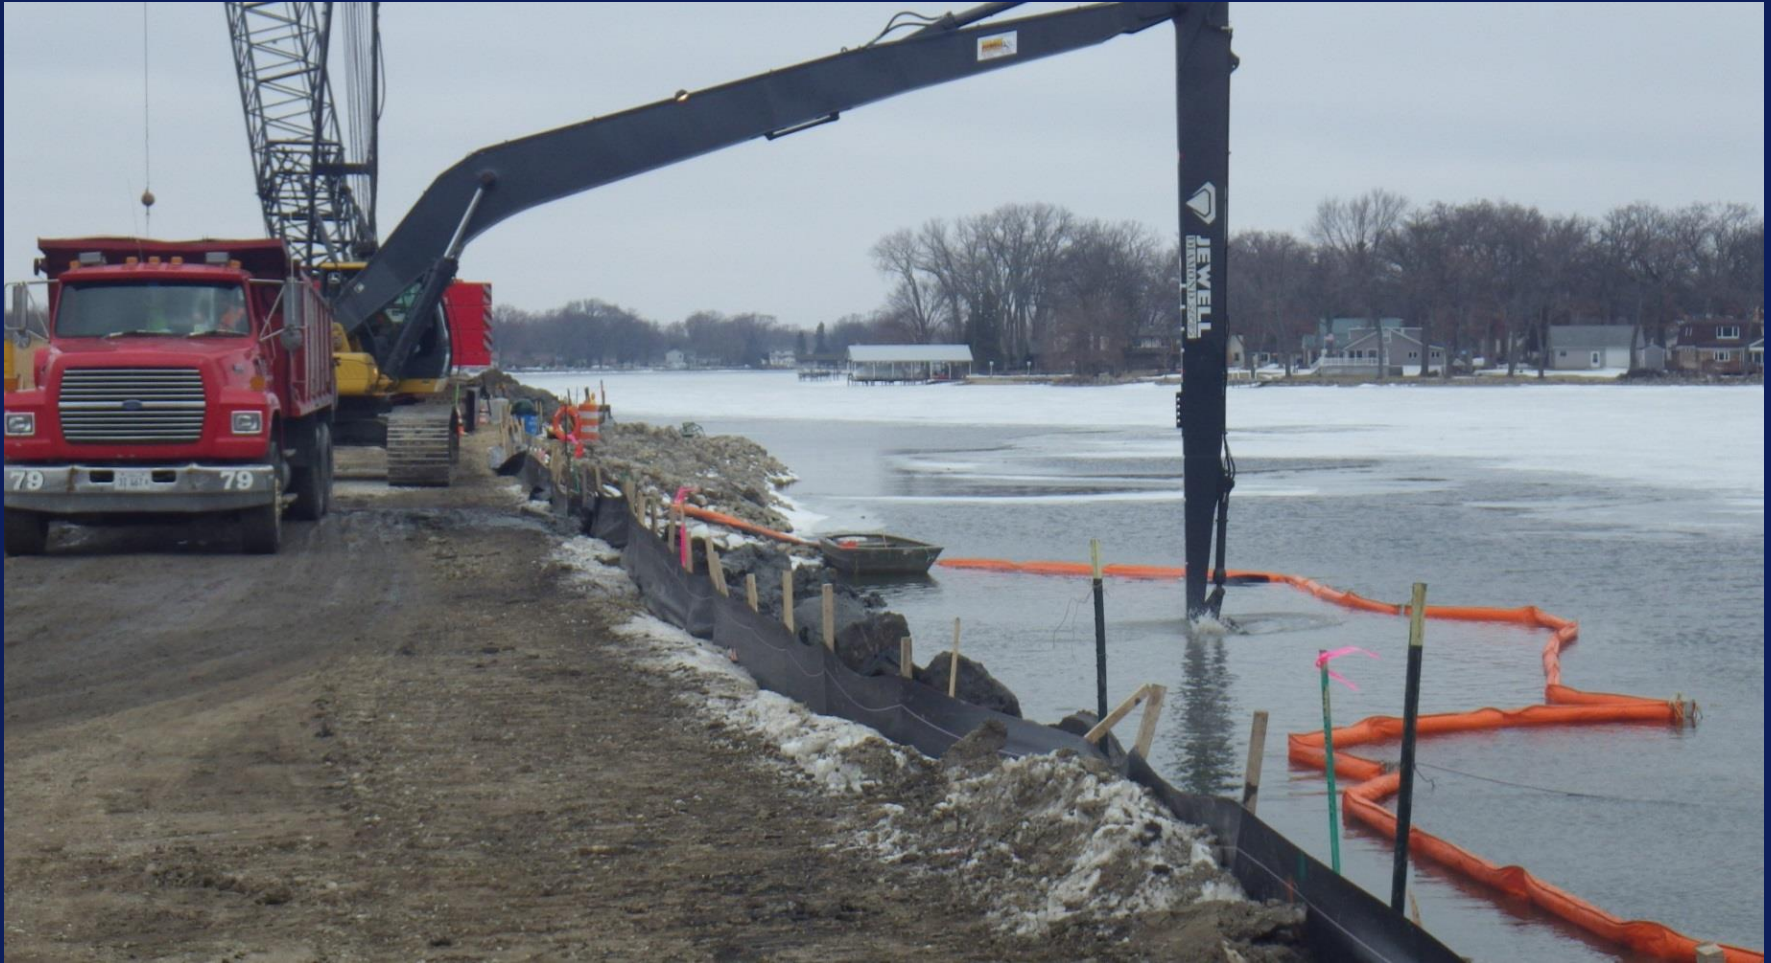
■ Upstream Berm/Levee Rehabilitation = 2,300'

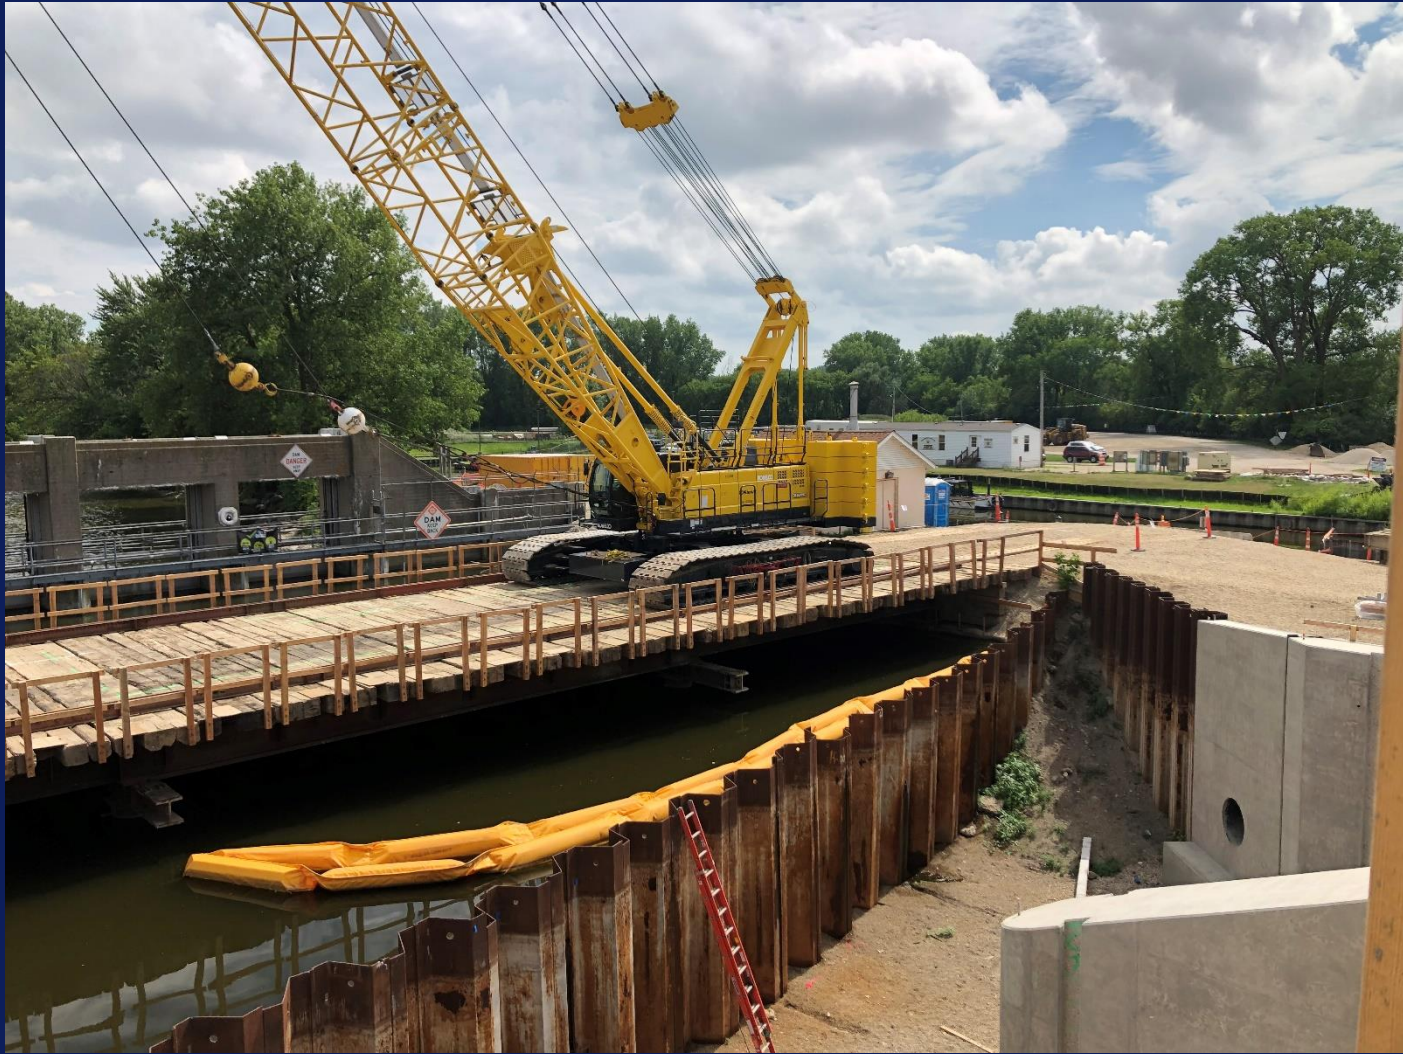
Trestle bridge being constructed downstream
of cofferdam to allow access to eastern island

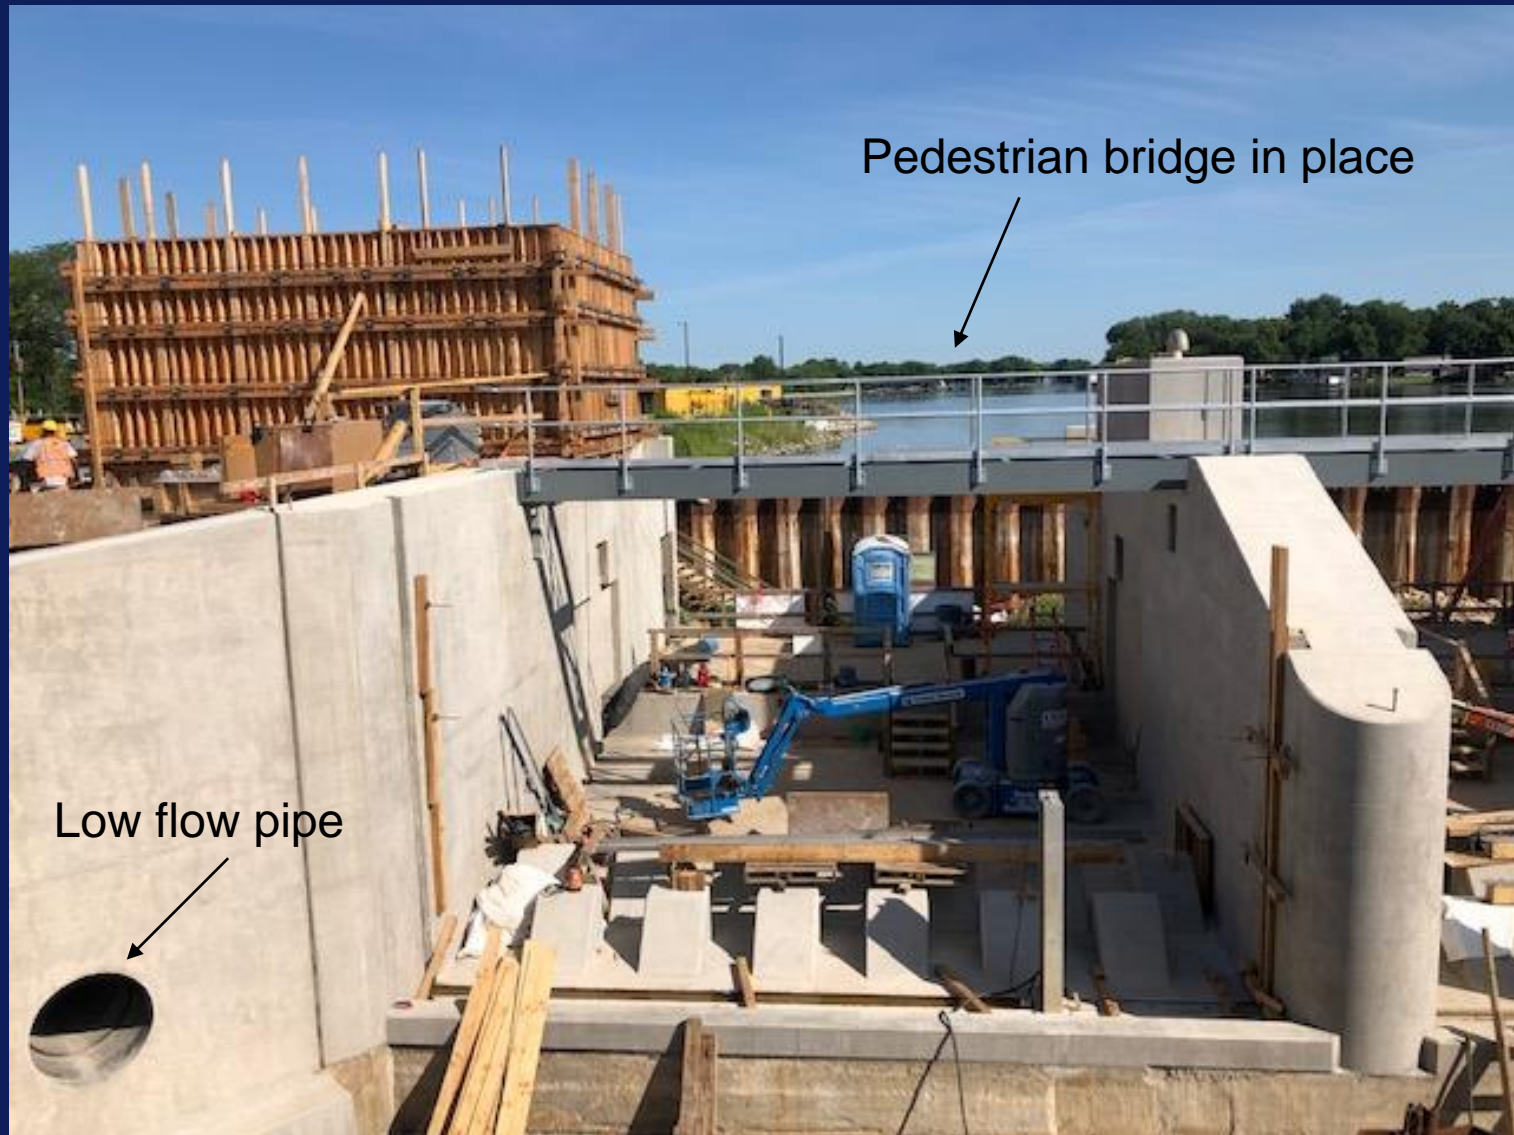
Vault 2 upper floor beginning to emerge

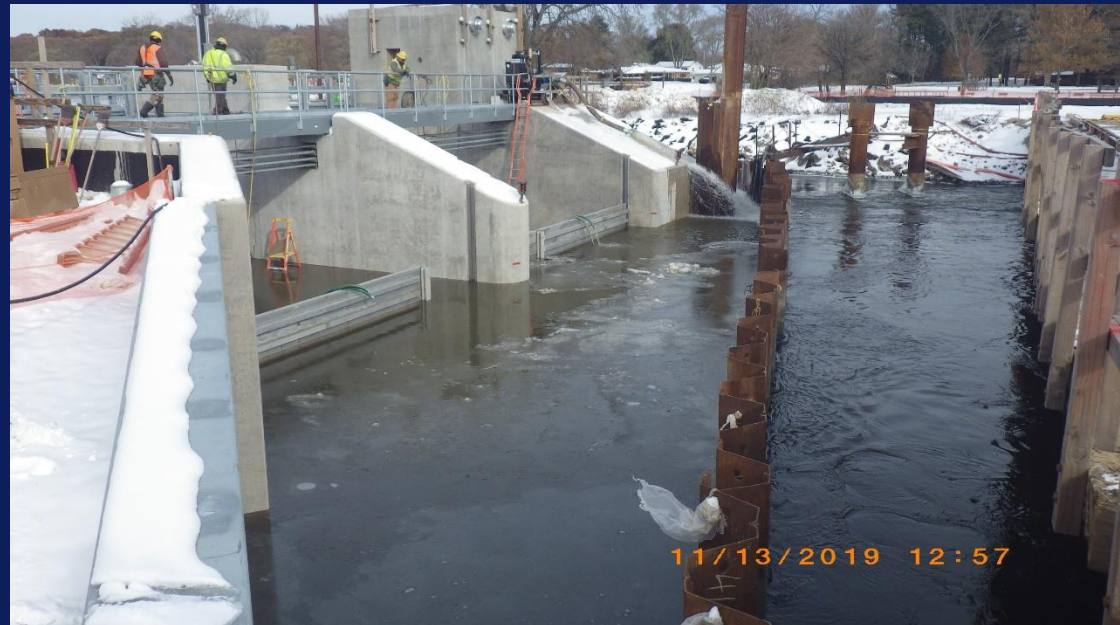
Intentional flooding
cofferdam upstream
of bulkheads

Leakage Testing
