**Illinois Association of Floodplain & Stormwater Management
Annual Conference
March 14, 2023**

Stratton-Bolger Lock & Dam Improvements McHenry, IL

Stratton Lock & Dam Improvements

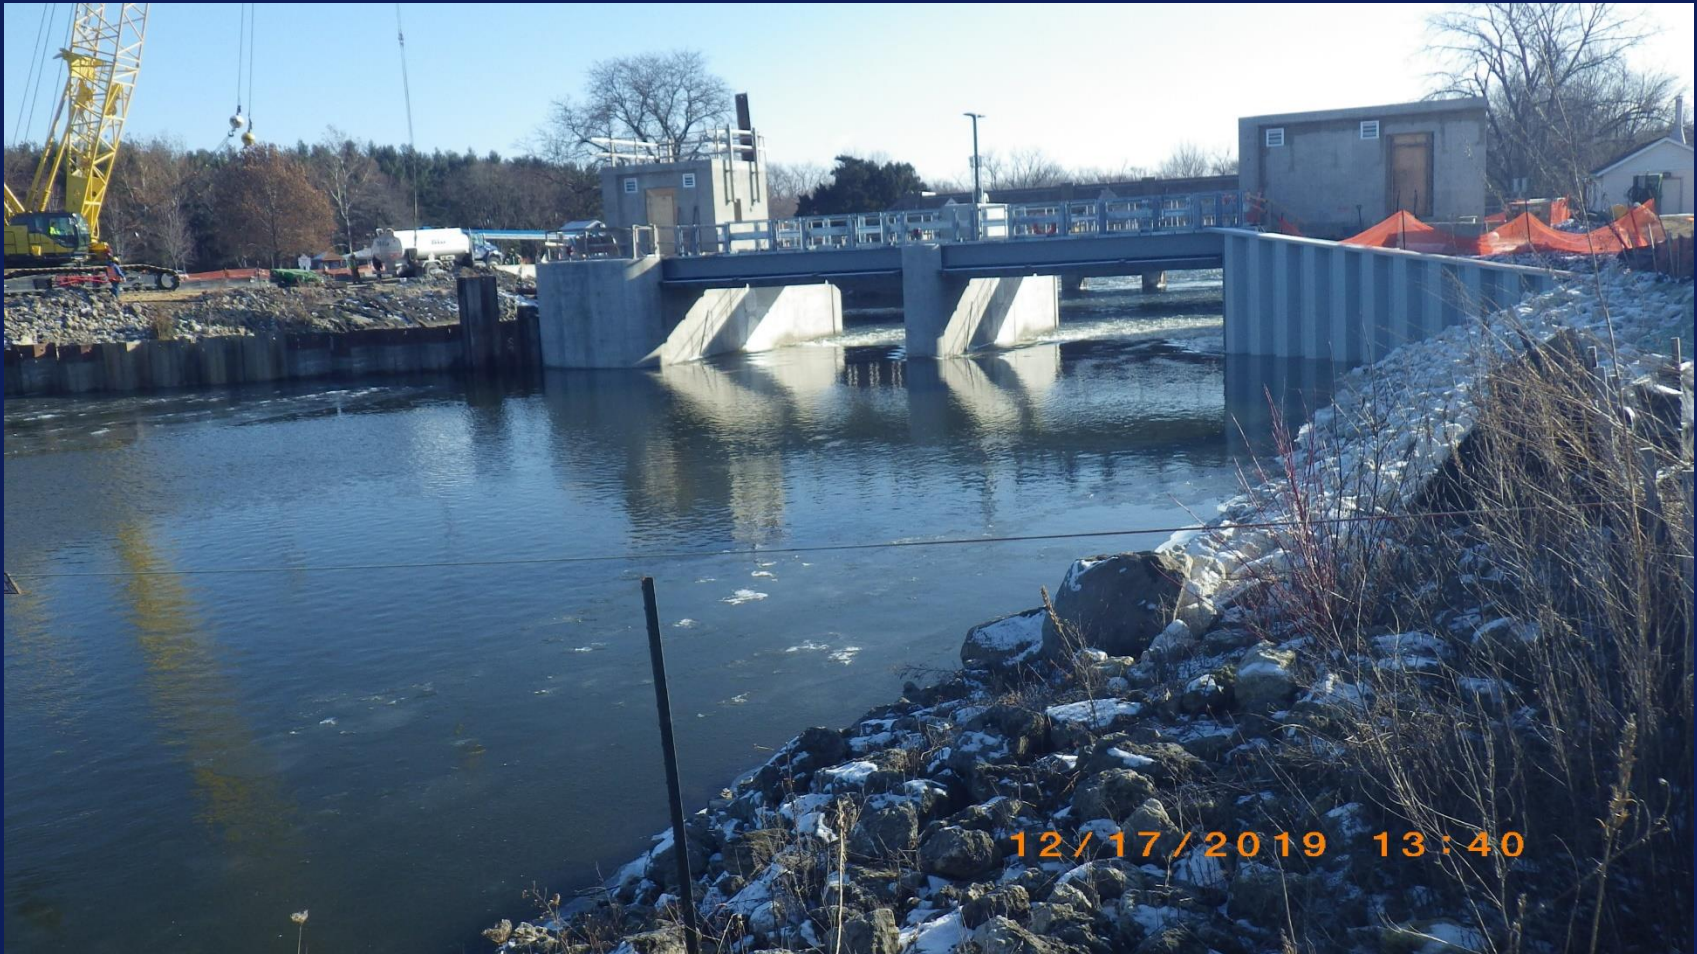
Bays 1 and 2 gates operational, Bay 3 Gate Construction beginning

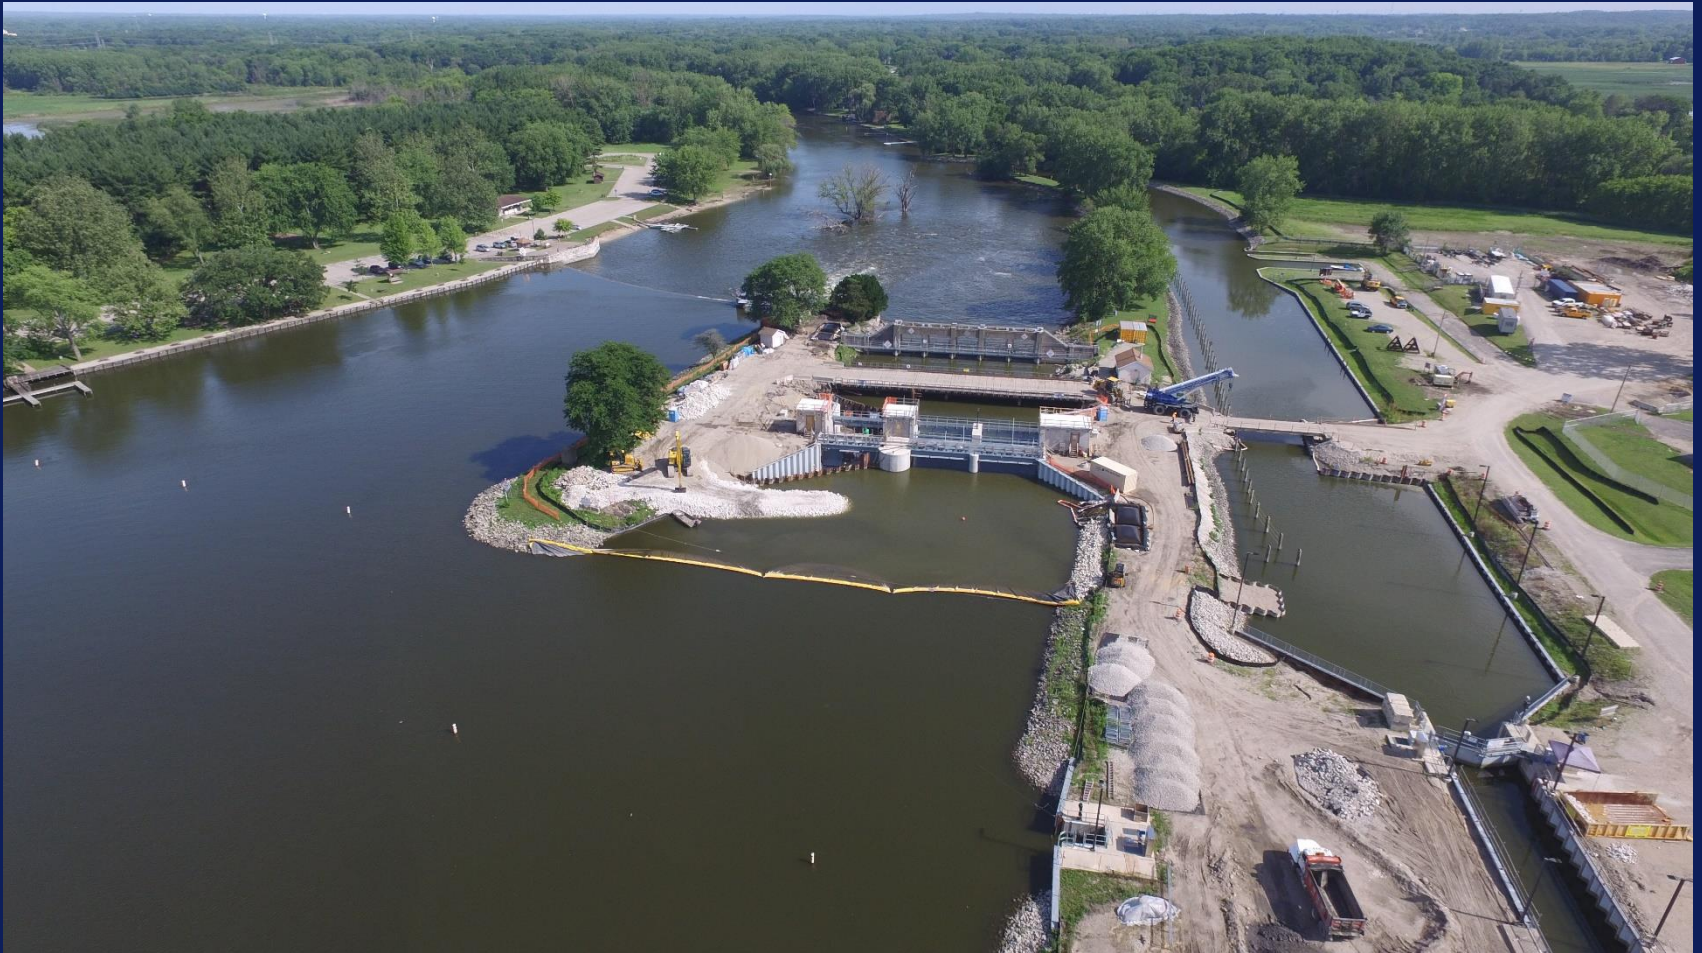
Bay 3 Gate Construction nearing completion

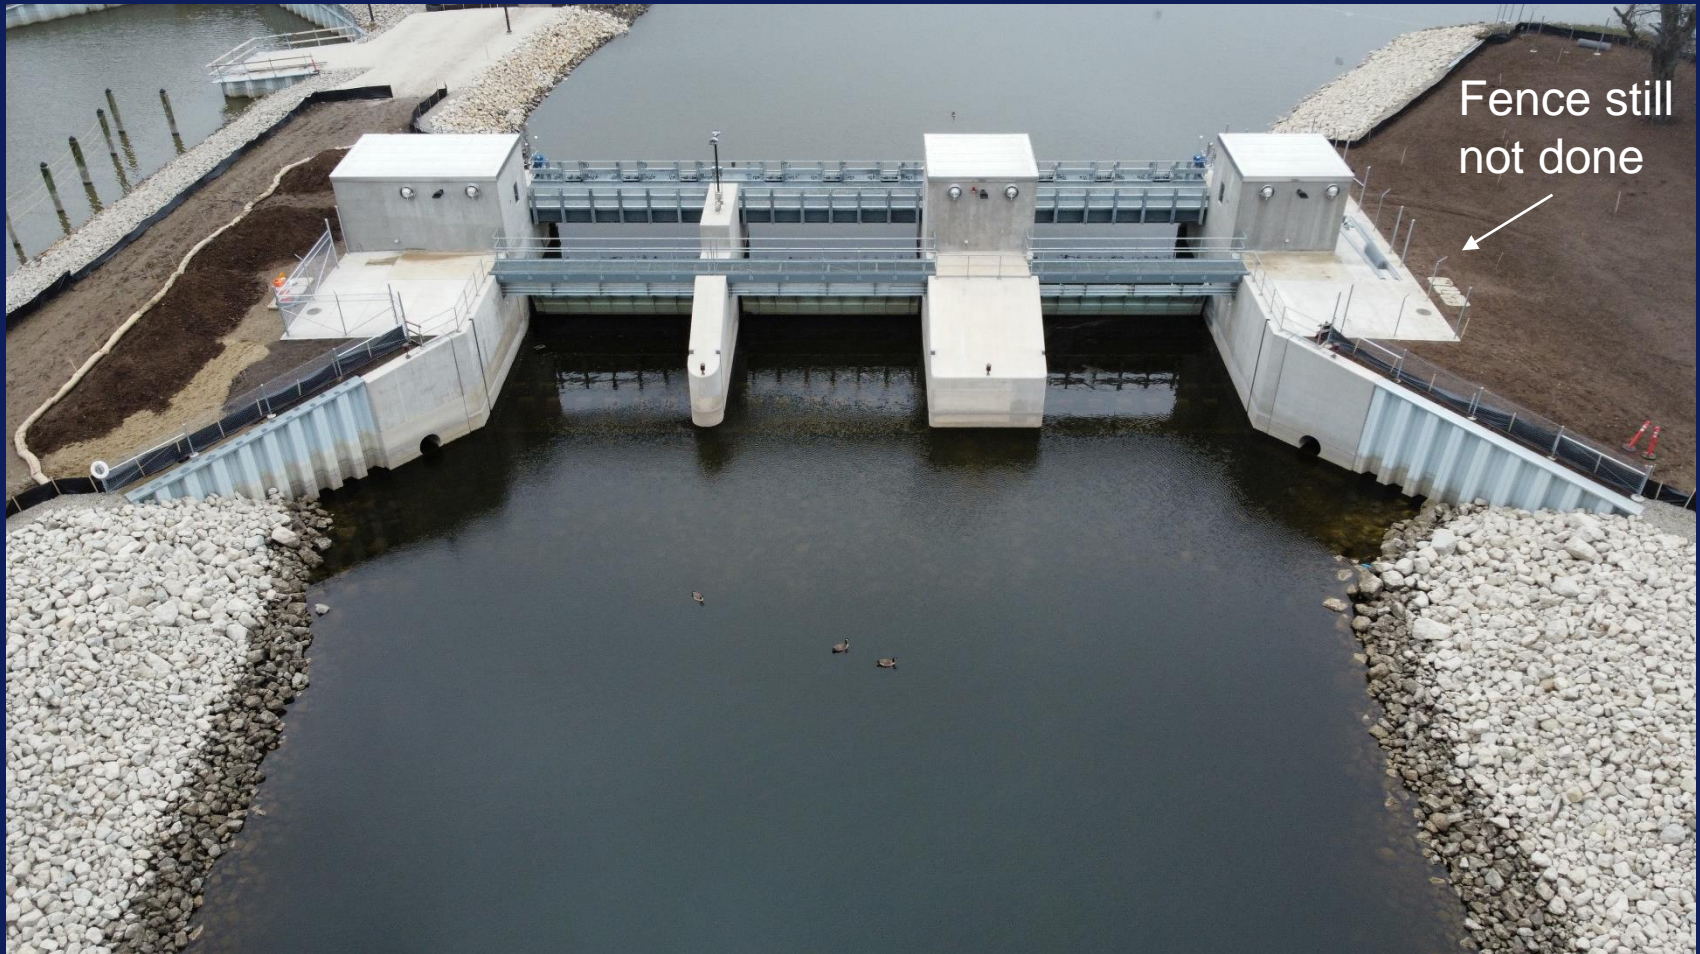
Dam Gate Structure Construction still not quite complete

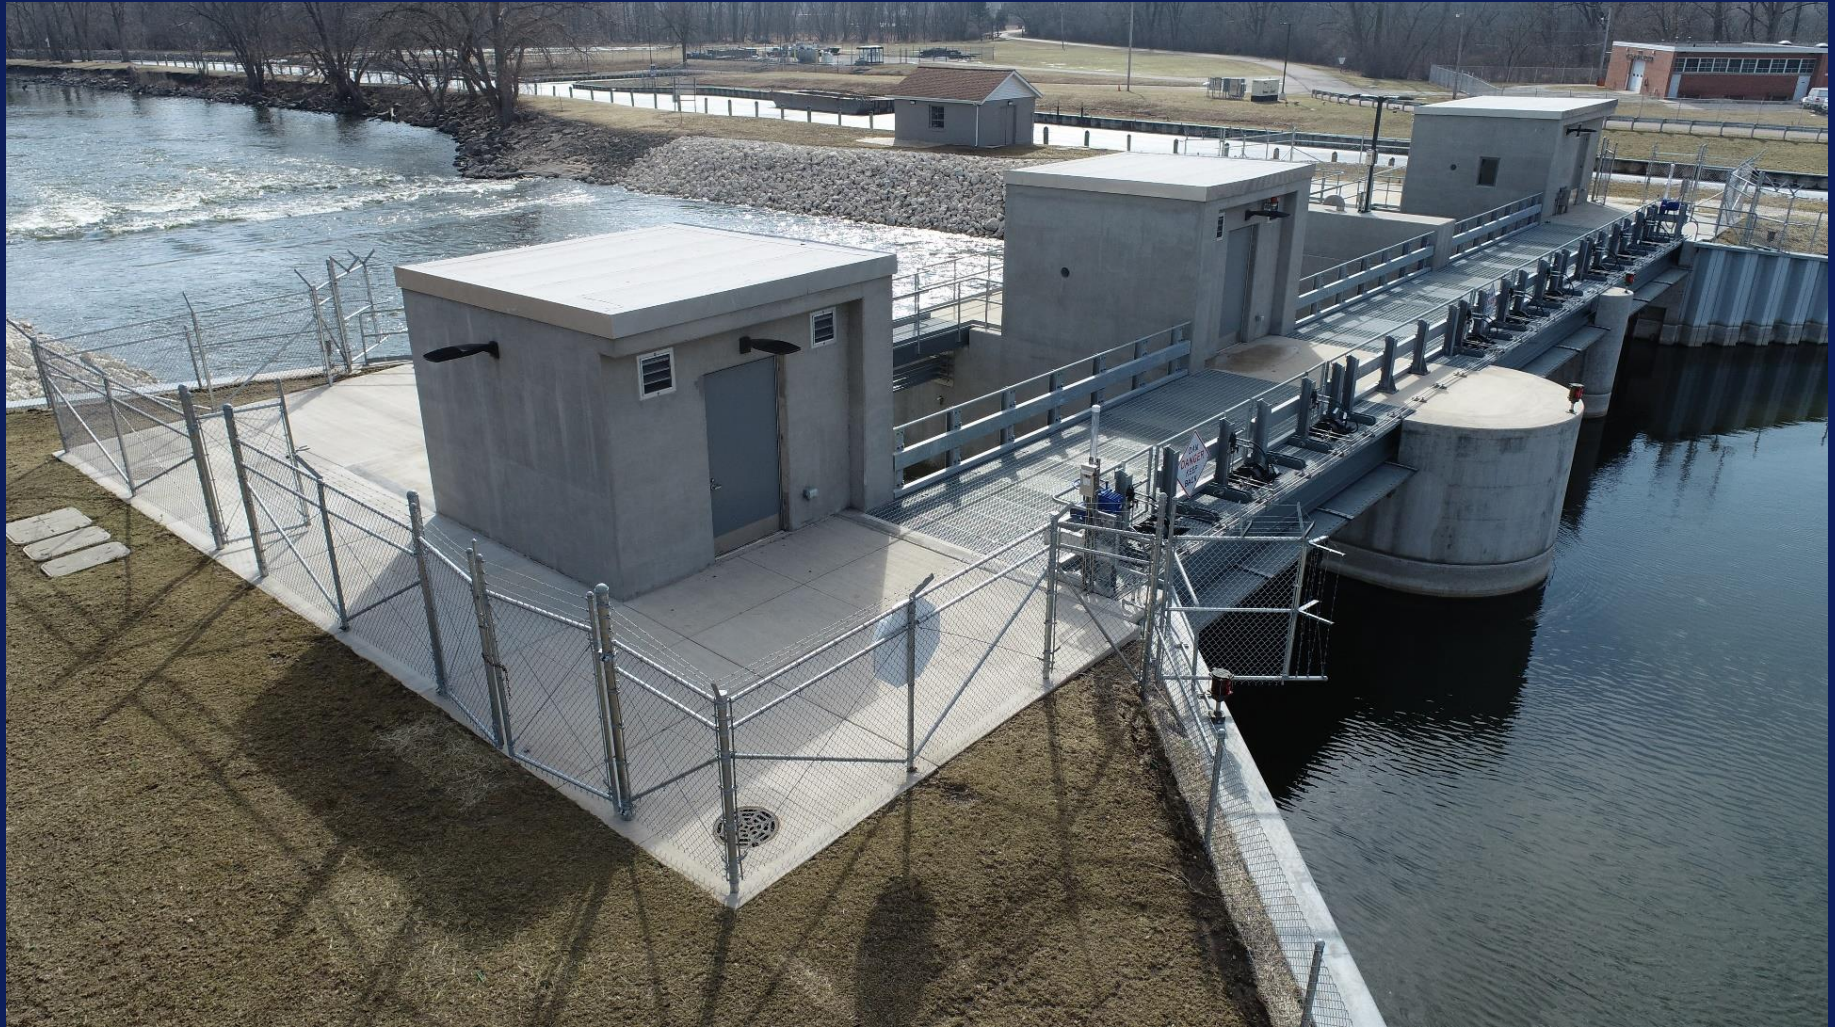
Completed Dam Structure

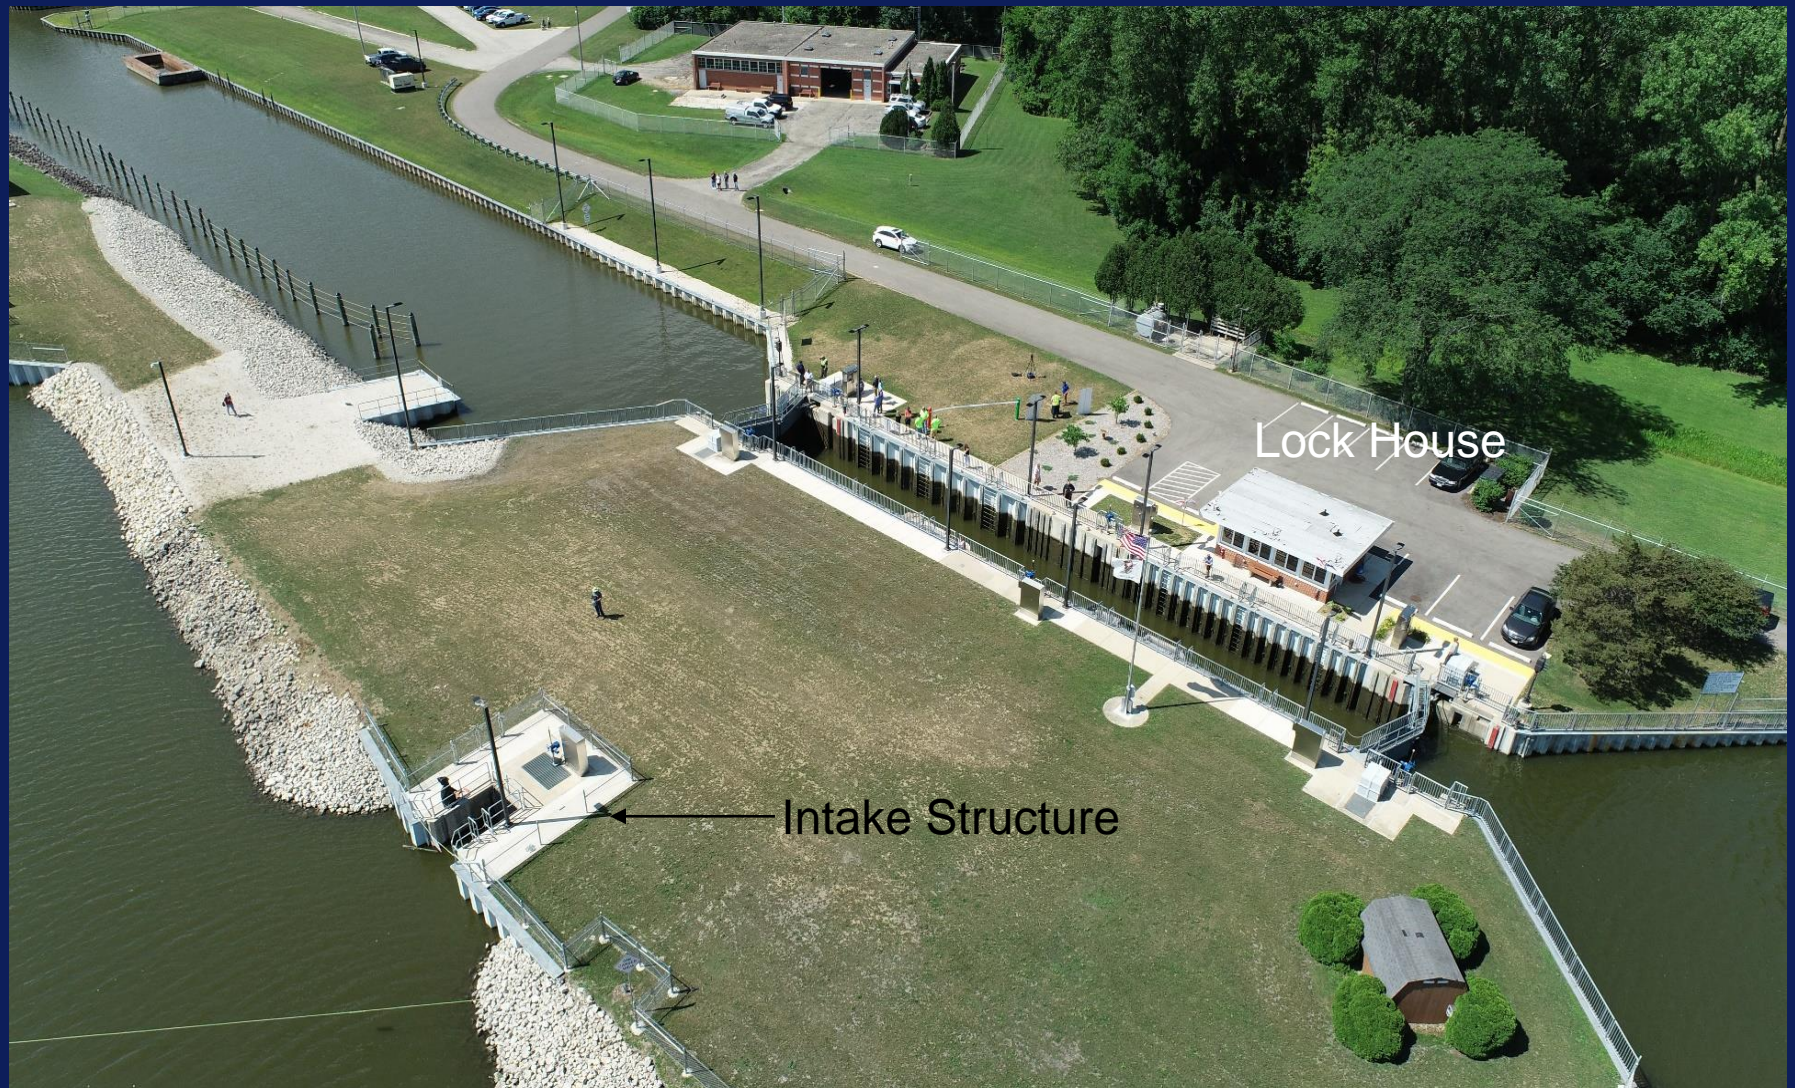
Completed Lock and Intake Structure
