### Risk Assessment in Hydrology and Hydraulics

Lessons Learned from the Analysis of the El Aguacate River, Guatemala

- Bridge Replacement,
   Aguacate Guatemala
- Engineers Without Borders (EWB), WI Professional Partners

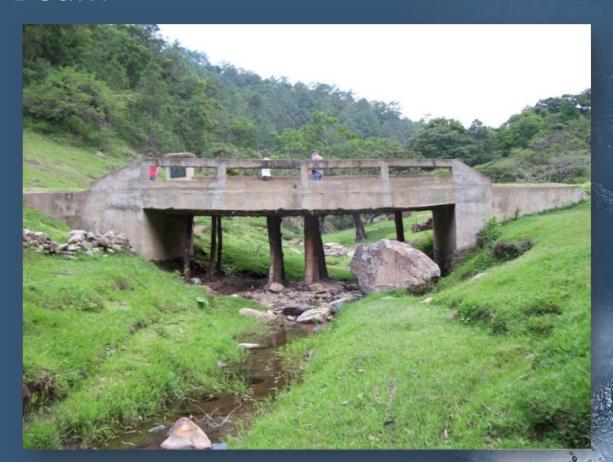
- Existing Bridge Built 1987
- Concrete T Beam
- 32' Span

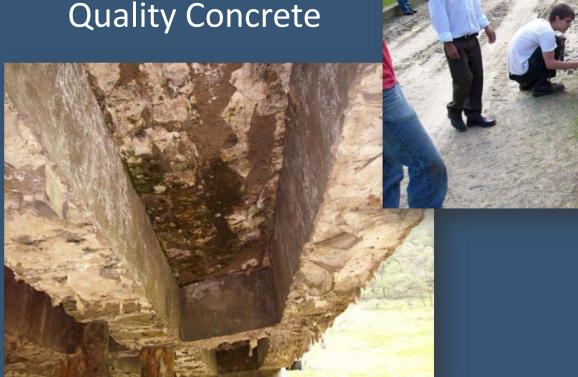
Structural Analysis
 Indicates Design is
 Inadequate – Low
 Quality Concrete

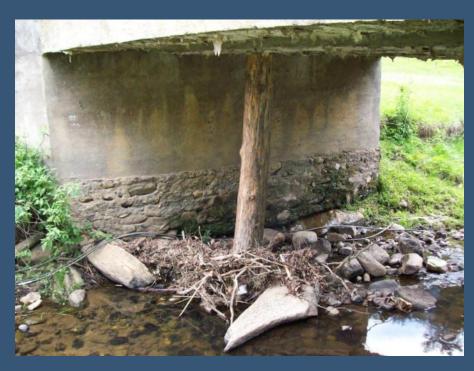
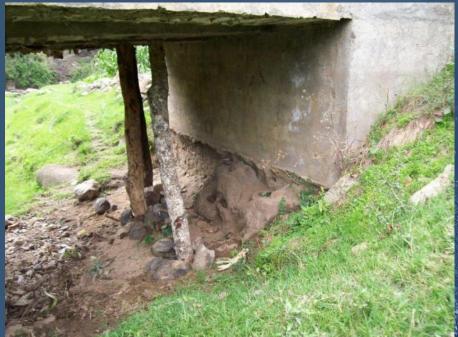
Shallow Abutments – No Footings

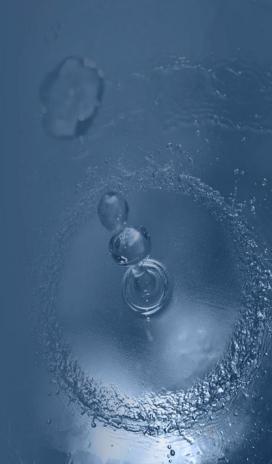
### El Aguacate Watershed

- -1225 Acres (10 M topography)
- Predominantly Woods and Grass Combination (Aerial photography)

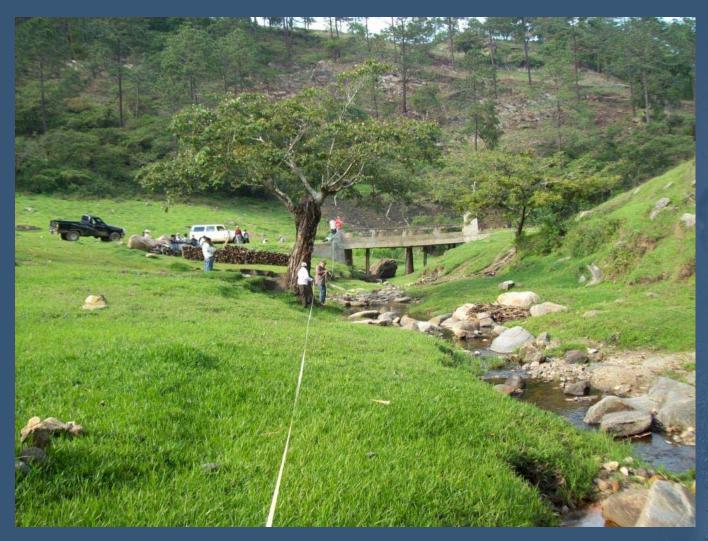
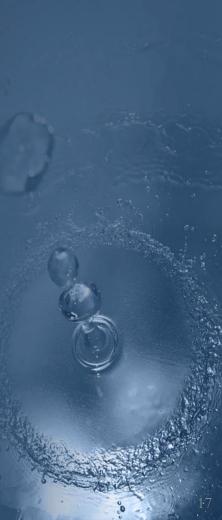
### **Stream Characterstics**

- Hydraulic Modeling Approach HEC RAS
- Assumed negligent stream base flow; used flow directly from Hydrologic Analysis
- Cross section geometry field survey
  - 6 stream cross sections
  - Bridge geometry and road profile
- Stream characteristics site photos

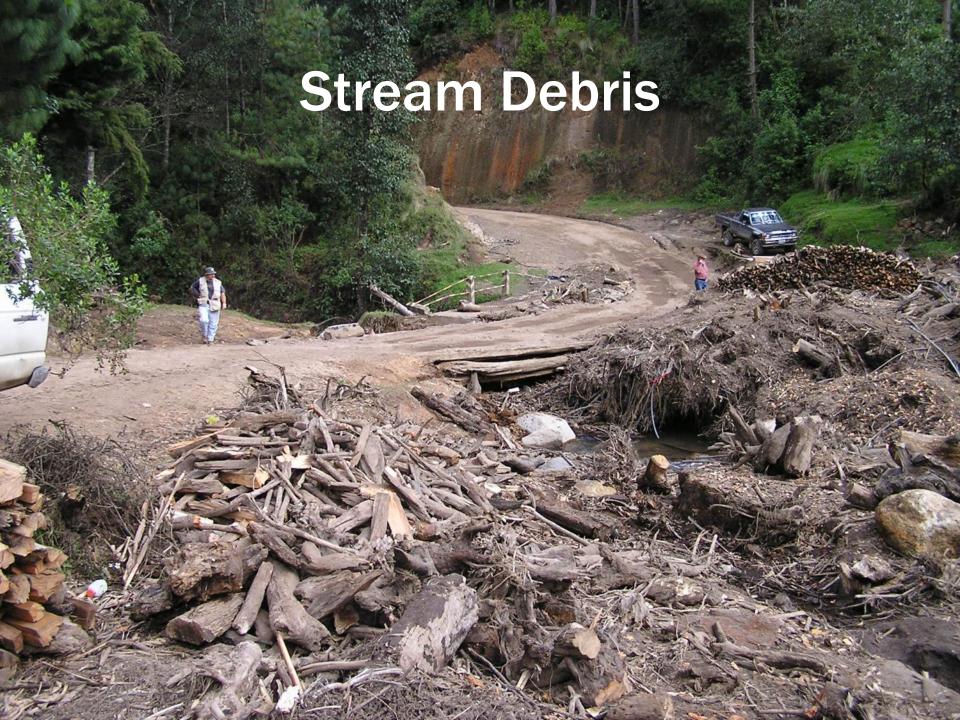
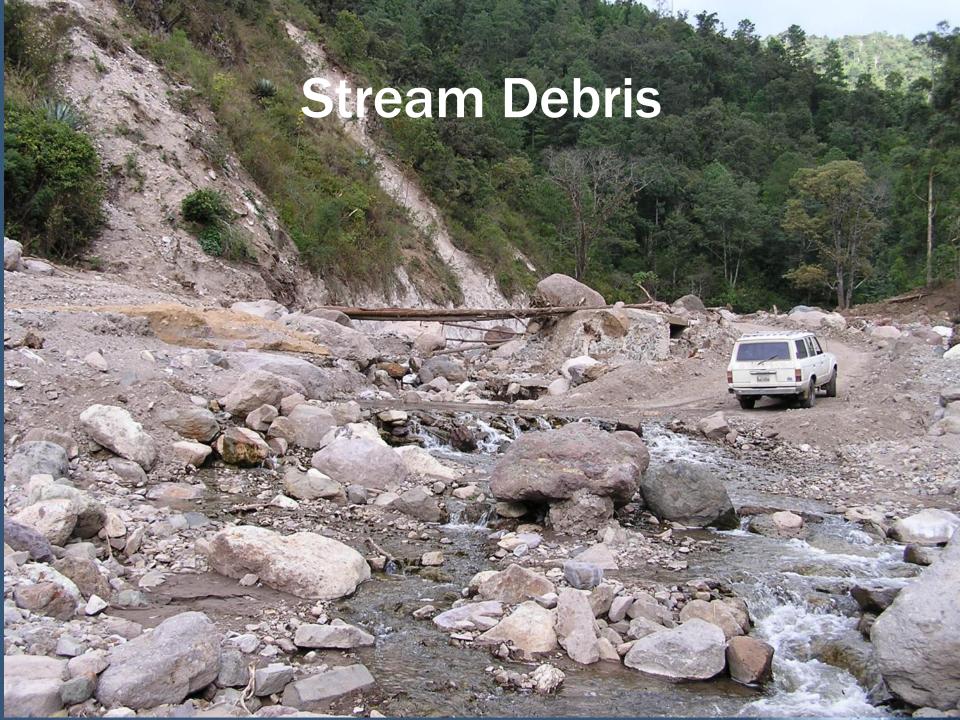
Design bridge opening to pass debris

Special Geographic Conditions – mudslides produce "Dam Break" effects

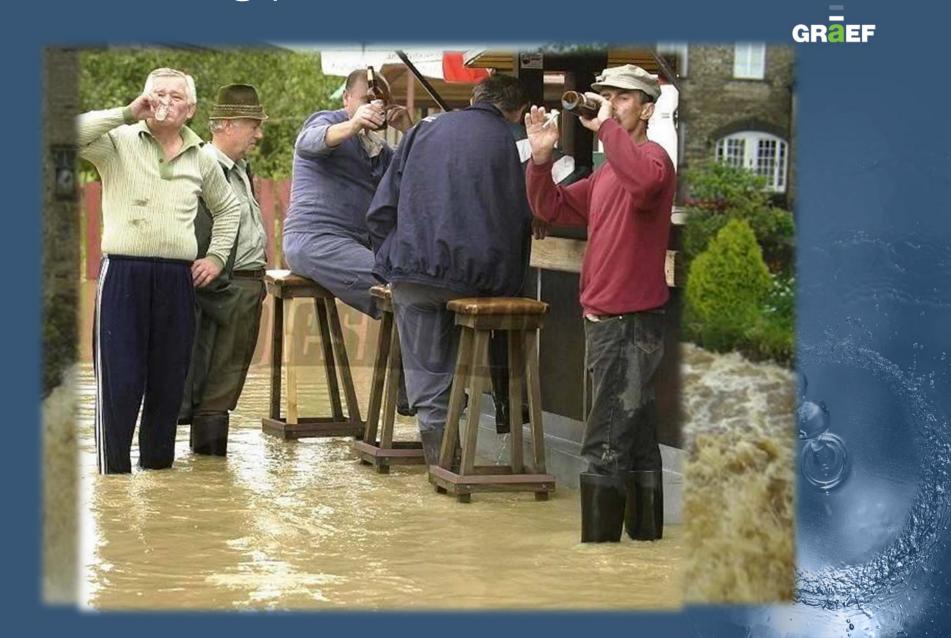
### **Bridge/Road Closure Plan**

Emergency Planning – Bridge/Road Closure
 Plan
