## What Has Limited the Risk of Damages in Western Cook County? Good Policy or Good Luck?

Jeff Wickenkamp, P.E., CFM, D.WRE Hey and Associates, Inc.

Metropolitan Water Reclamation District of Greater Chicago

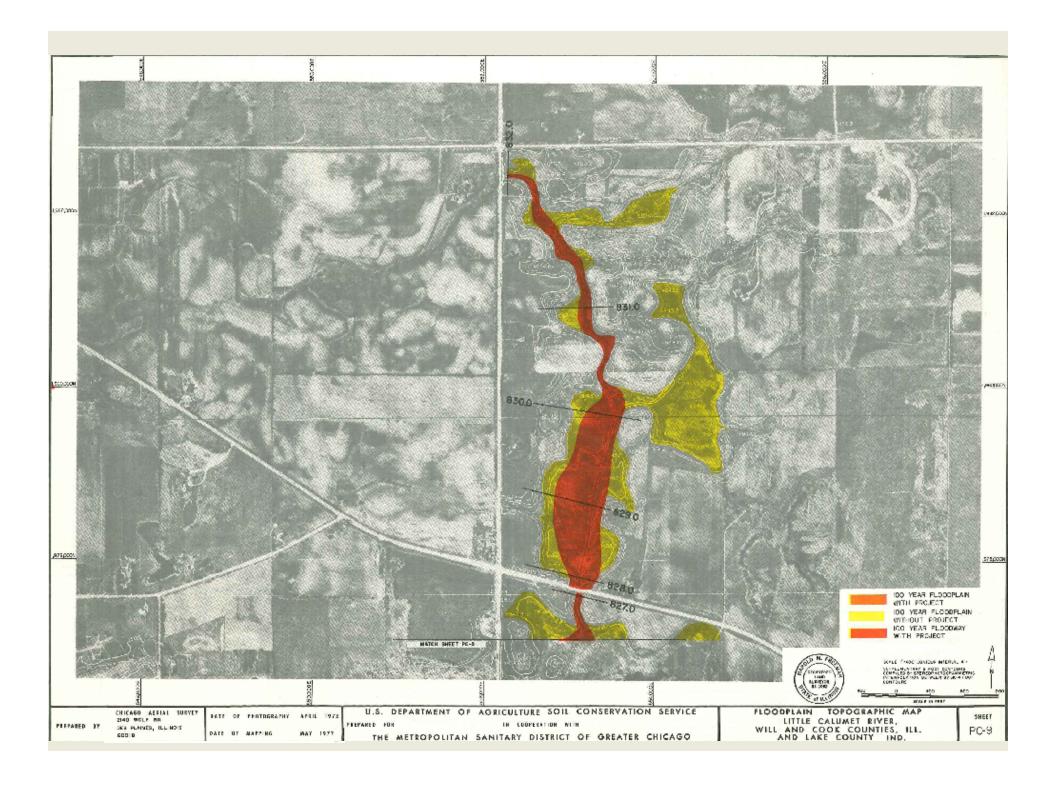
### 100-Year Inundation Risk

- FEMA Zone A and AE total 4,356 acres in the study area
- DWP 100-year inundation area totals 5,038 acres in the study area (16% increase)

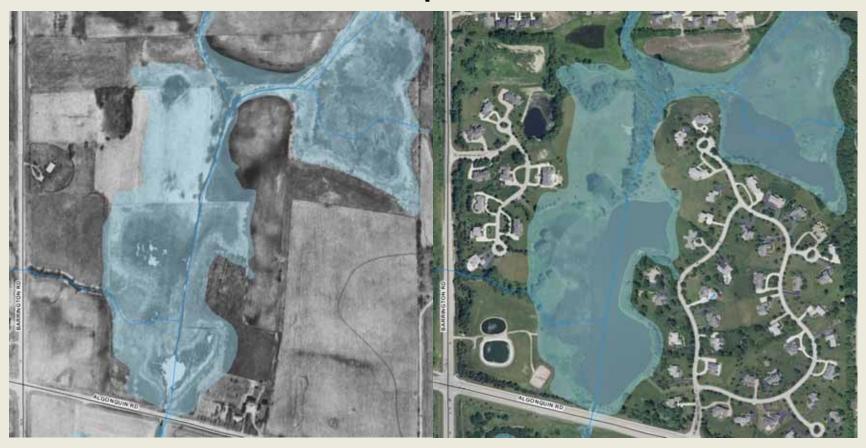
## Development Respecting Established Floodplains

1970 2008

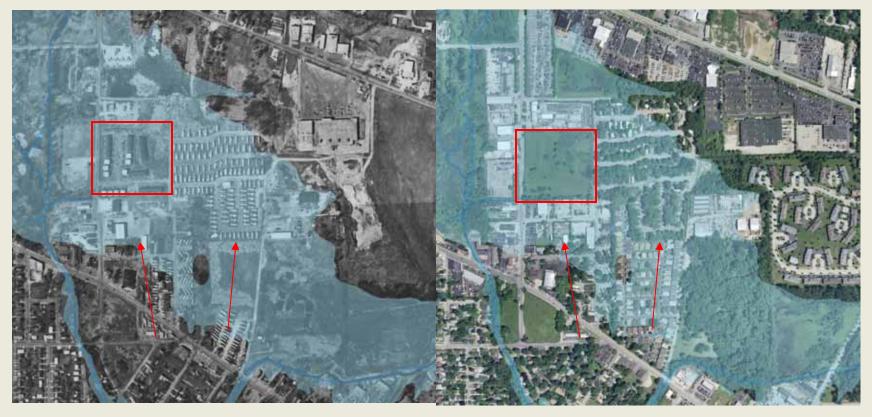
## Converting Developed Land to Open Space (sometimes)

1970 2008

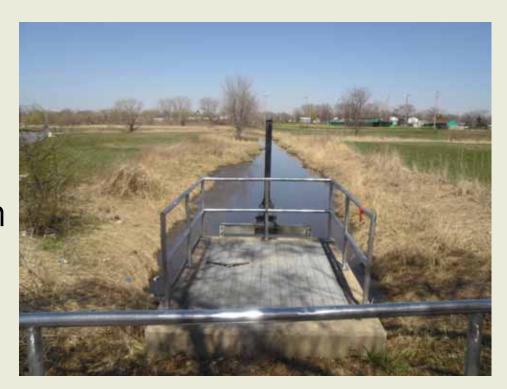
### Regional Flood Control

- Three flood control basins constructed in Streamwood between 1973 and 1974
- No current damages on Poplar Creek South Branch (Primarily Streamwood)
