saving a sanitary sewer:

A Stream Restoration Story

Emily Poynter Jenkins, PE, PhD, CFM

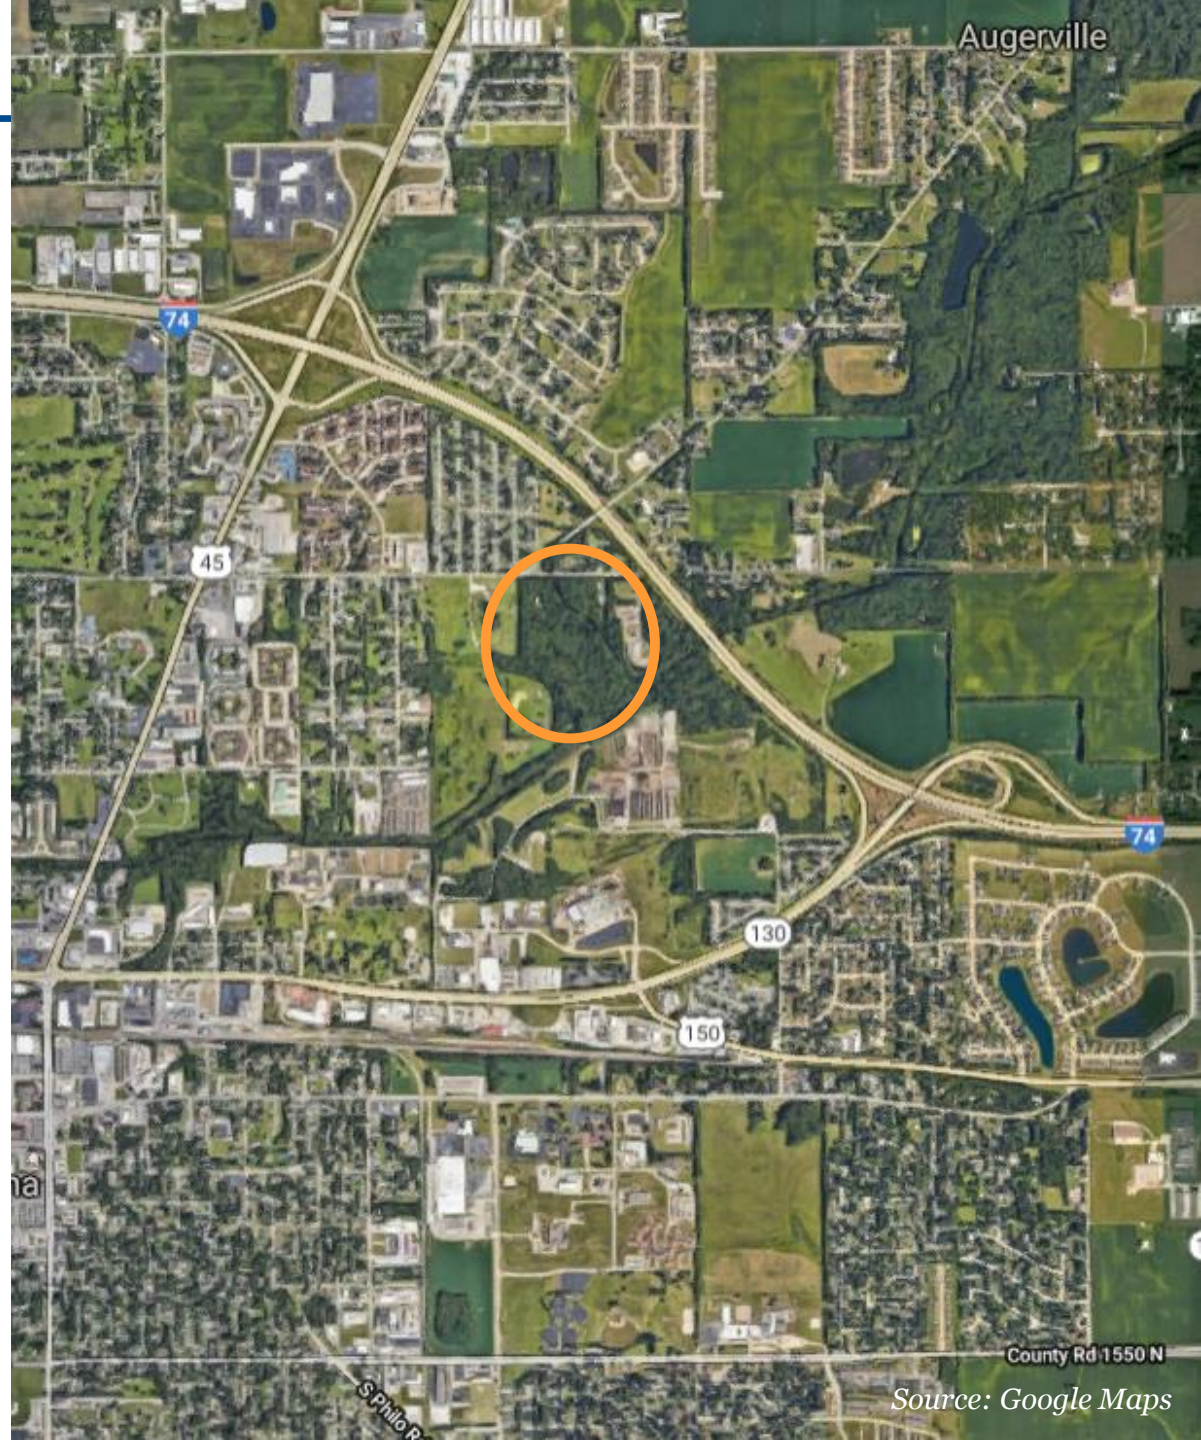
1965

Urbana-Champaign
Sanitary District
installed an
interceptor
next to *existing ditch*

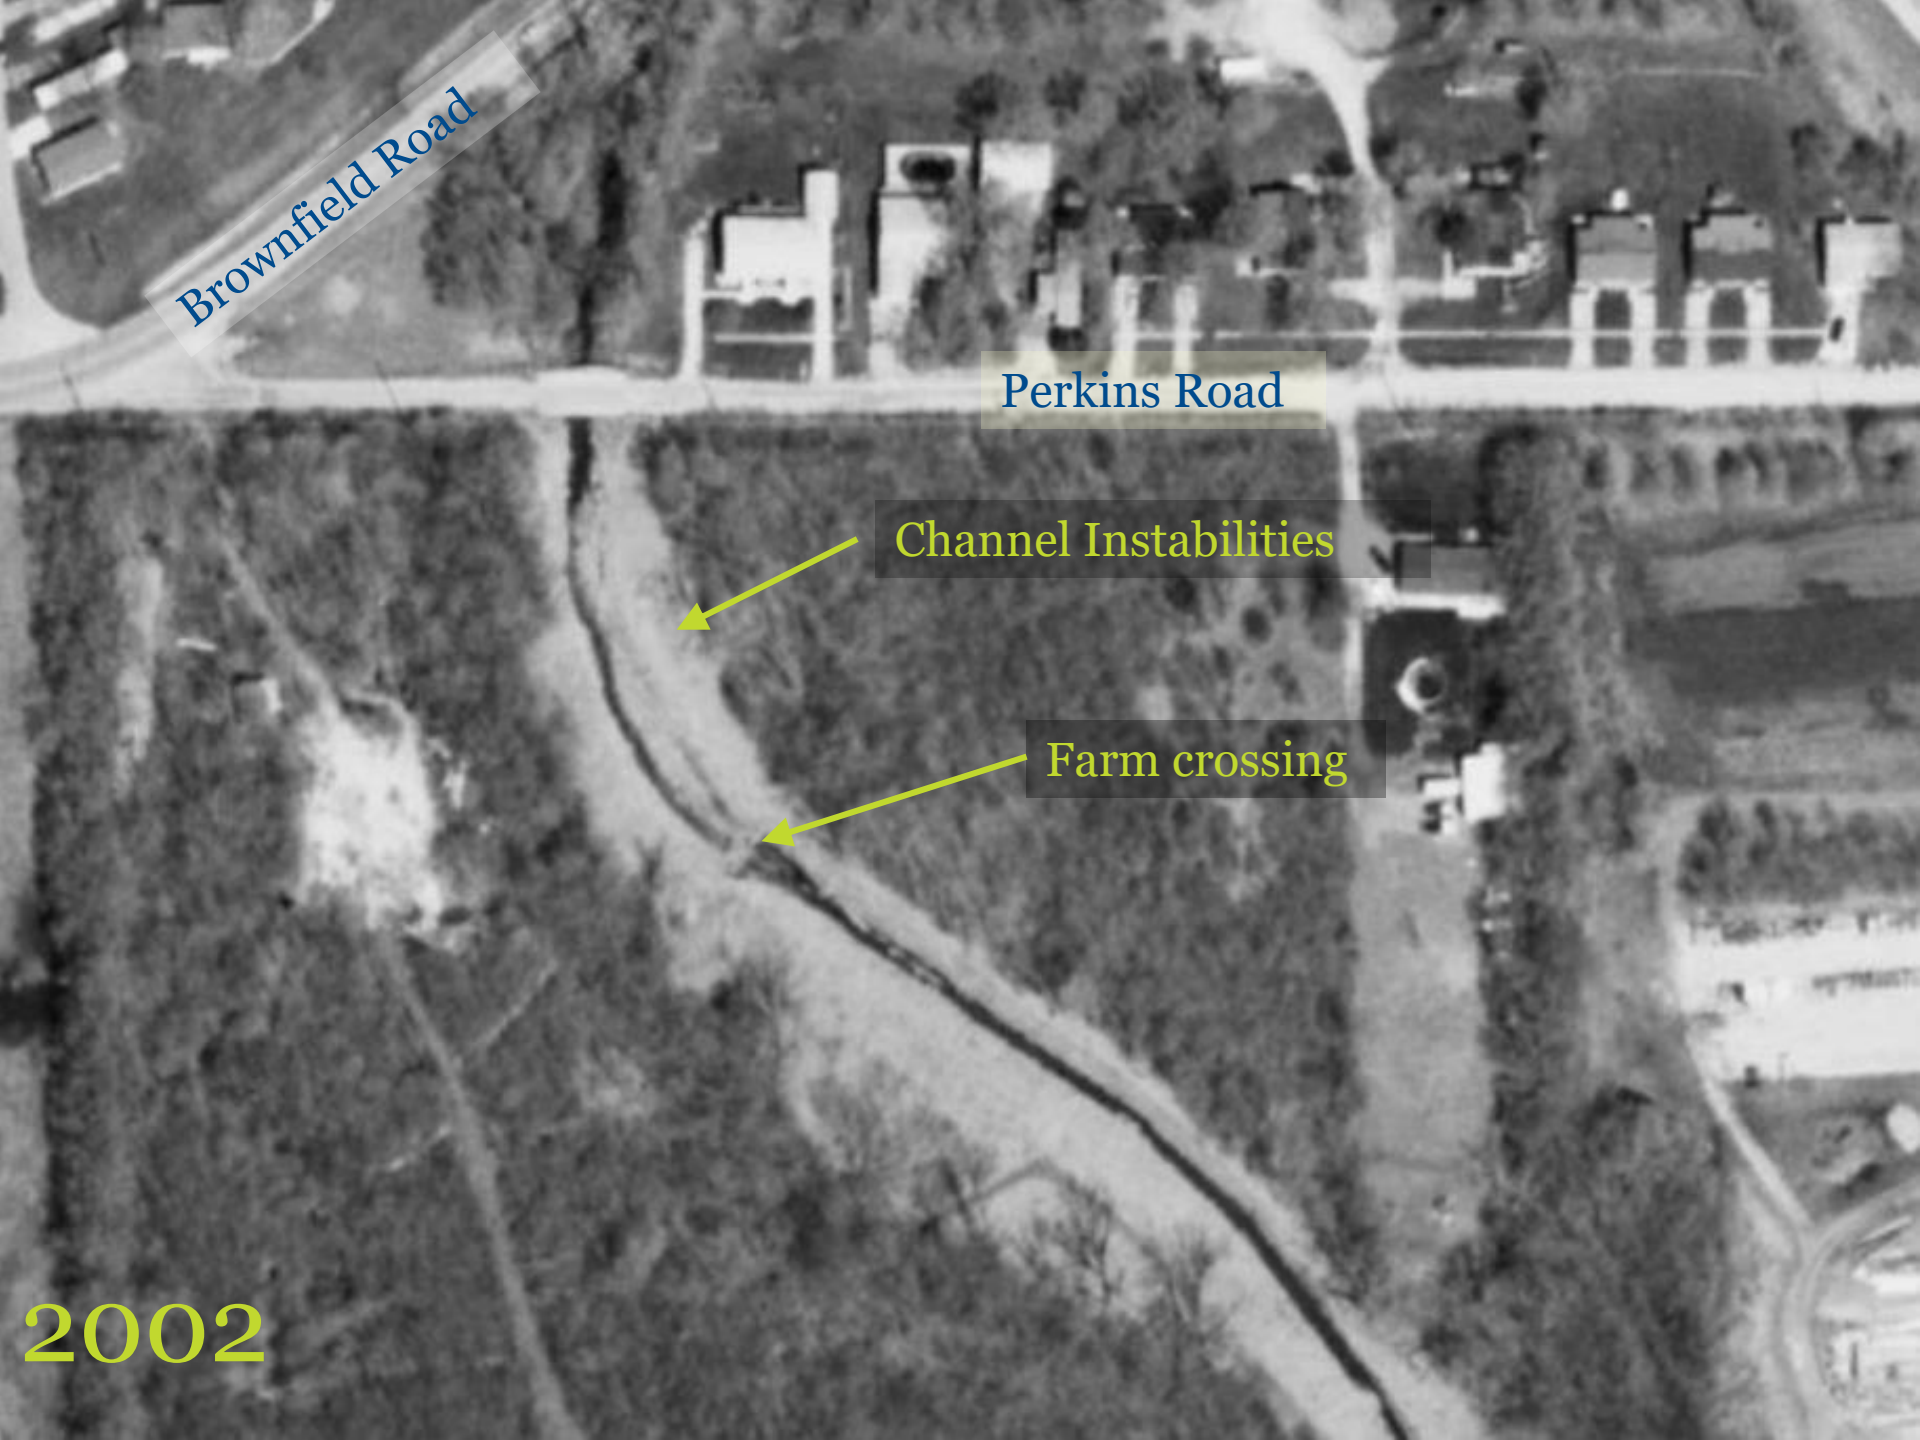
2002

Channel Instabilities

Farm crossing

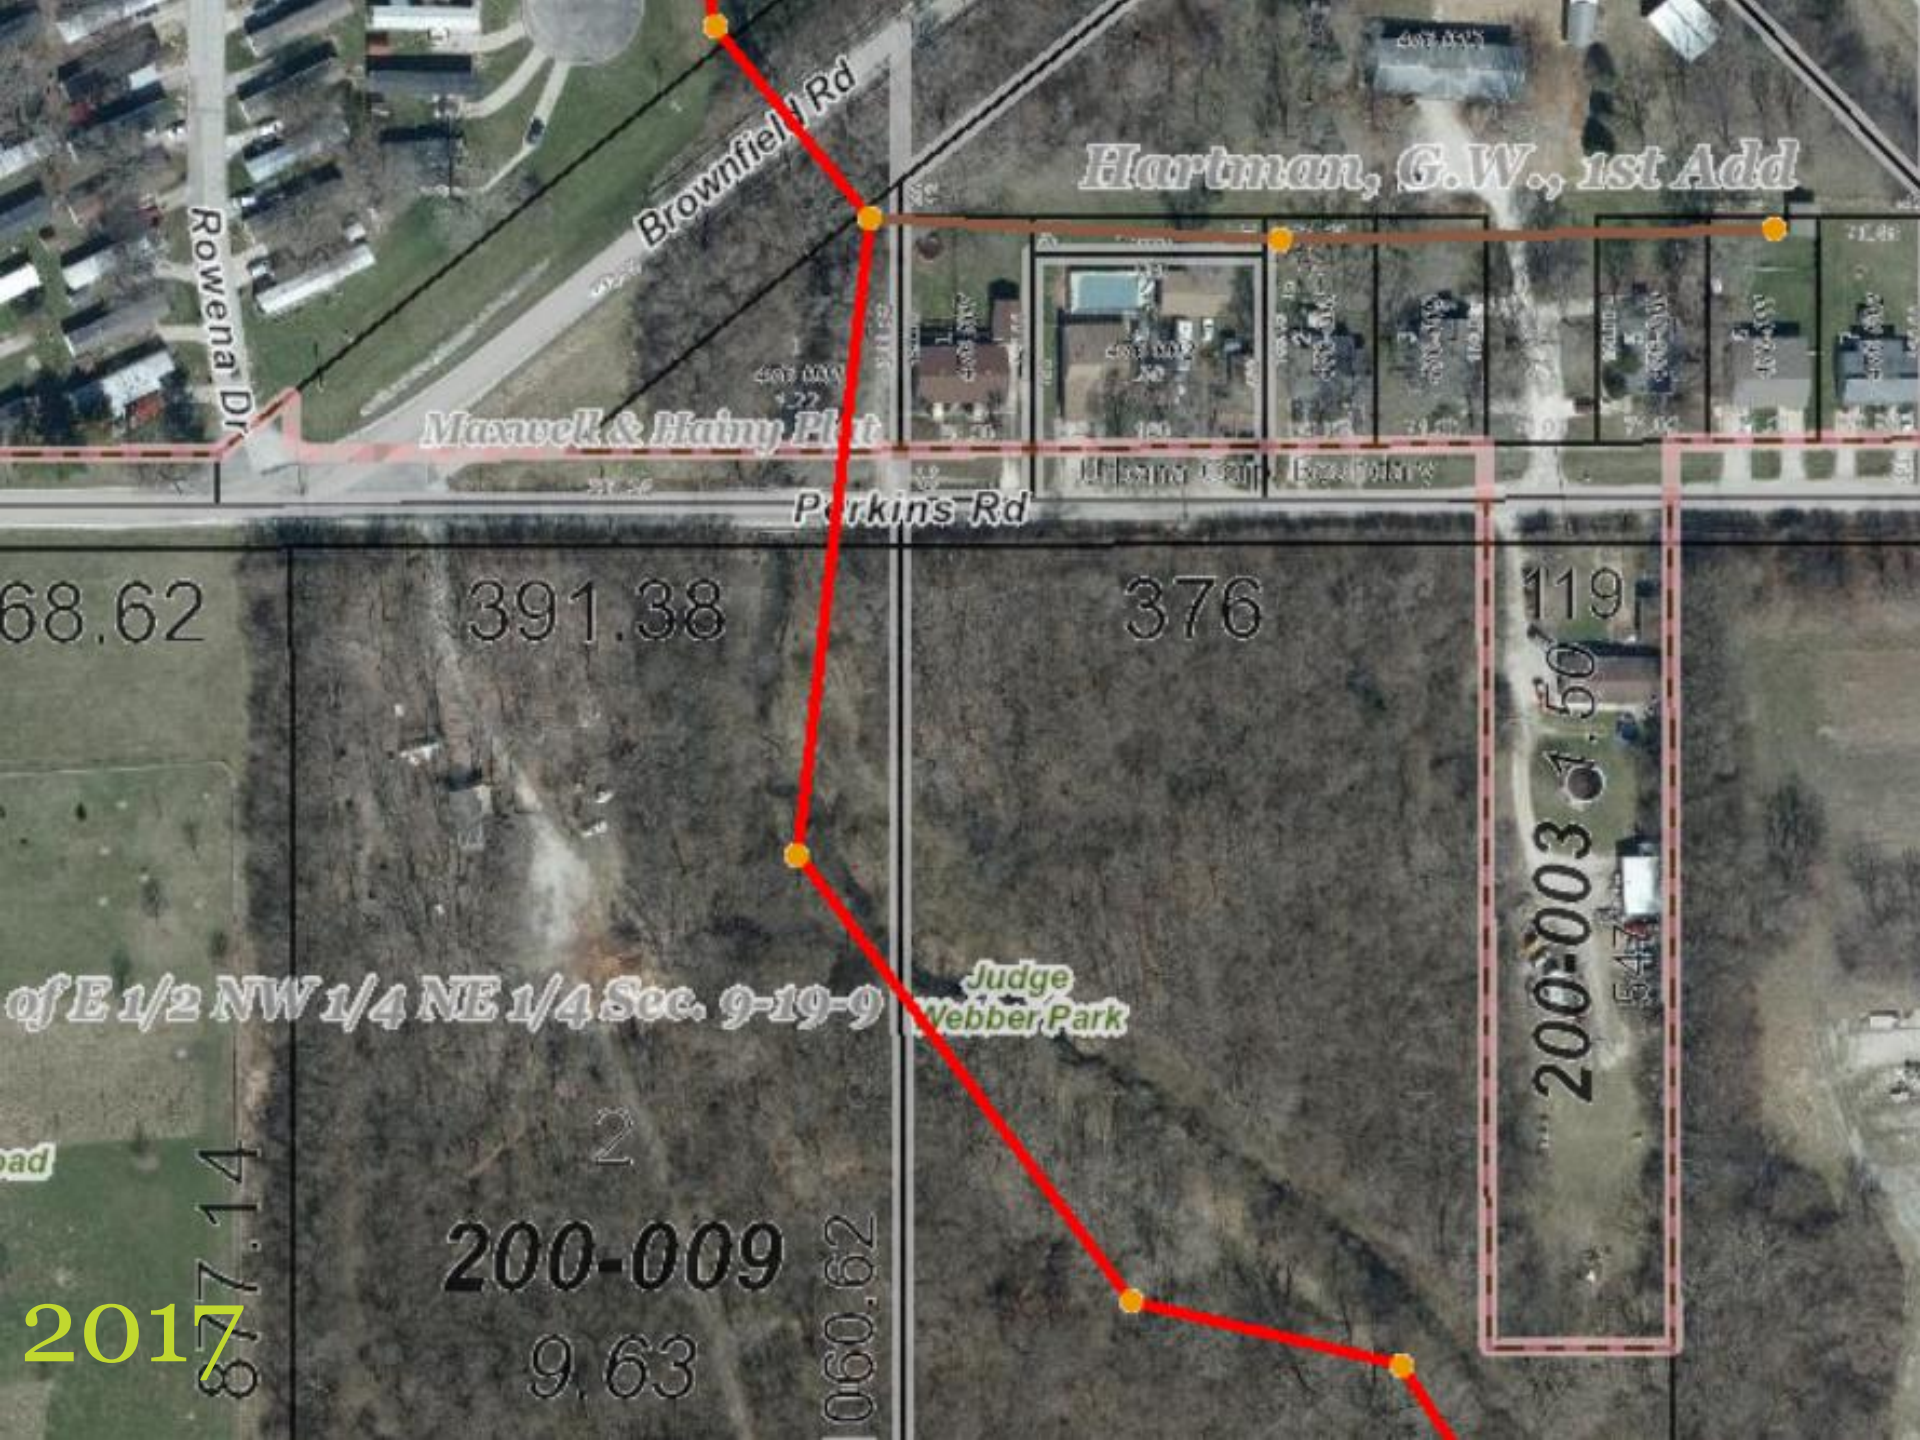
2017

Exposed Sanitary Pipe

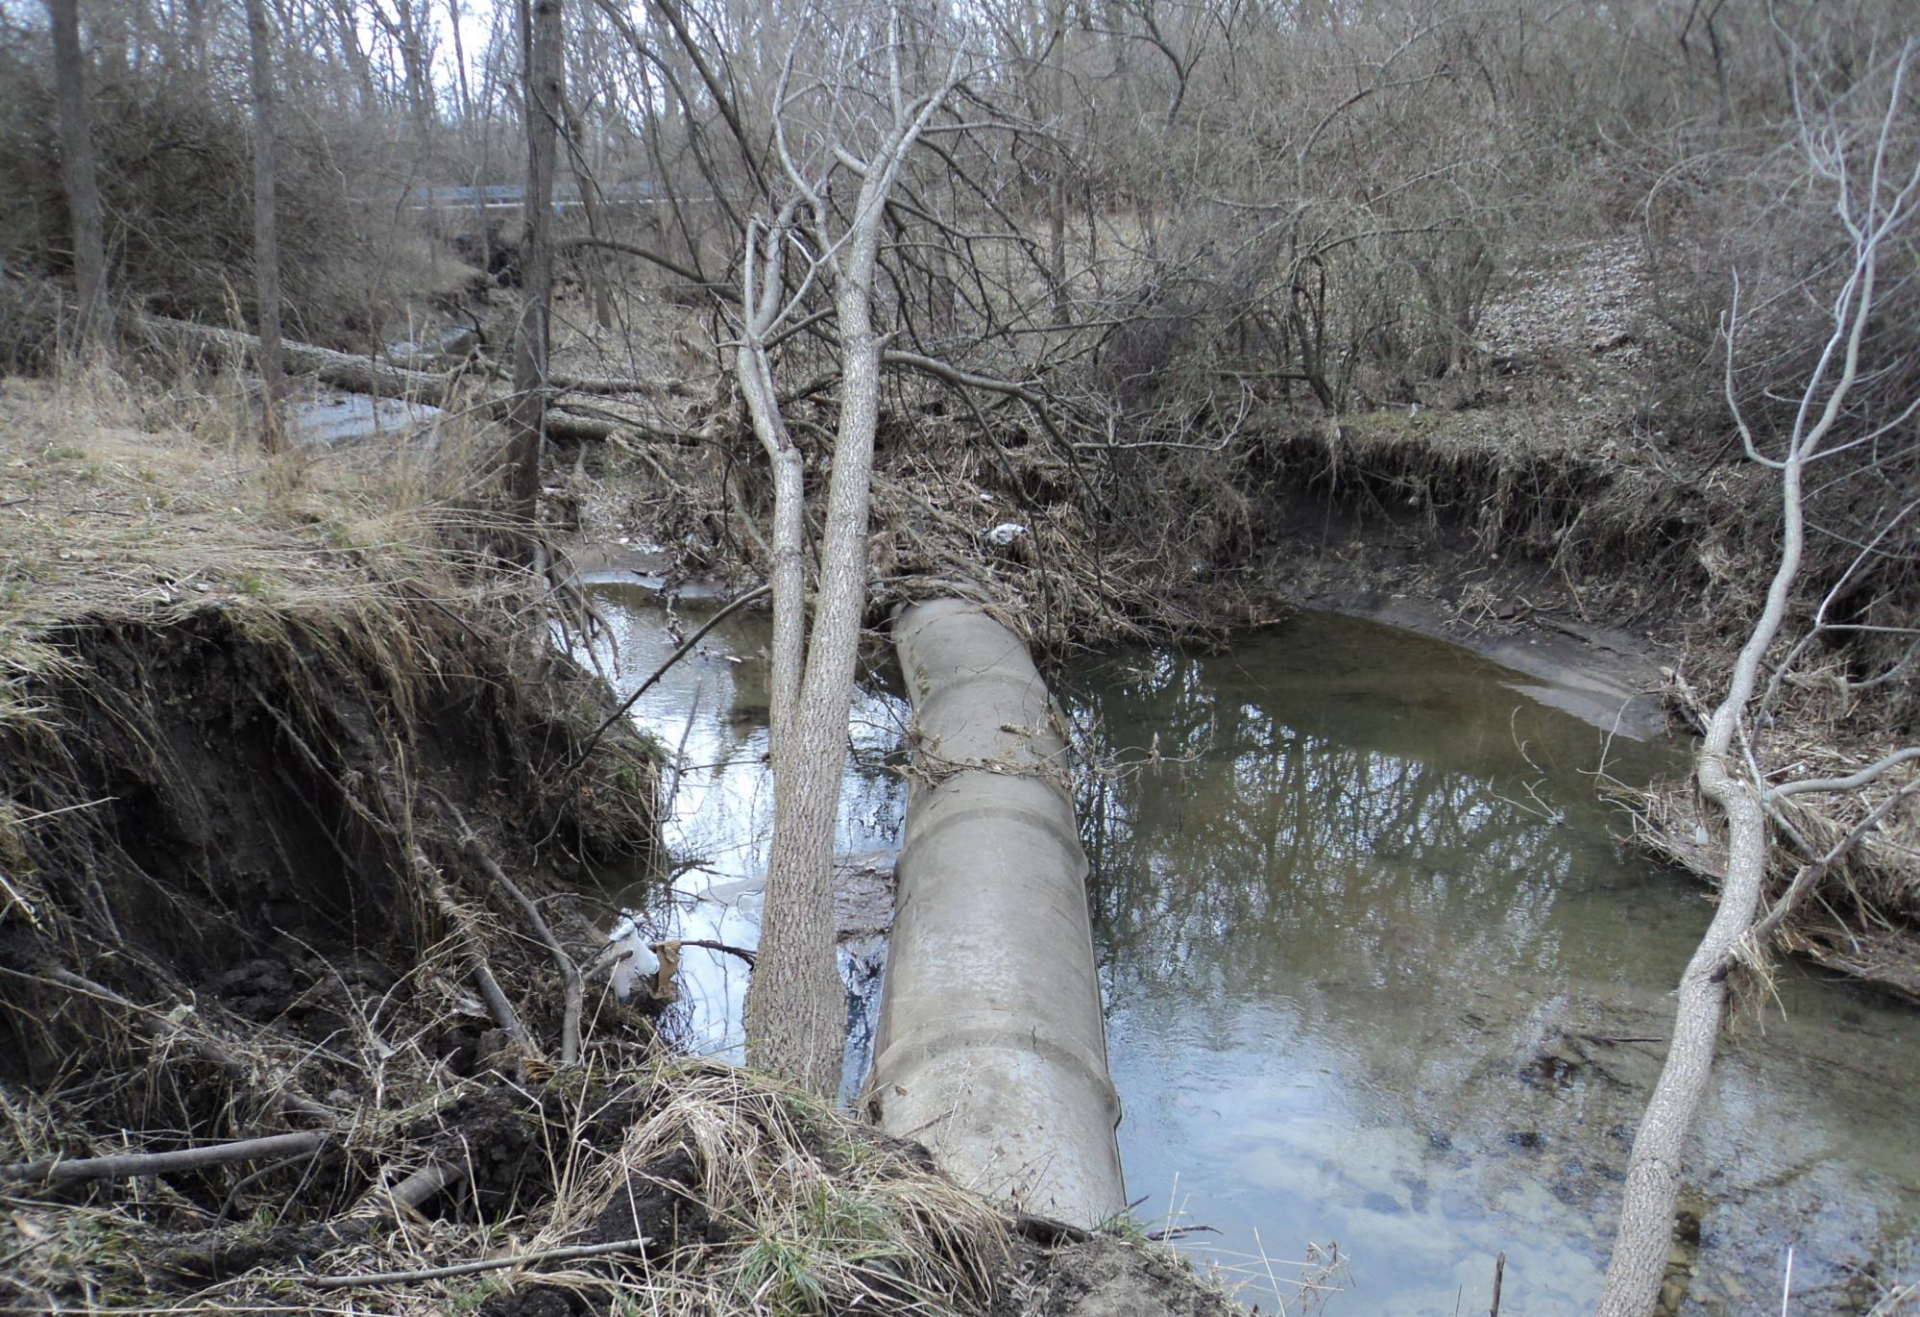
Looking north/upstream towards Perkins Road

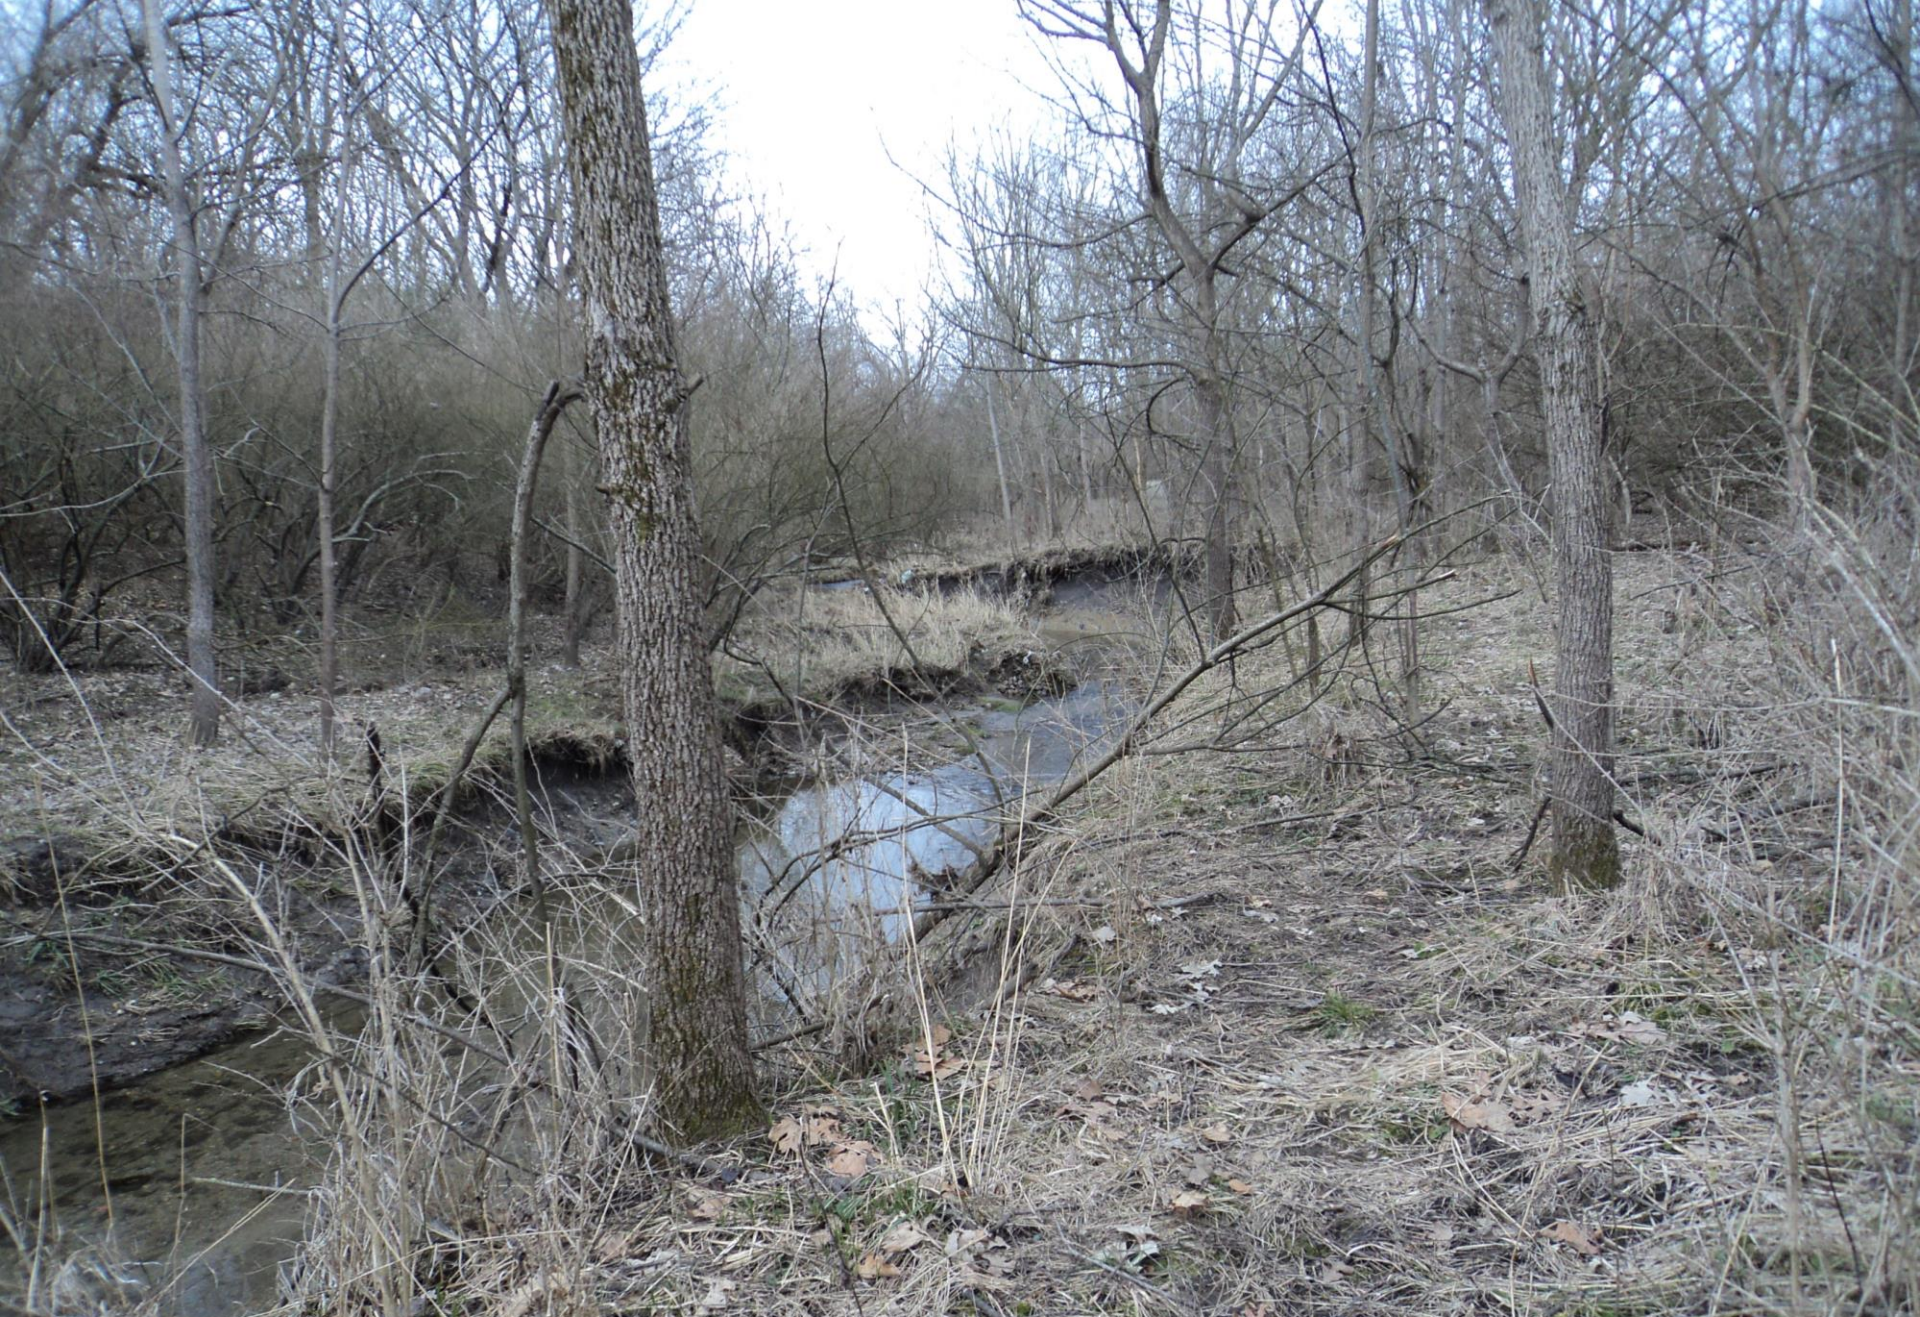
Same location looking south/downstream

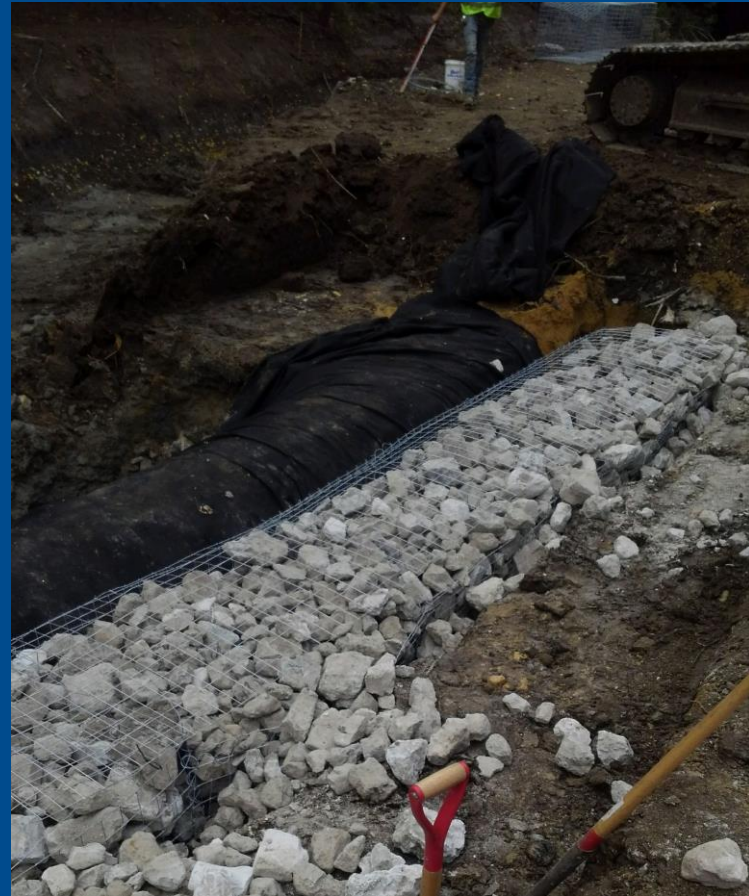
construction challenge

Pipe originally backfilled with sand
Concerns with pipe stability

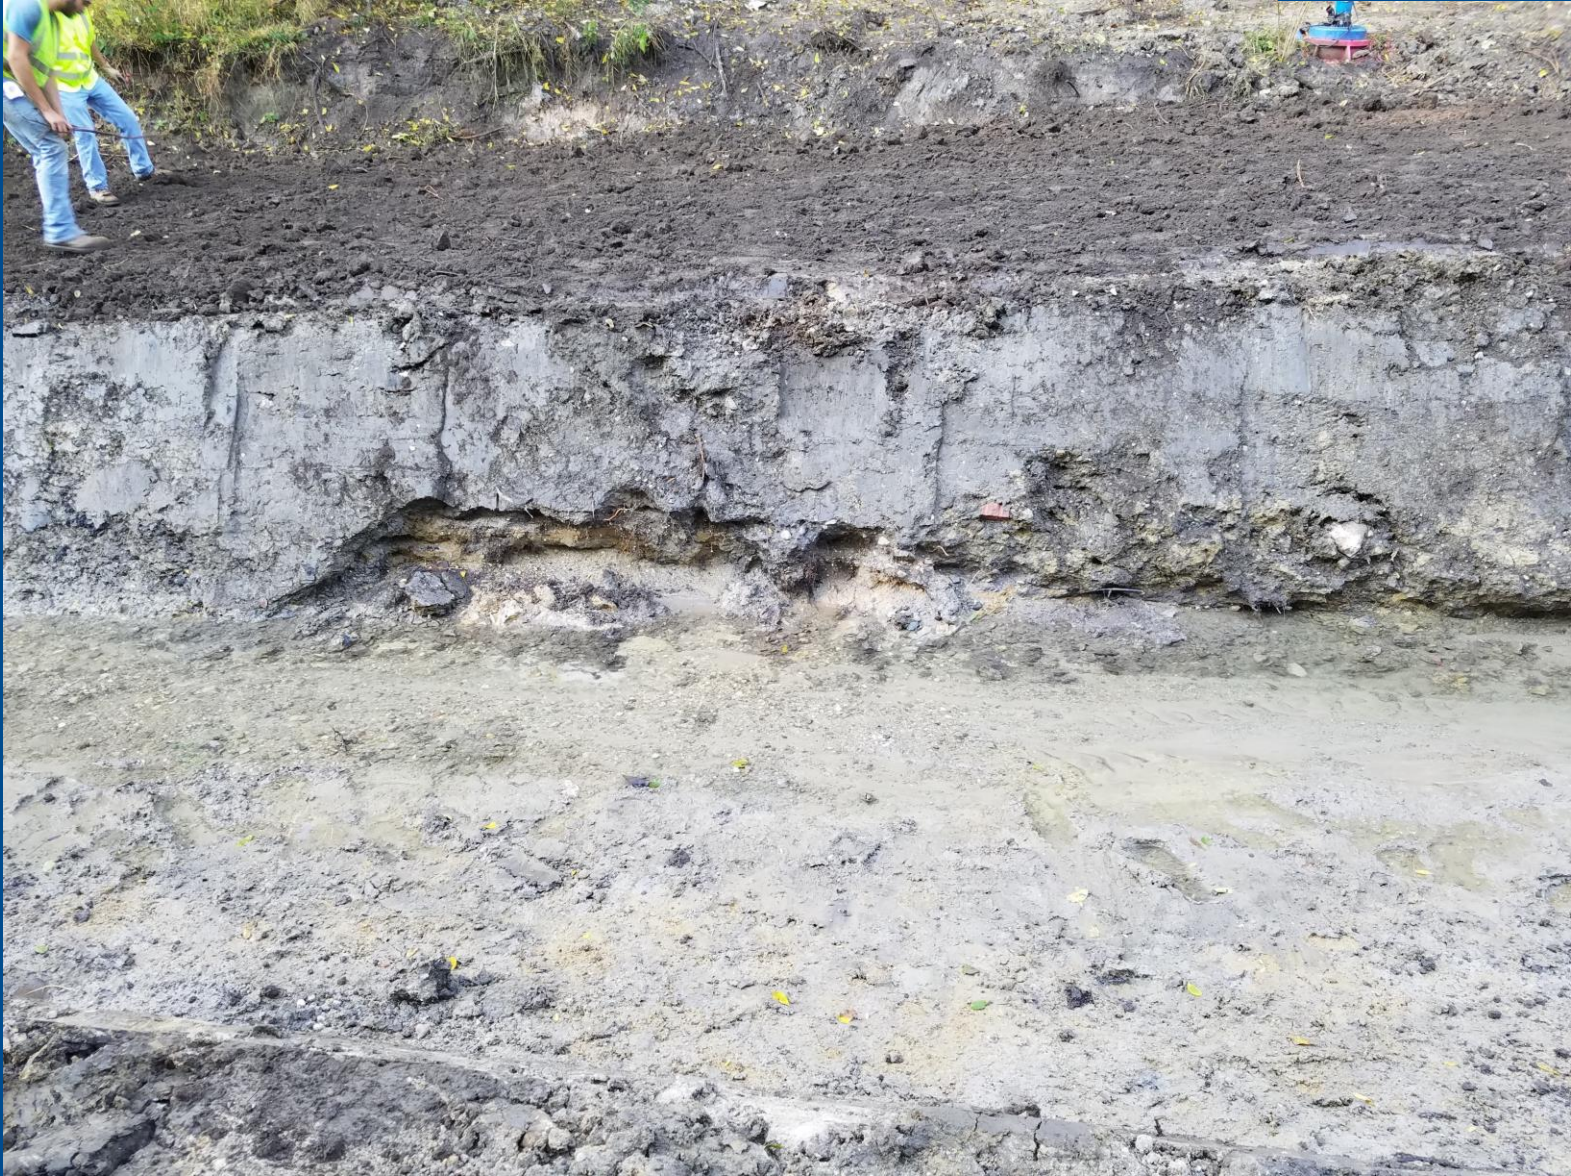
Structure of soil

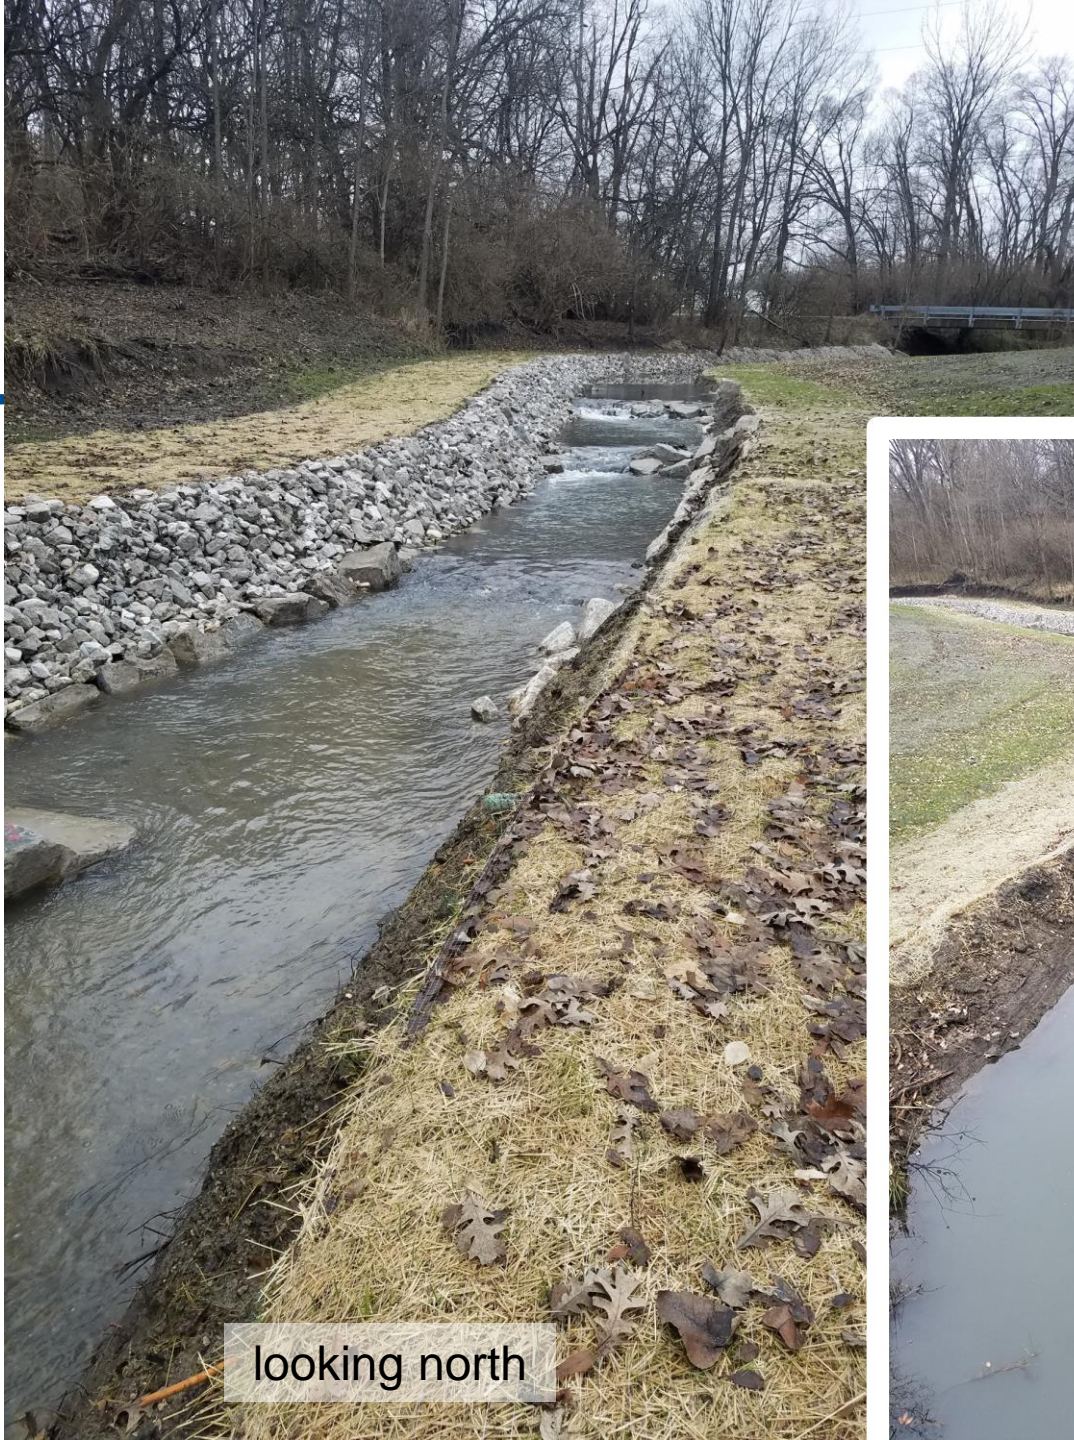
looking north

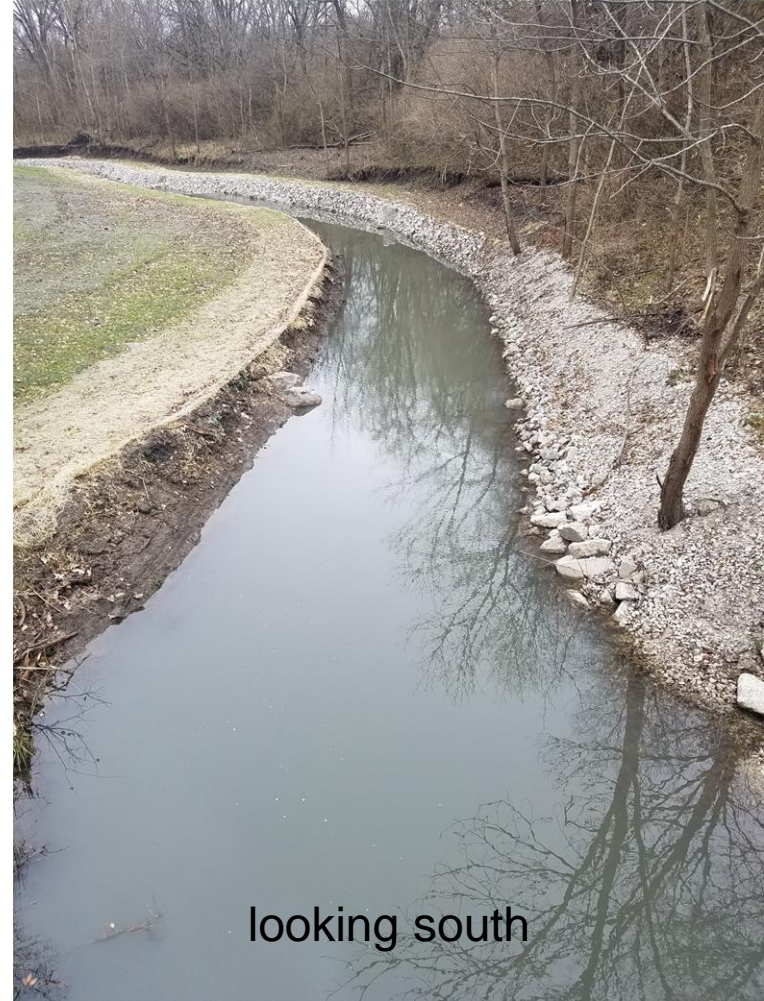
looking south
