# Stream Restoration – Case Studies

Tatiana H. Papakos, PE,CFM

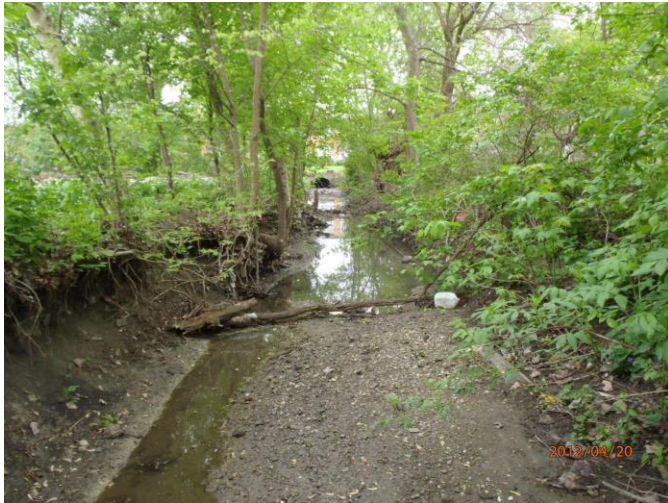
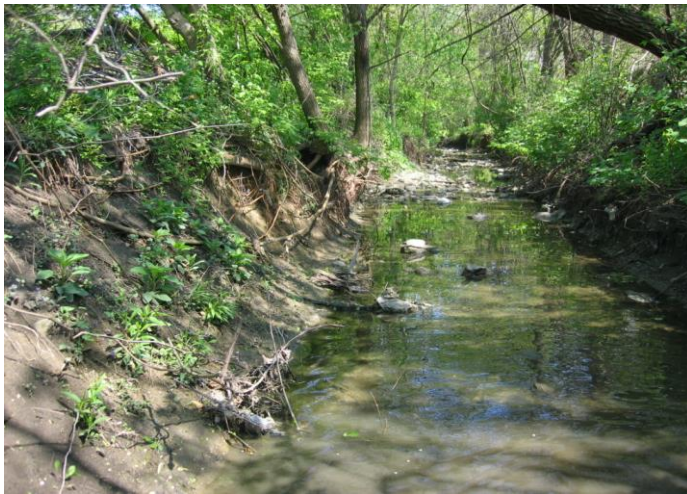
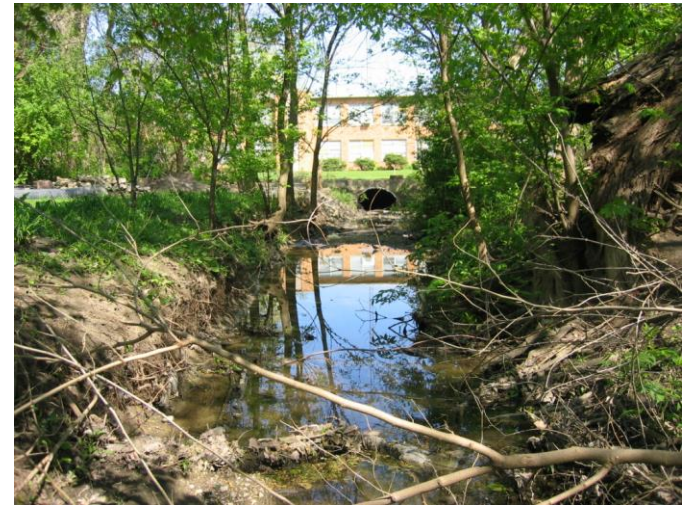
# Calumet Union Drainage Ditch - Photos

- Located in Markham, IL
- Drains to the Little Calumet River Watershed
- Drainage Area: 0.4 sq. mi.
- 2,500 Linear Feet of Creek Restoration
- Issues: Bank Stability and Flooding

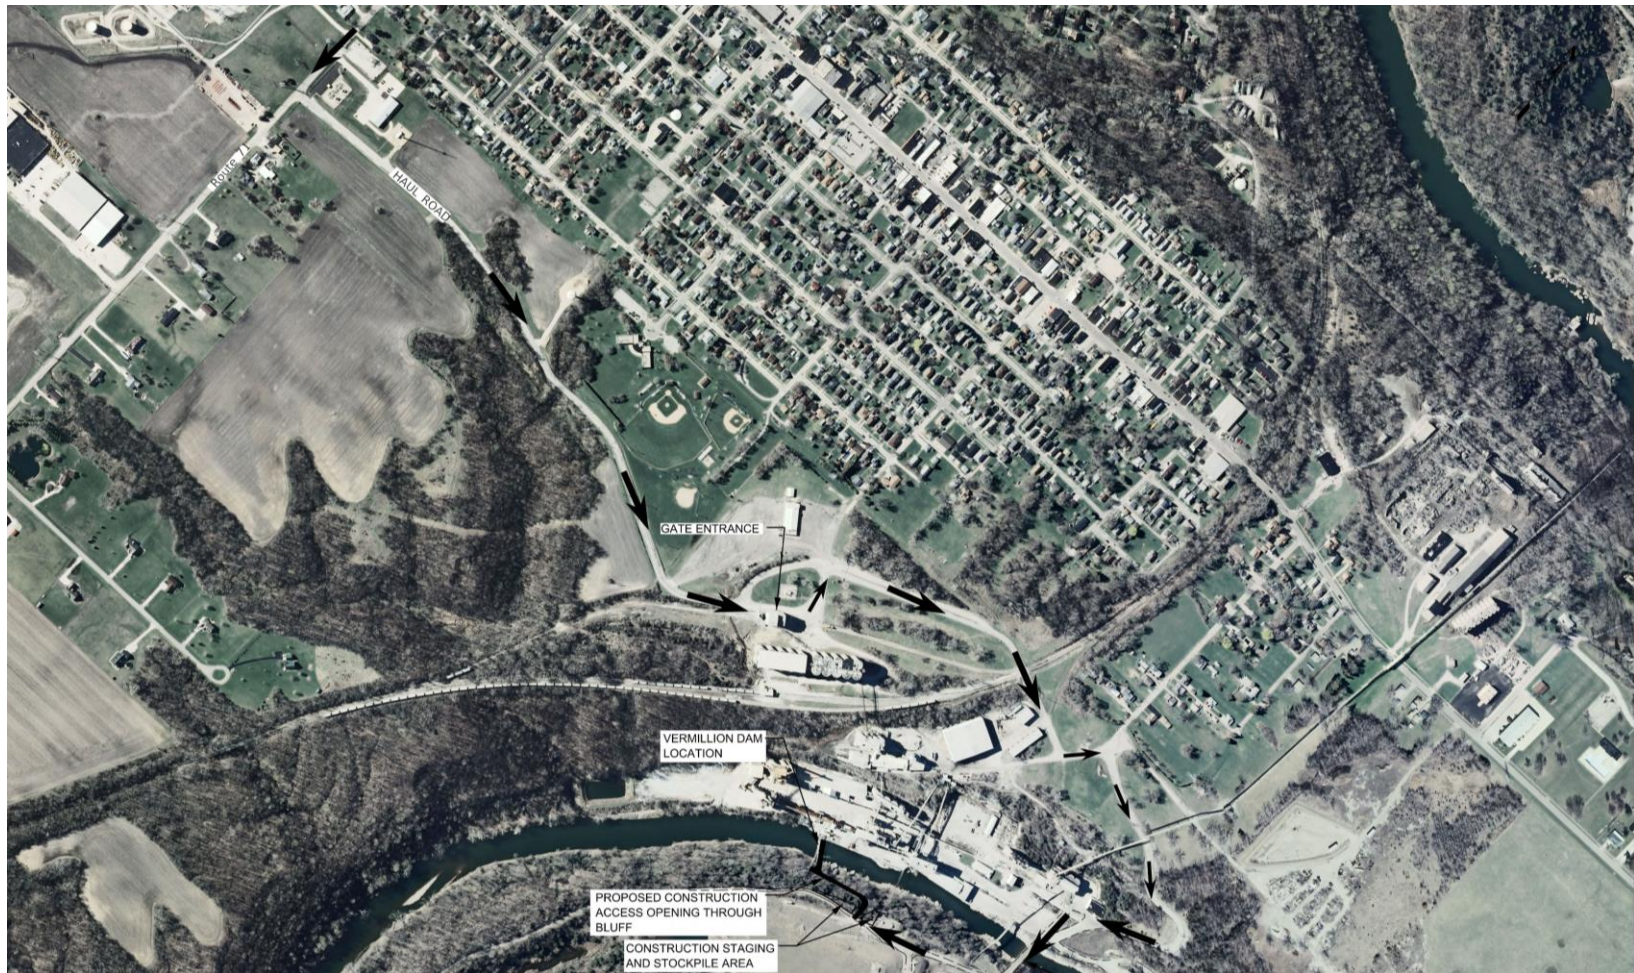
## Double Wing Deflector

## Soil Lift
