# Plum Creek / Hart Ditch Flooding Watershed Study

March 11, 2009

Christopher B. Burke Engineering

# Plum Creek / Hart Ditch Watershed

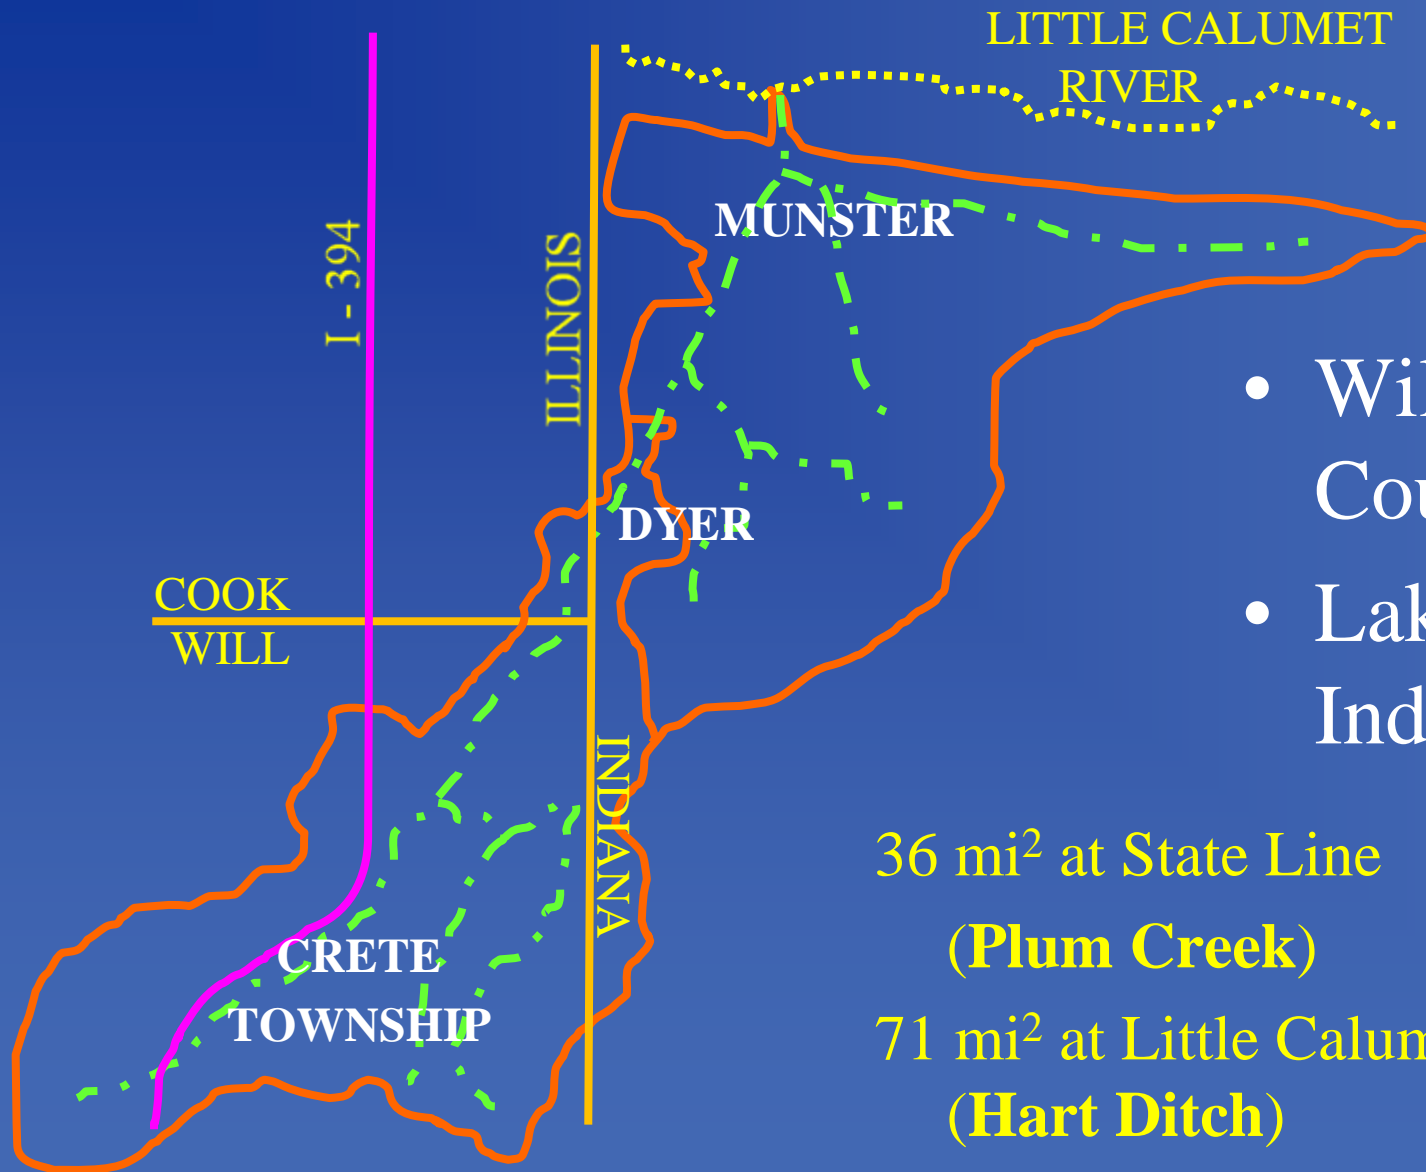
- Will and Cook County Illinois
- Lake County Indiana

36 mi<sup>2</sup> at State Line  
(**Plum Creek**)

71 mi<sup>2</sup> at Little Calumet River  
(**Hart Ditch**)

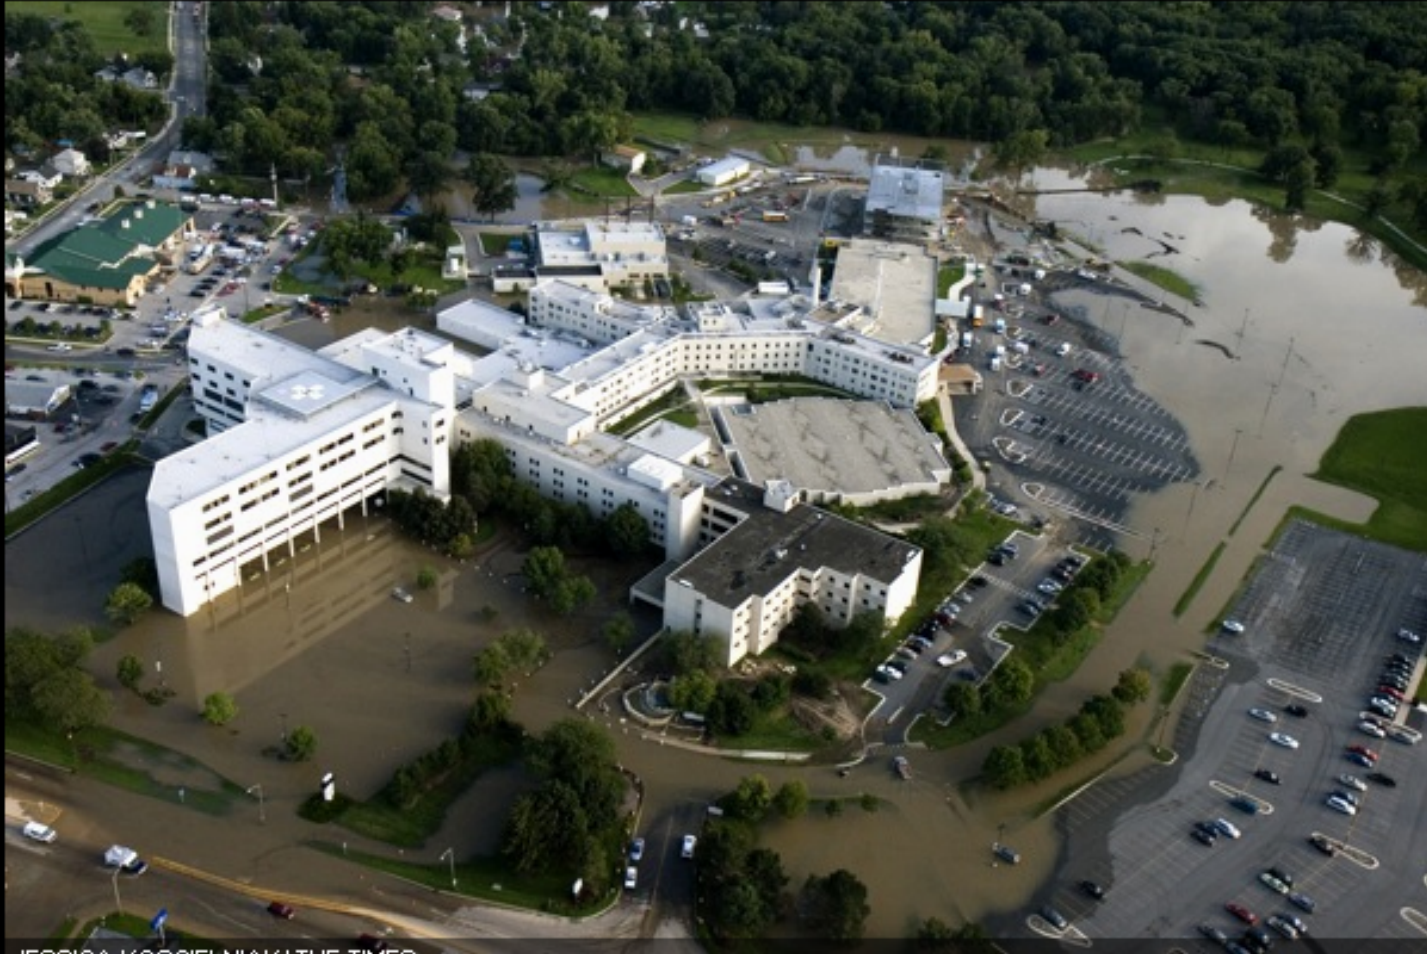
JESSICA KOSCIELNIAK/ THE TIMES  
Flood waters at St. Margeret Mercy in Dyer , Indiana.

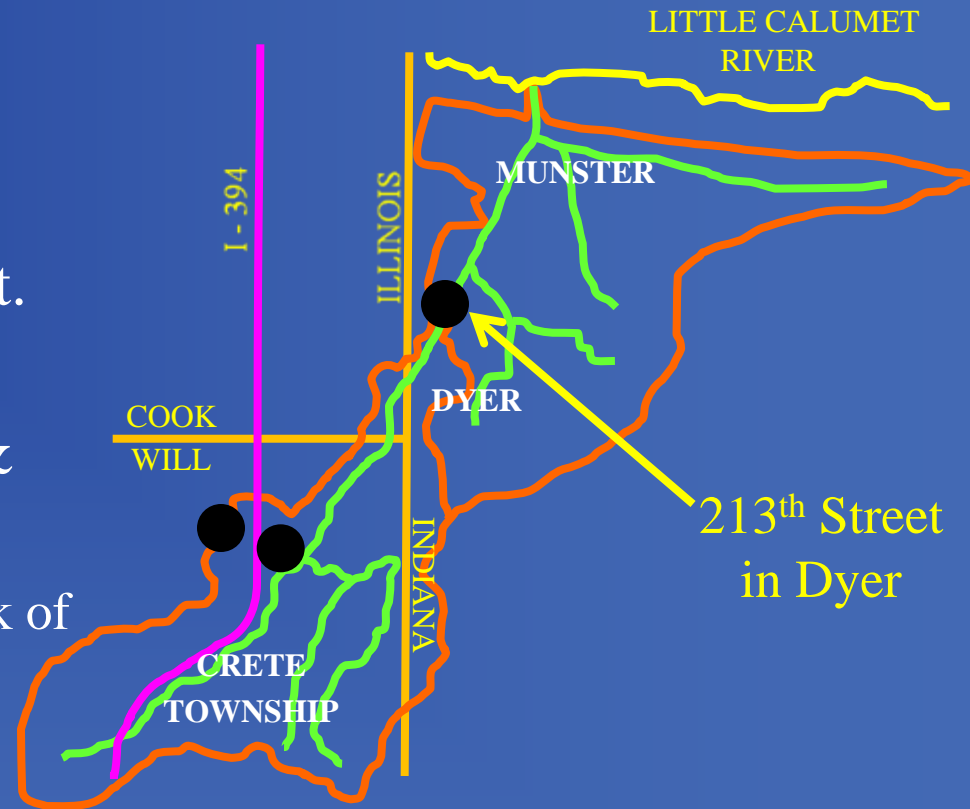
- USGS – Crete and 213<sup>th</sup> St.
- CoCoRaHS (Community Collaborative Rain, Hail & Snow Network)
  - Community-based network of volunteers
  - Located in Will County

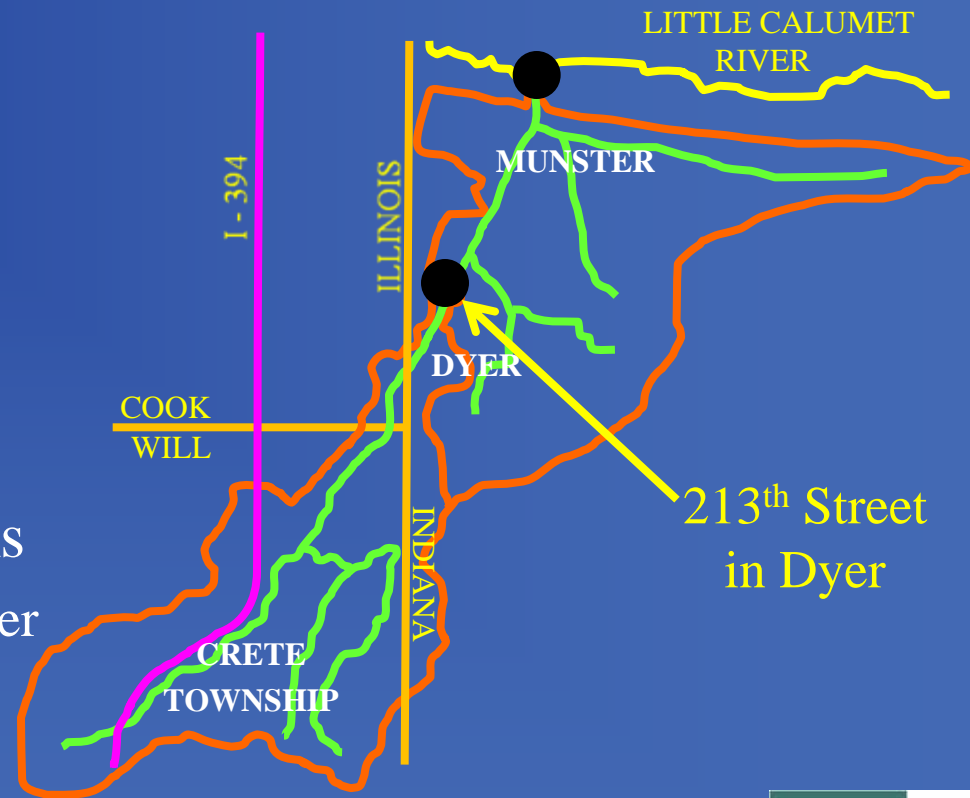
- Hydraulic Modeling
  - Stage Gages
    - USGS – Hart Ditch at 213<sup>th</sup> Street
    - USGS – Hart Ditch at Munster
    - Local High Water Marks
      - Observed; Crete and Dyer

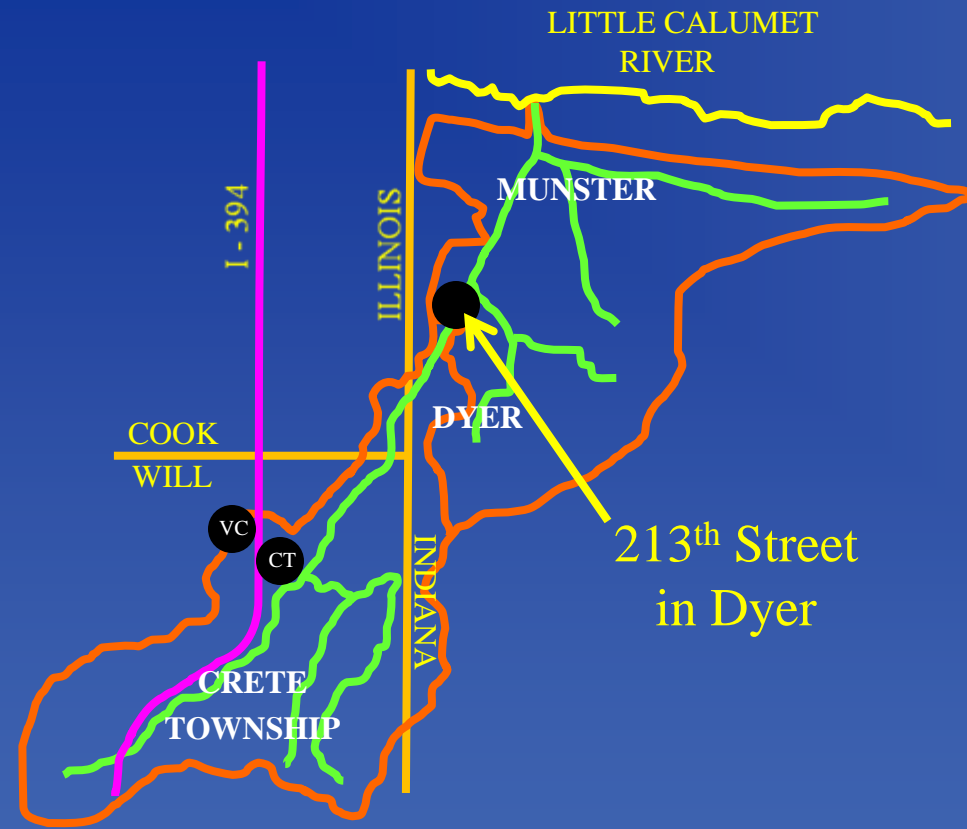
# August 2007 Storm Event

- Bulletin 70
  - 100-year, 5-day = 10.9 inches
- Measured
  - 10.2 inches in 5-days

Date	USGS	CoCoRaHS	
	213 <sup>th</sup> Street Dyer (IN)	Village of Crete VC(IL)	Crete Township CT(IL)
	NA	IL-WL-18	IL-WL-25
	(inches)	(inches)	(inches)
08/14/2007	0.37	0.32	0.21
08/15/2007	0.24	0.09	0.19
08/16/2007	0.01	0.01	0.00
08/17/2007	0.00	0.00	0.00
08/18/2007	0.30	0.00	0.00
08/19/2007	0.92	0.06	0.06
08/20/2007	2.51	2.94	2.97
08/21/2007	0.01	1.03	1.14
08/22/2007	1.09	0.20	0.13
08/23/2007	2.31	1.50	1.05
08/24/2007	0.97	3.95	4.94
<b>Total</b>	<b>8.73</b>	<b>10.10</b>	<b>10.69</b>

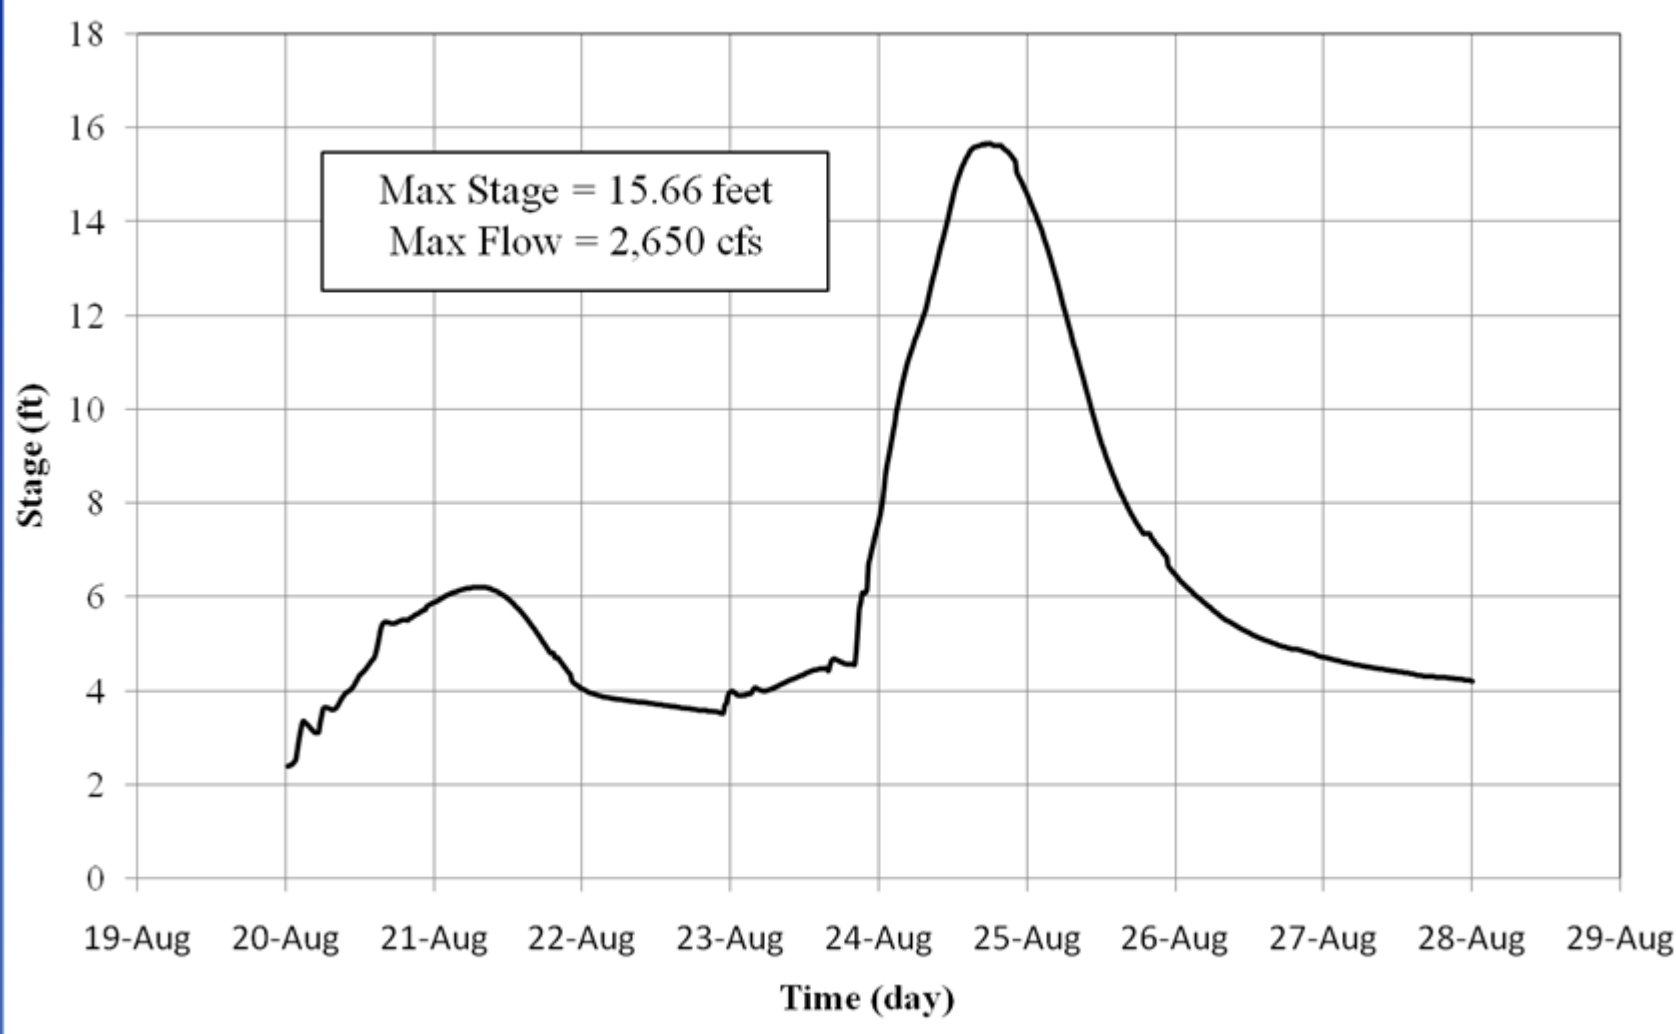
# August 2007 Storm Event

USGS Gage – 213<sup>th</sup> Street in Dyer

Regulatory 100-year flow rate, 1910 cfs at 213<sup>th</sup> St.

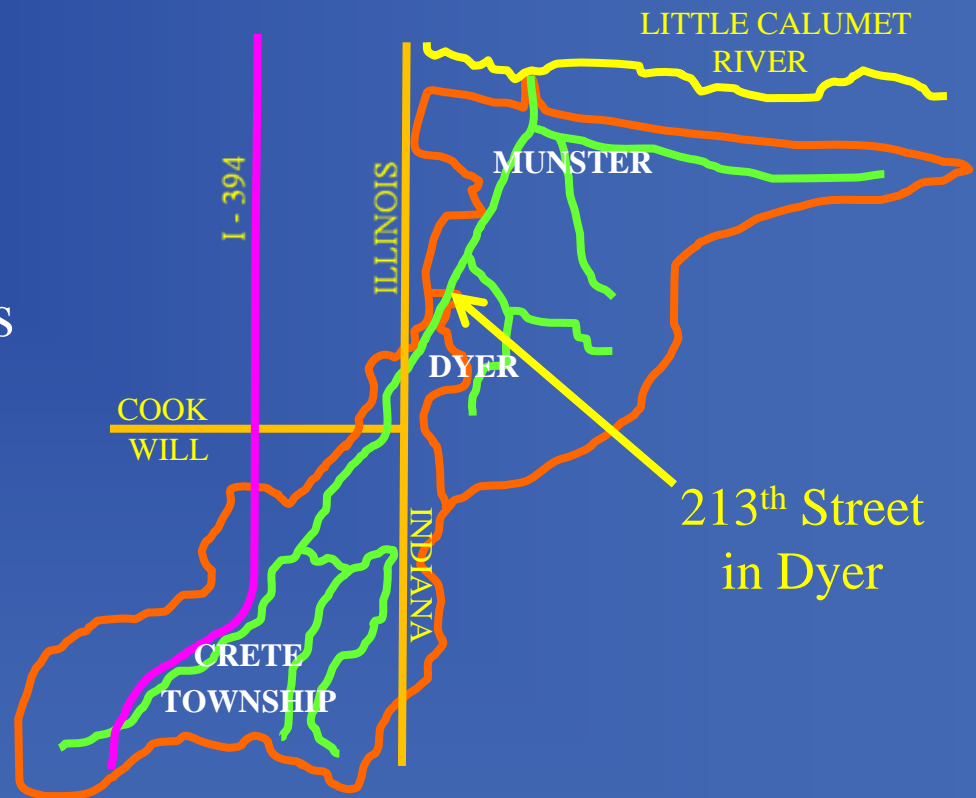
# Hydrologic Results at 213<sup>th</sup> Street

- Measured data
  - Measured vs. Simulated
    - 2,649 cfs vs. 2,645 cfs
- Design data
  - Bulletin 70
  - 100-year critical duration flow rate is more than double the measured flowrate

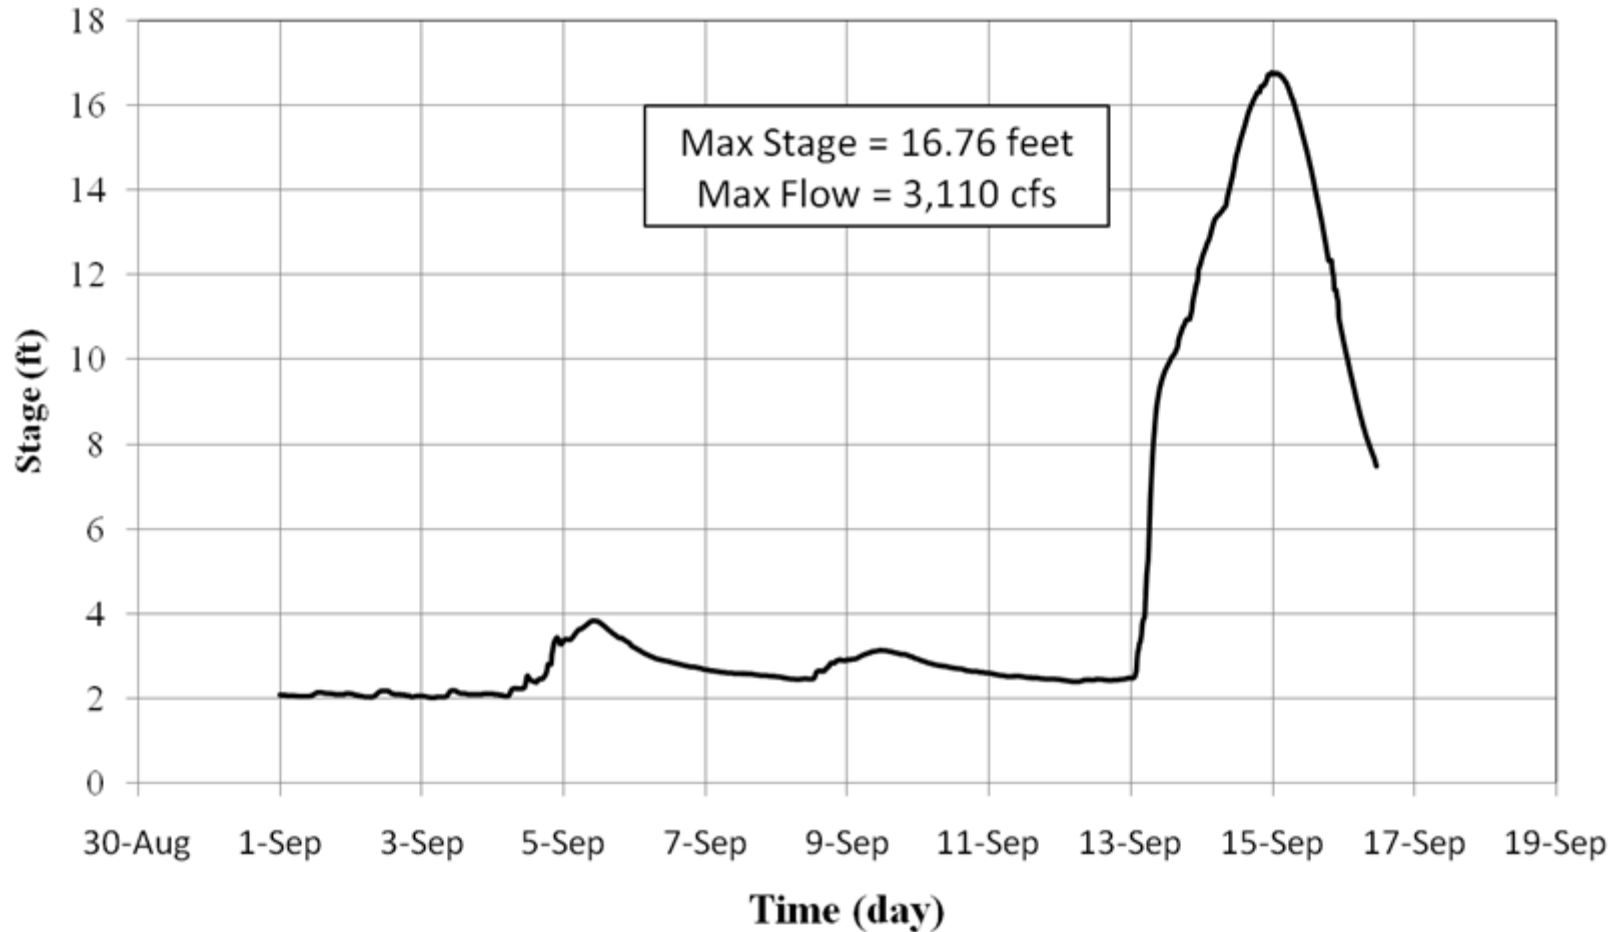
# September 2008 Storm Event

USGS Gage – 213<sup>th</sup> Street in Dyer

Regulatory 100-year flow rate, 1910 cfs at 213<sup>th</sup> St.

- Execute hydrologic model using the September 2008 precipitation data
  - Match flowrate measured at 213<sup>th</sup> Street
    - Measured flow = 3,110 cfs
    - Simulated flow = 3,151 cfs
- Enter flowrates into HEC-RAS hydraulic model to verify measured stage at 213<sup>th</sup> St. gage

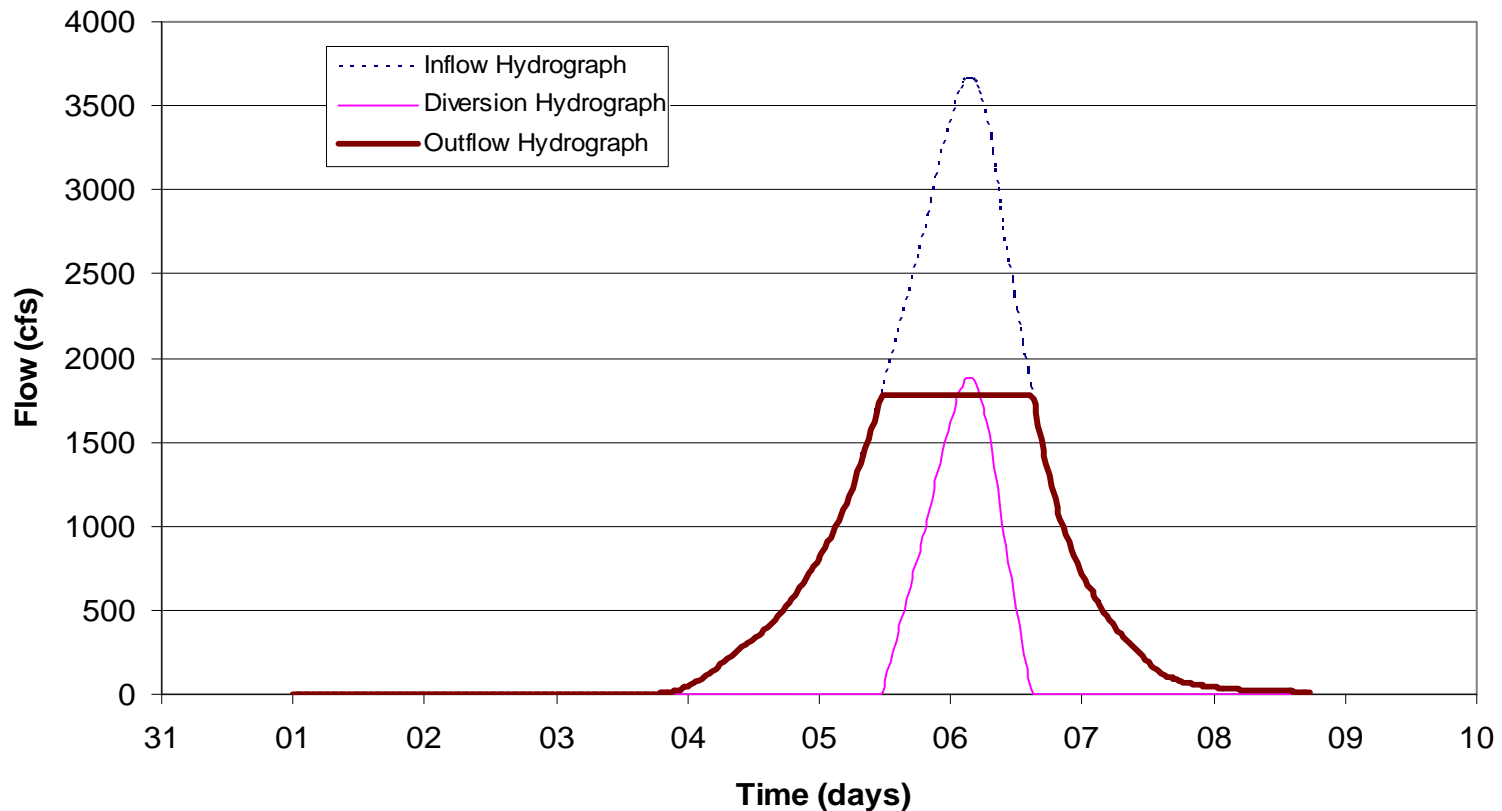
**Inflow - Outflow Hydrograph at  
Potetial Flood Control Reservoir**

Determine reservoir size by diverting volume off the peak

- Flood storage upstream of flooding areas
  - Identified two locations in Illinois
    - One for the benefit of Crete Township
    - One for the benefit of Indiana
- Utilize flood storage by “cutting off” the peak of the hydrograph
