2019 IAFSM Annual Conference

The Estabrook Dam Removal

Paul D. Drew, P.E., CFM

GEI Consultants, Inc.

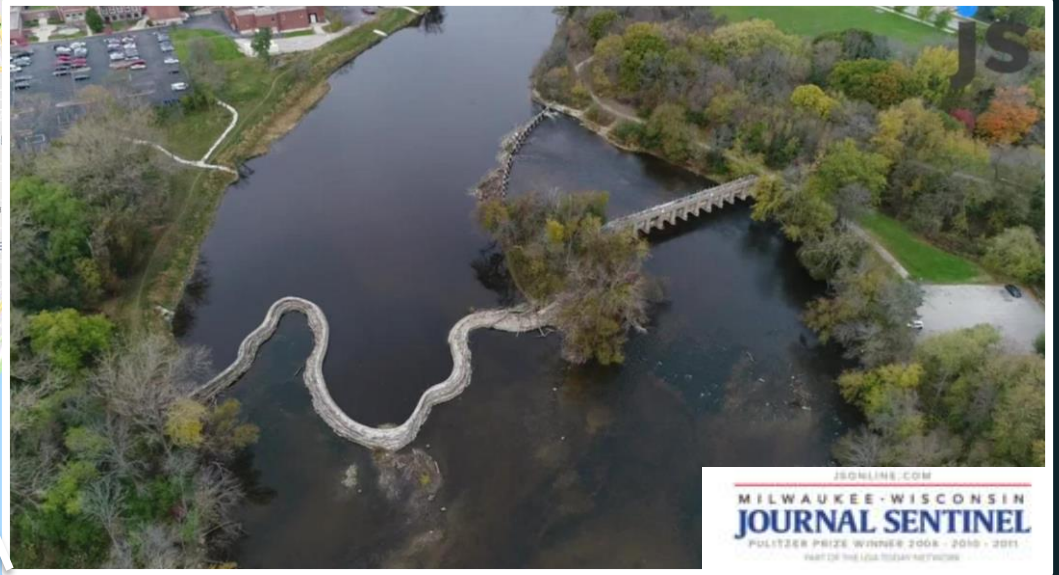
Estabrook Dam:

- Milwaukee River
- Low Hazard Dam
- Constructed in 1930's
- Normal Pool Impoundment : 200-acre-ft
- Flood Pool Impoundment: 700 acre-feet
- Spillway capacity: 25,800 cfs

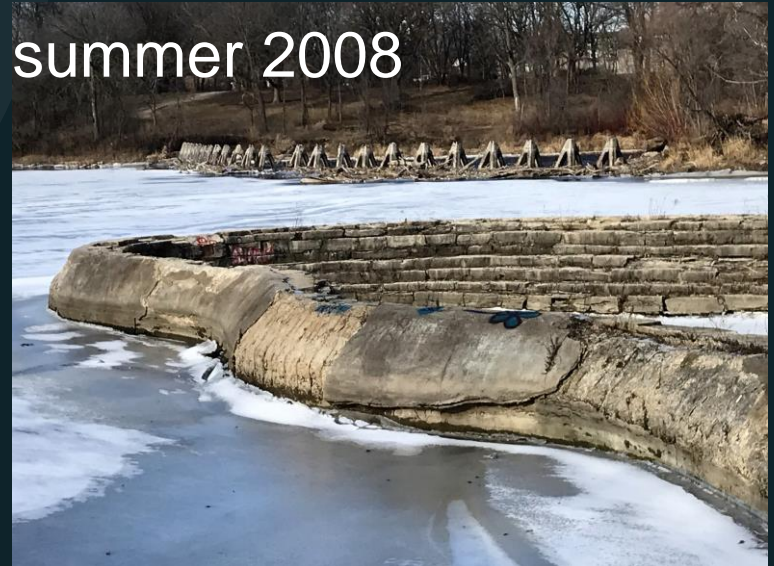
2008 WDNR Inspection:

- WDNR Ordered Inspection
- Consultant & WDNR noted dam safety deficiencies
 - Upgrade Gates
 - Remove Trees
 - Remove Woody Debris
 - Perform Structural analysis
- Gates opened for drawdown in summer 2008

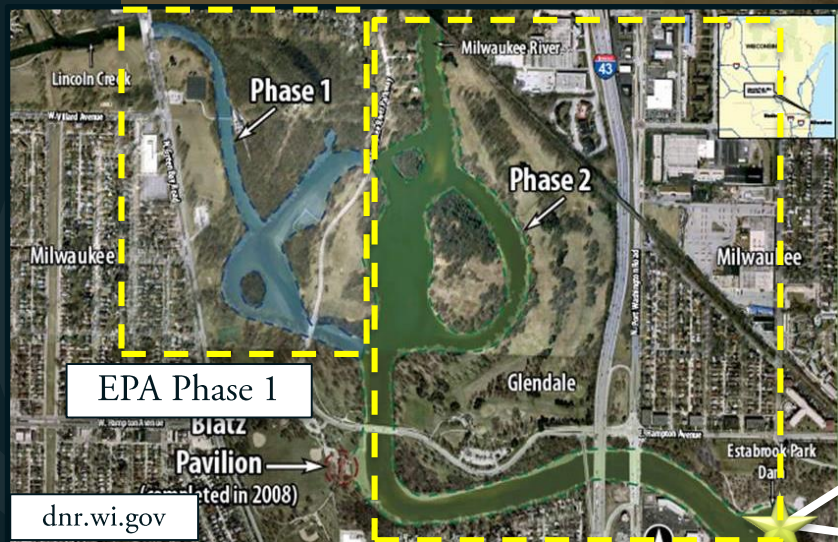
2014 EPA Sediment Cleanup:

Sand Cover over Residual PCB's

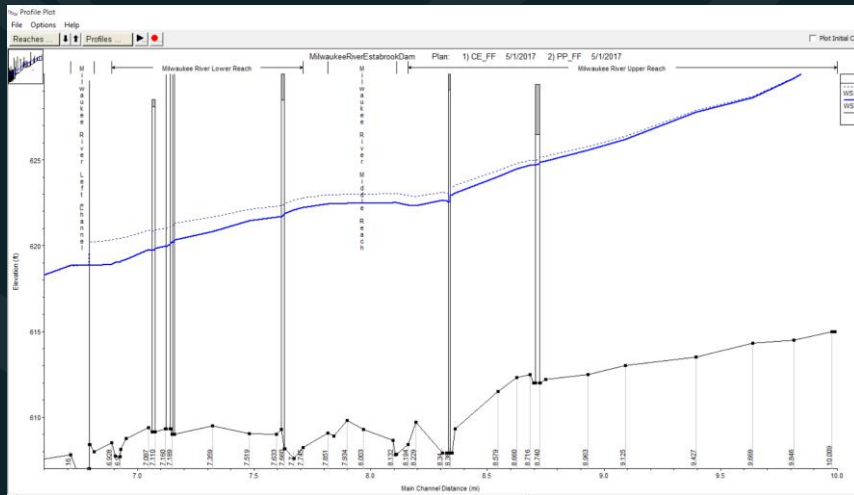
Dam Removal Process

- HEC-RAS Hydraulic Analysis
 - Dam in place (gates open)
 - Dam in place (gates down)
 - Dam Removed
- Milwaukee River Flow Conditions
 - Flood Flows (10-,50-,100-,500-year recurrence interval)
 - Low Flows (low, median, mean, spring runoff)

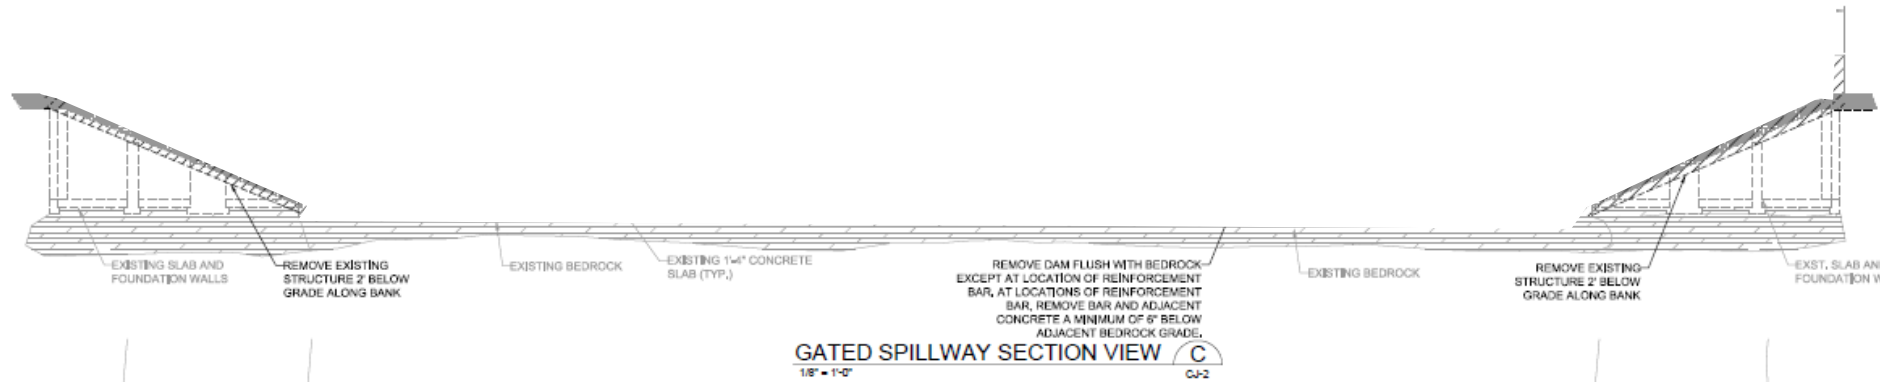
Dam Removal Process

- Gated Spillway
 - Removed to bedrock in the river channel
 - Removed to shoreline on the river banks

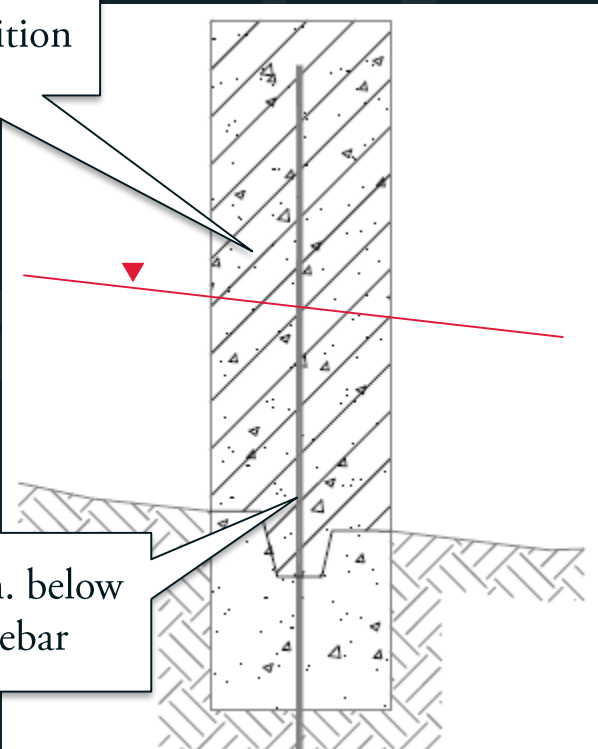
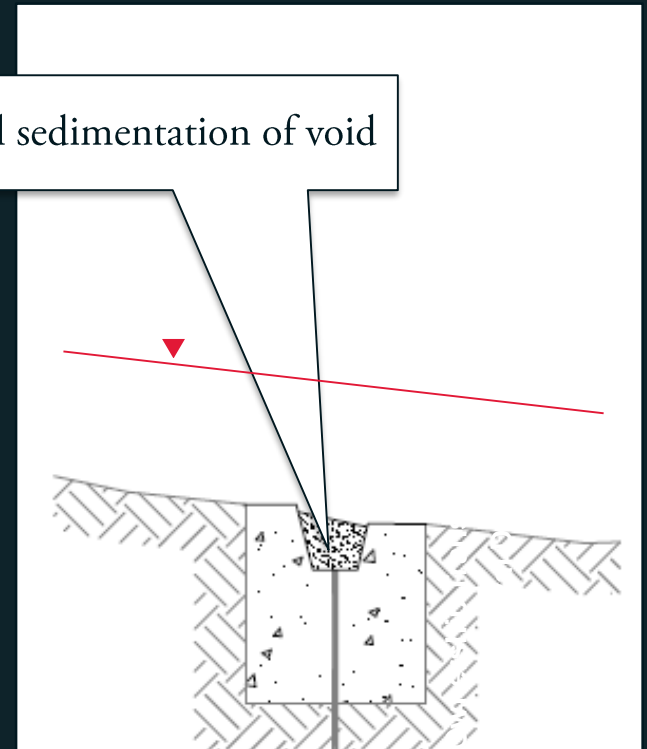
Dam Demolition

- Fixed Crest Spillway
 - Removed to bedrock in the river channel
 - Removed to shoreline on the river banks

Removal 6" min. below river bed at rebar

Natural sedimentation of void

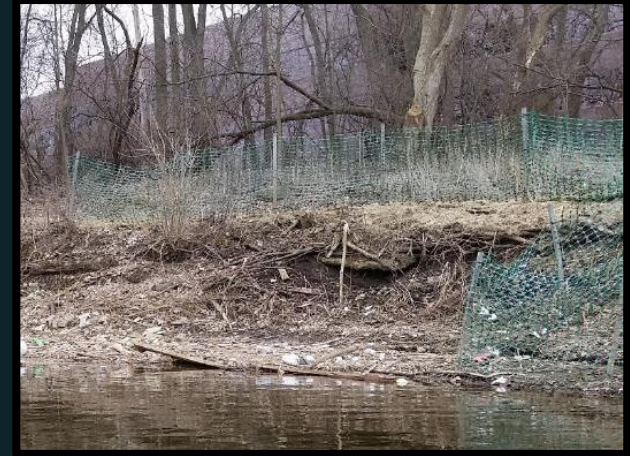
Dam Removal Process

- Streambank Restoration
 - Geomorphology Study
 - Field Assessment
 - Shear stress analysis
 - Hydraulic model

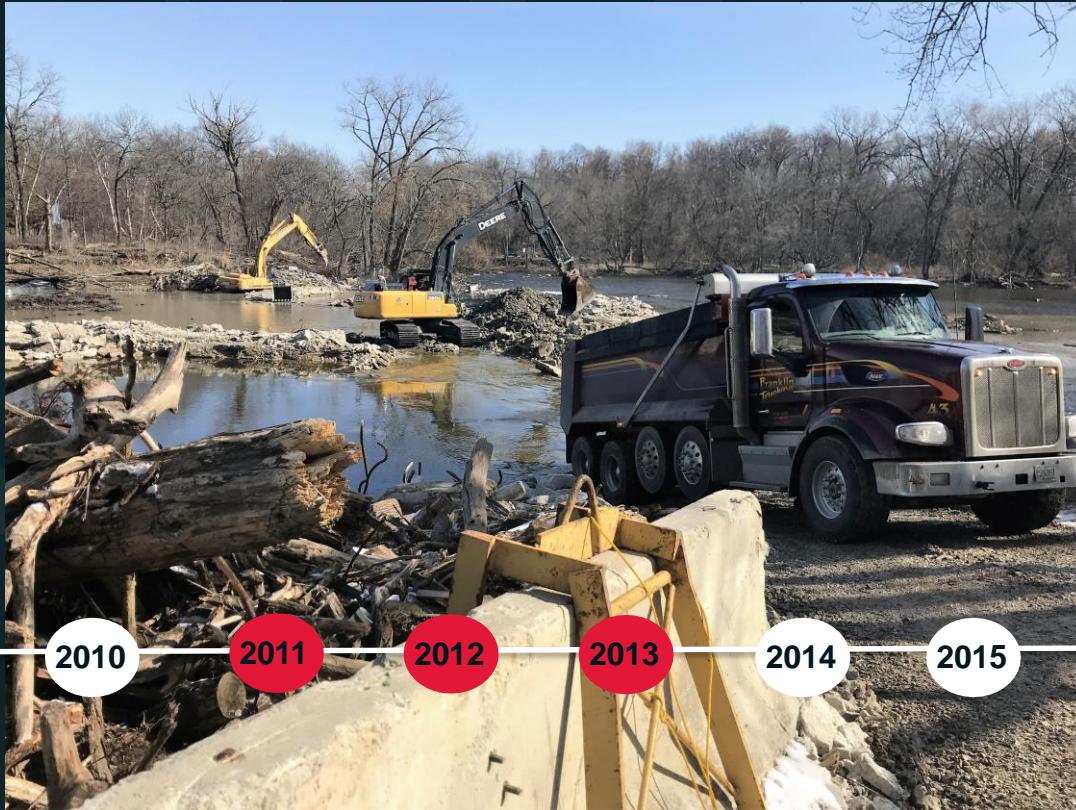
Material Management

- Sediment: 700 Tons
- Concrete: 1,425 Cubic Yards
- Limestone Block 1,240 Cubic Yards
- All Concrete and Limestone crushed and recycled
