Lake Lou Yaeger Watershed Implementation Project

Illinois Association of Floodplain and Stormwater Management

2022 Annual Conference

REDUCE THE SEDIMENT AND NUTRIENTS ENTERING LAKE YAEGER

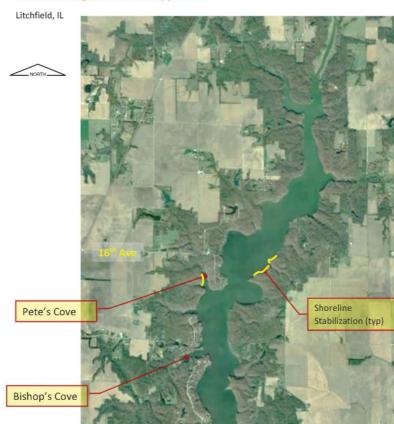
General Lake Map

Lake Lou Yaeger 319 Grant Application

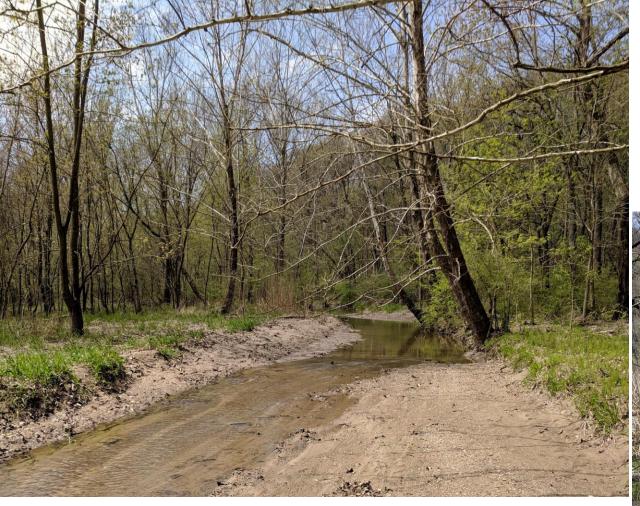
Bishop's Cove tributary

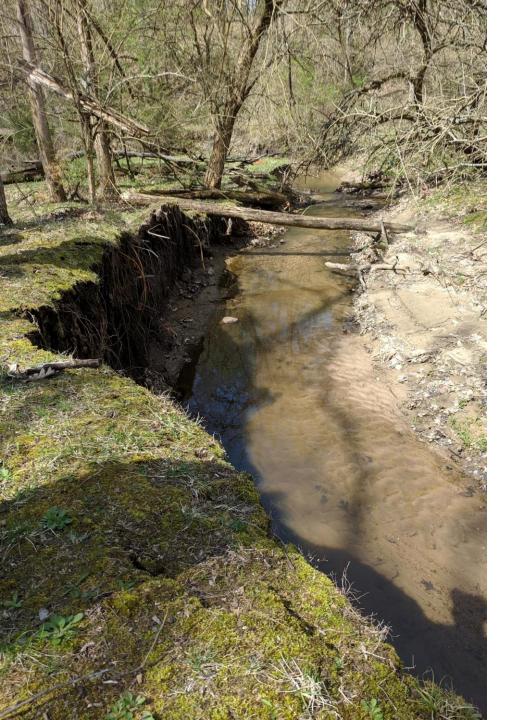
Pete's Cove tributary

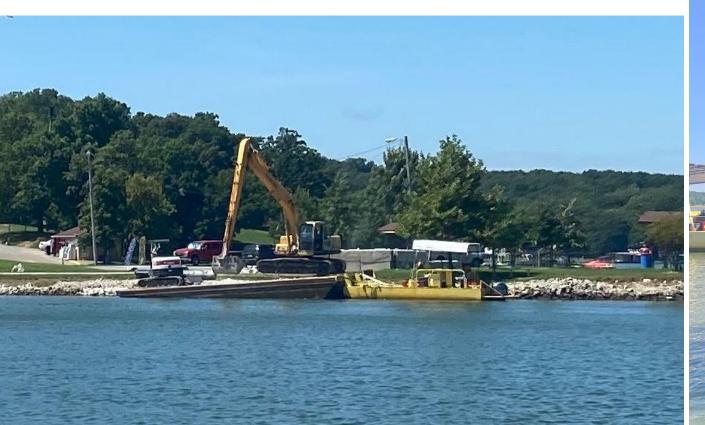
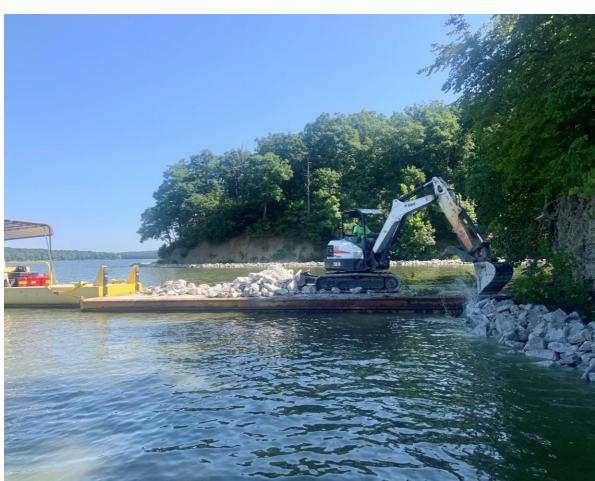
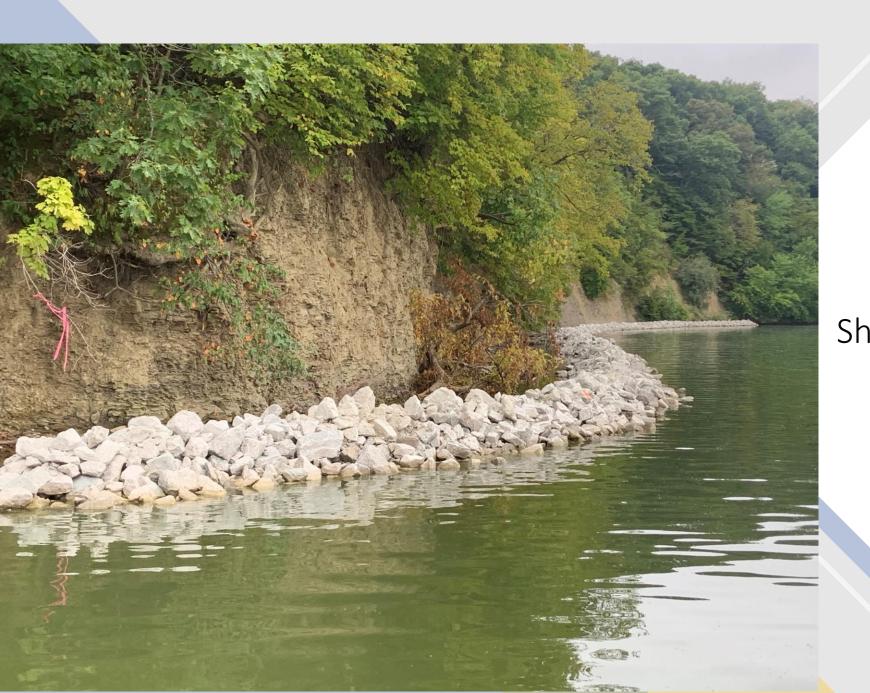
Riprap ridge placed by barge

Shoreline Protection 2,270 feet

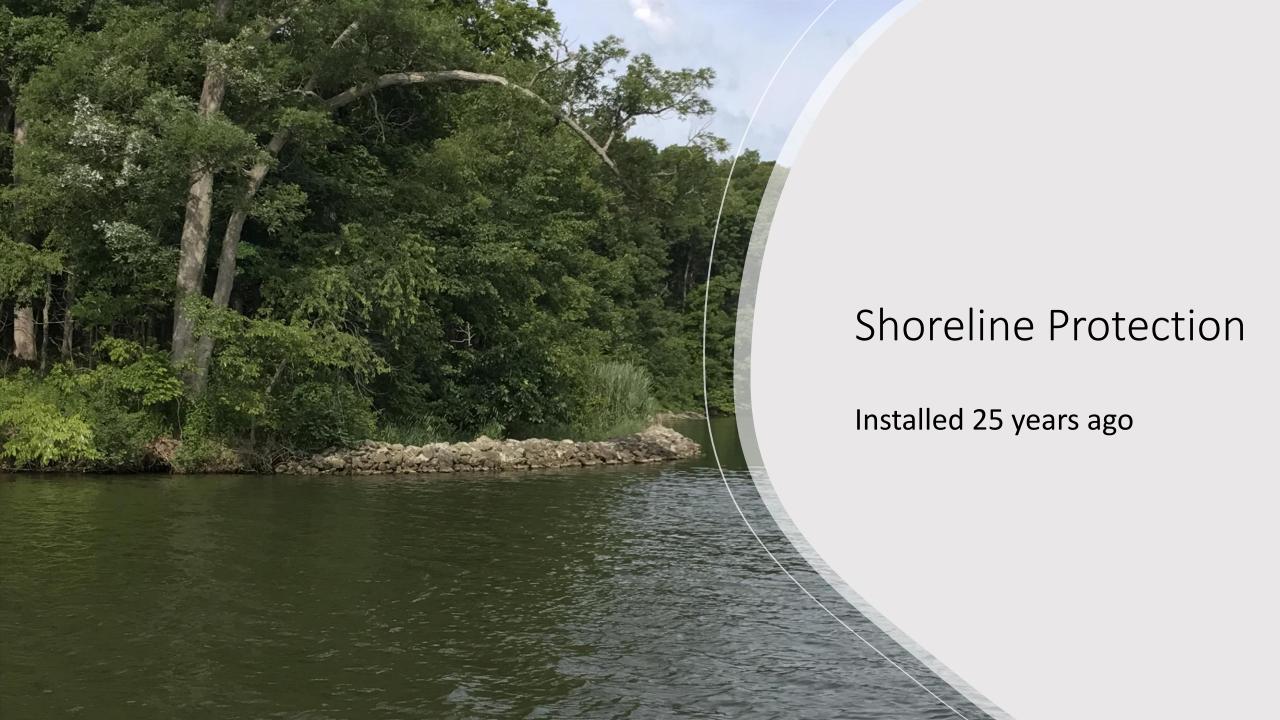
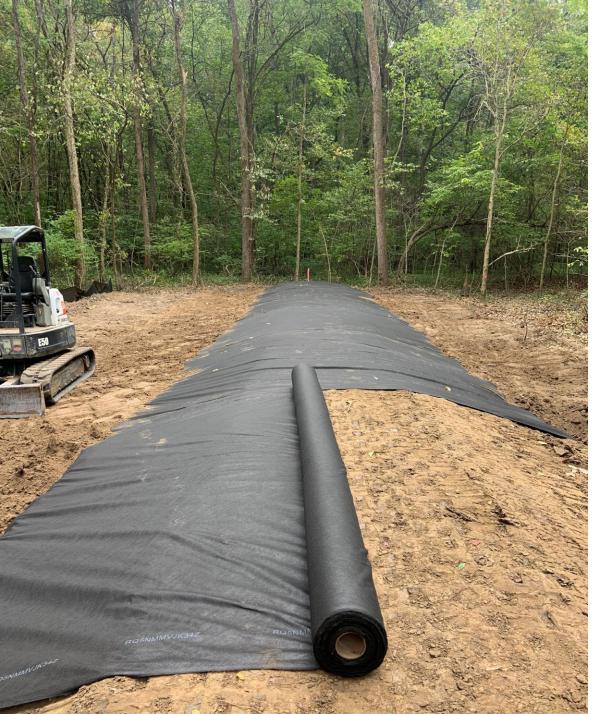
Shoreline Protection at Vertical Bank

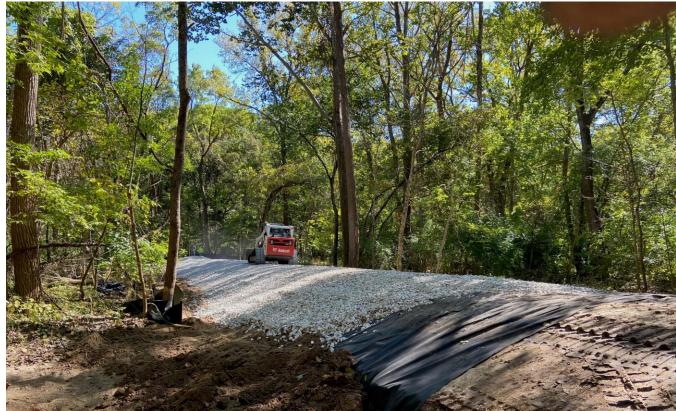
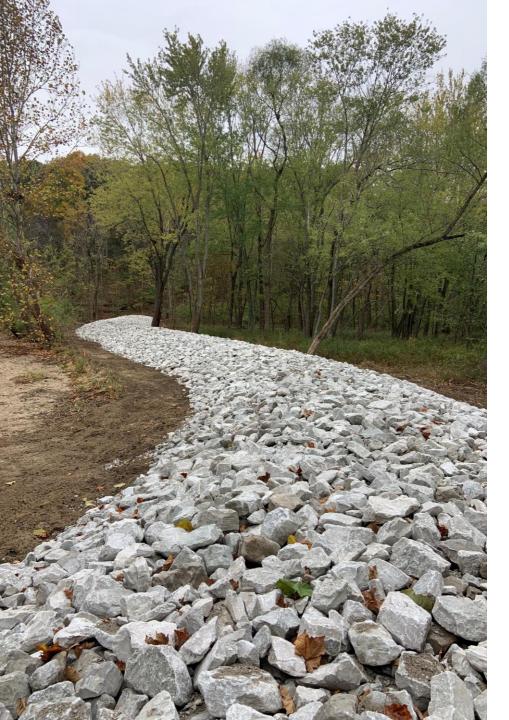
Sediment Trapping Cells

Three low height earth and riprap berms

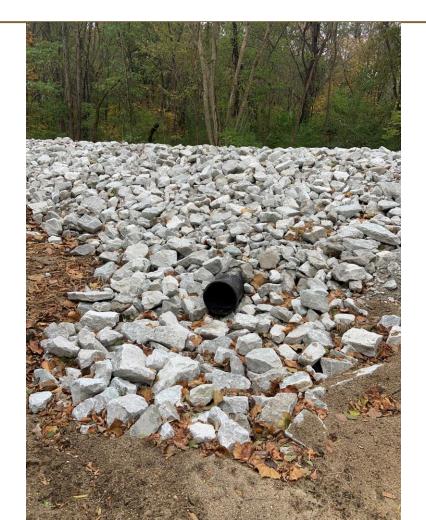
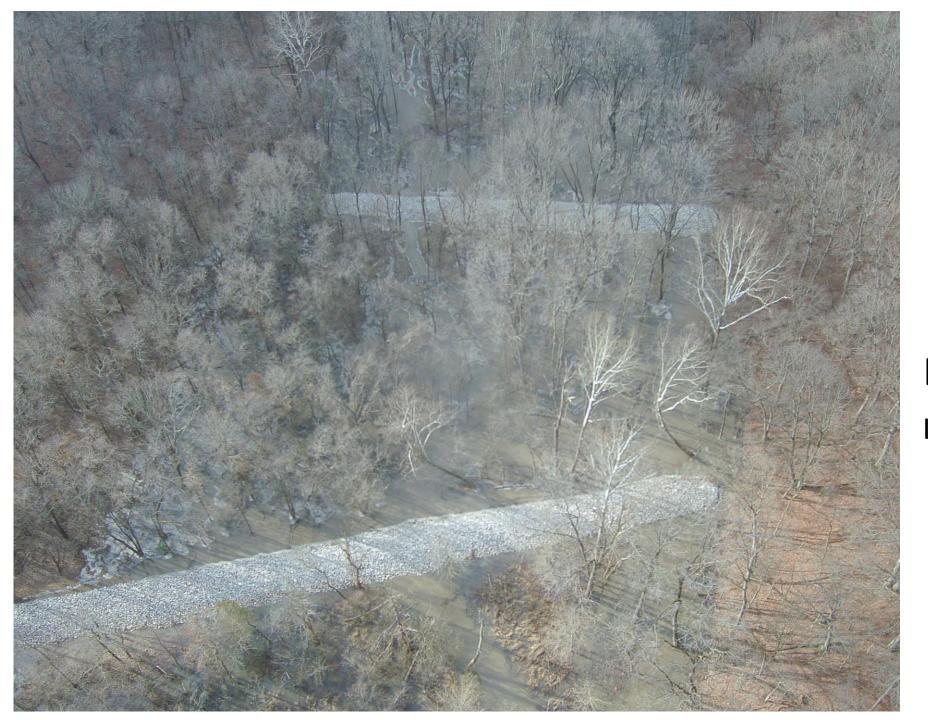
Completed berms

Low flow pipes through berms Aligned to avoid wetlands

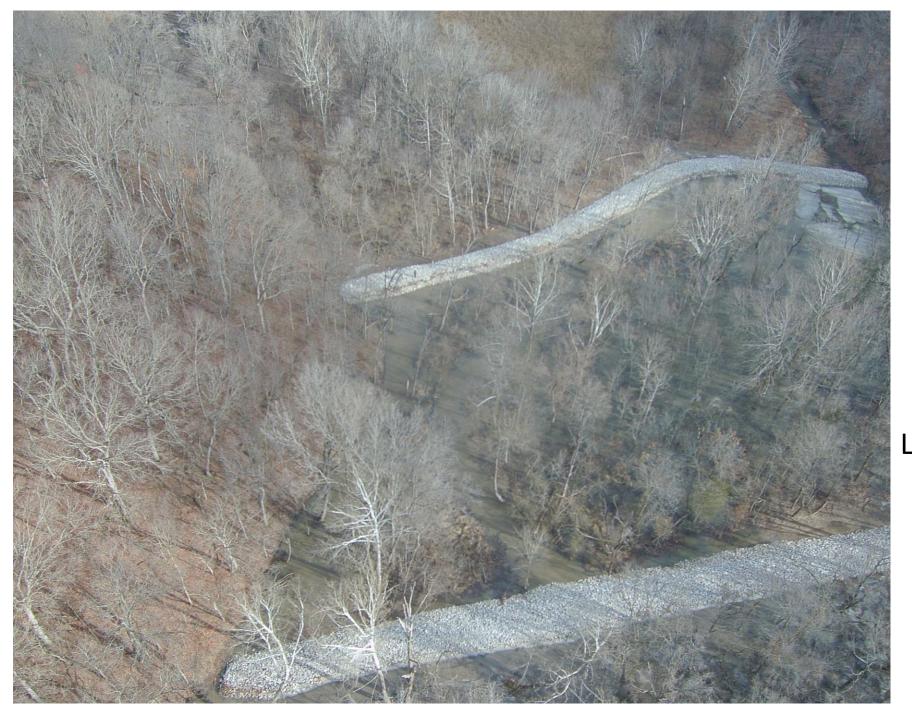
Berms 1 & 2 Looking upstream - Drone

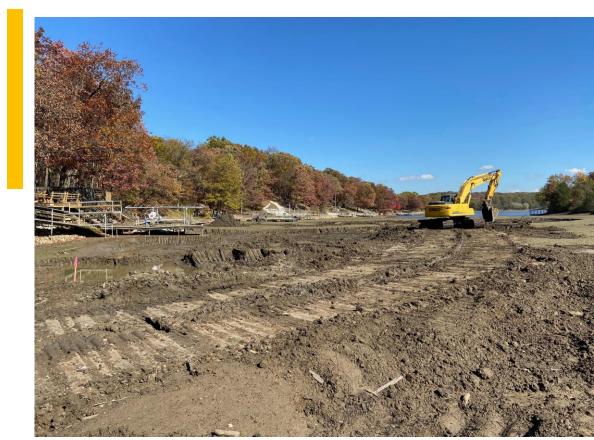
Berms 2 & 3

Looking downstream to lake

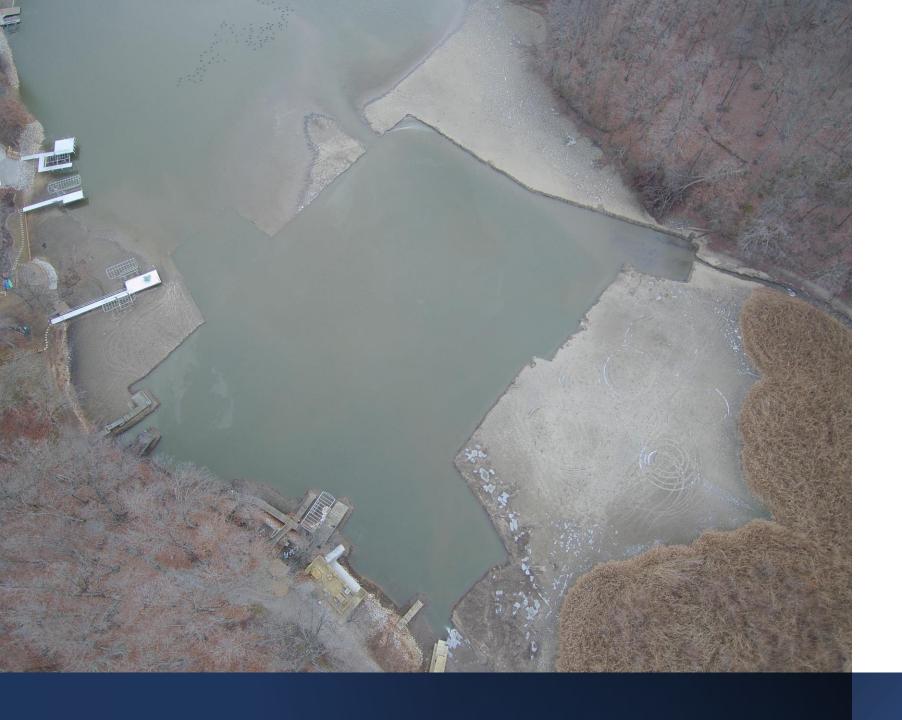
In-lake Sediment Basin Excavation with lake level lowered 6 feet

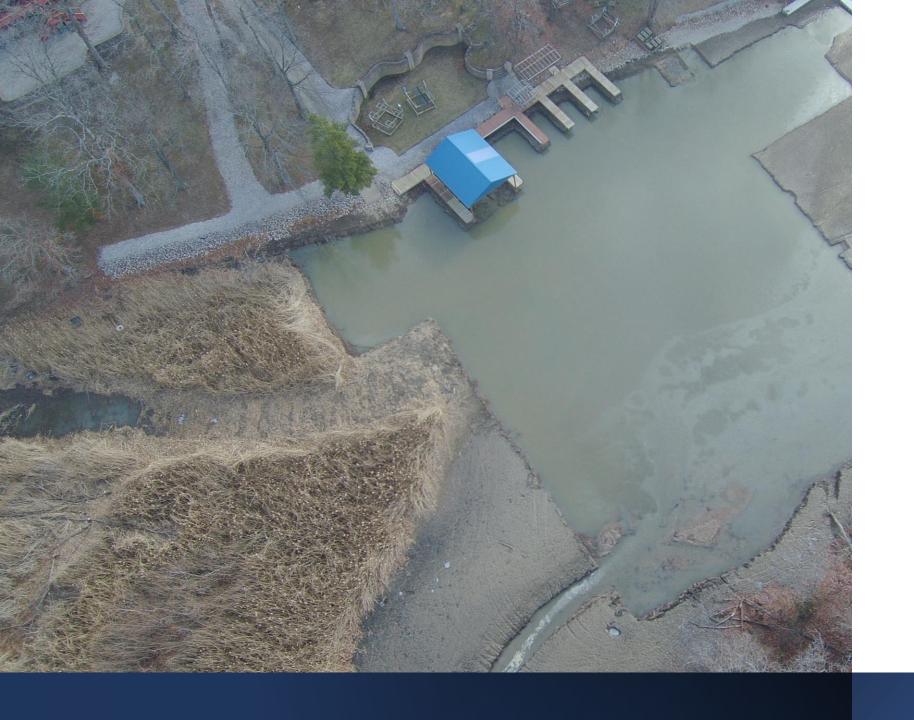
Pete's Cove

Completed basin after two storms

Sediment deposits at creek entry

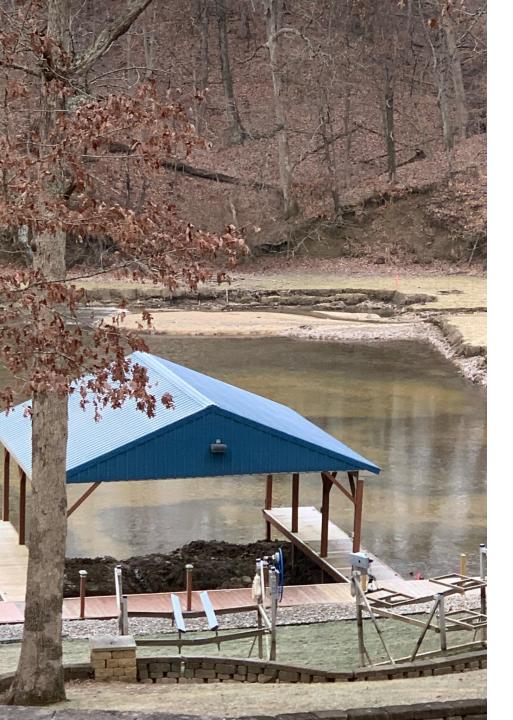
Pete's Cove

Sediment deposit after two storms in first half of December

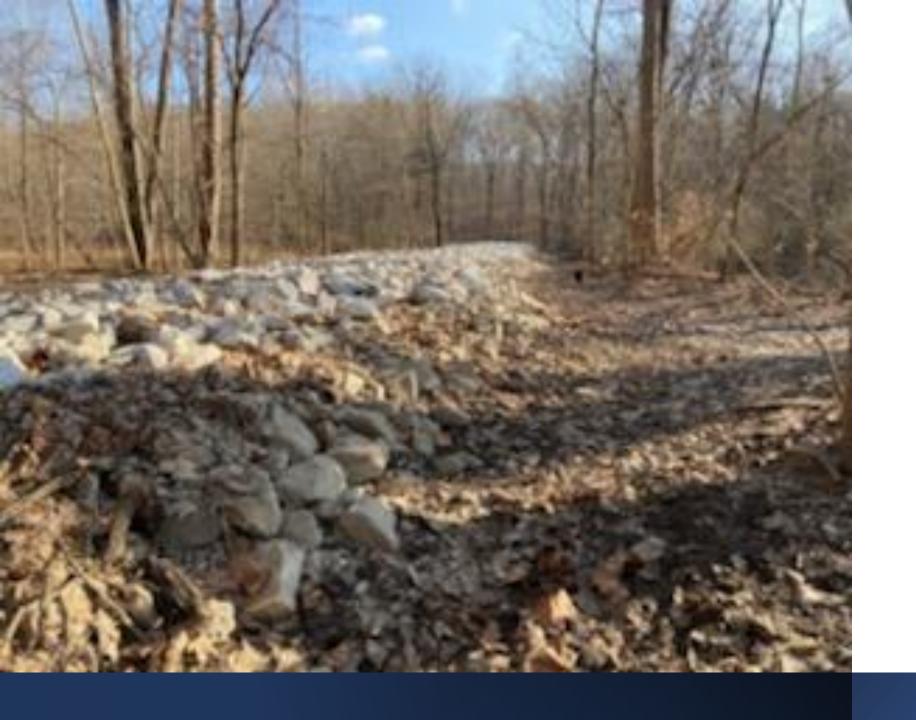
Upstream berm 1 after two storms

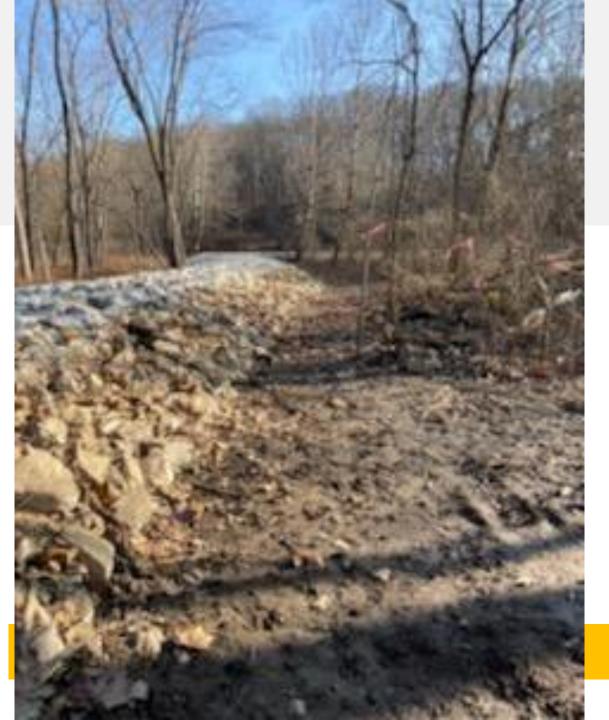
• Downstream berm 3

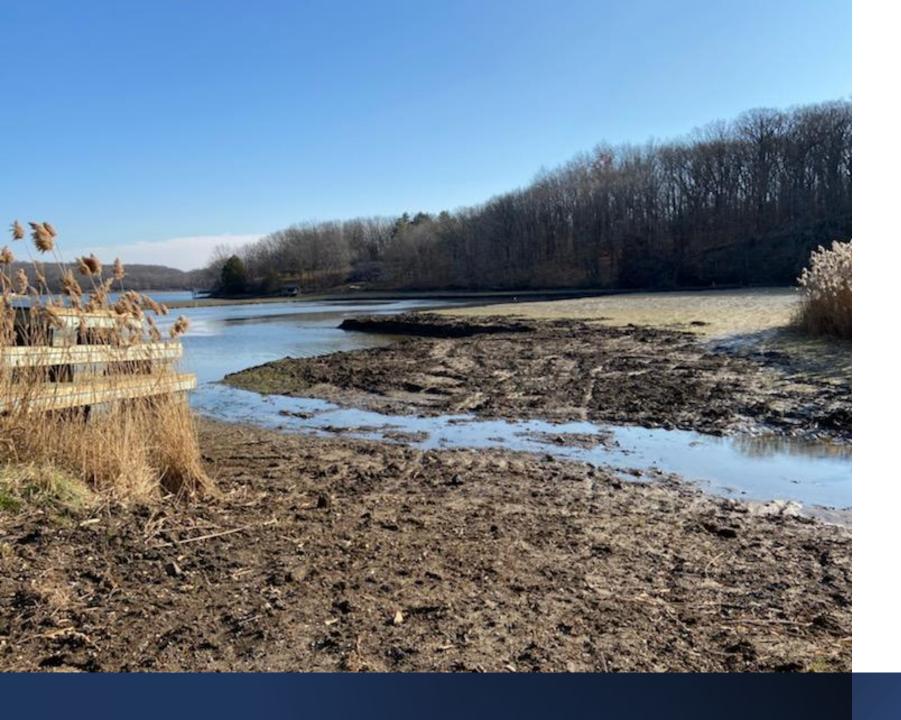
West creek into cove

No visible sediment downstream of the berms

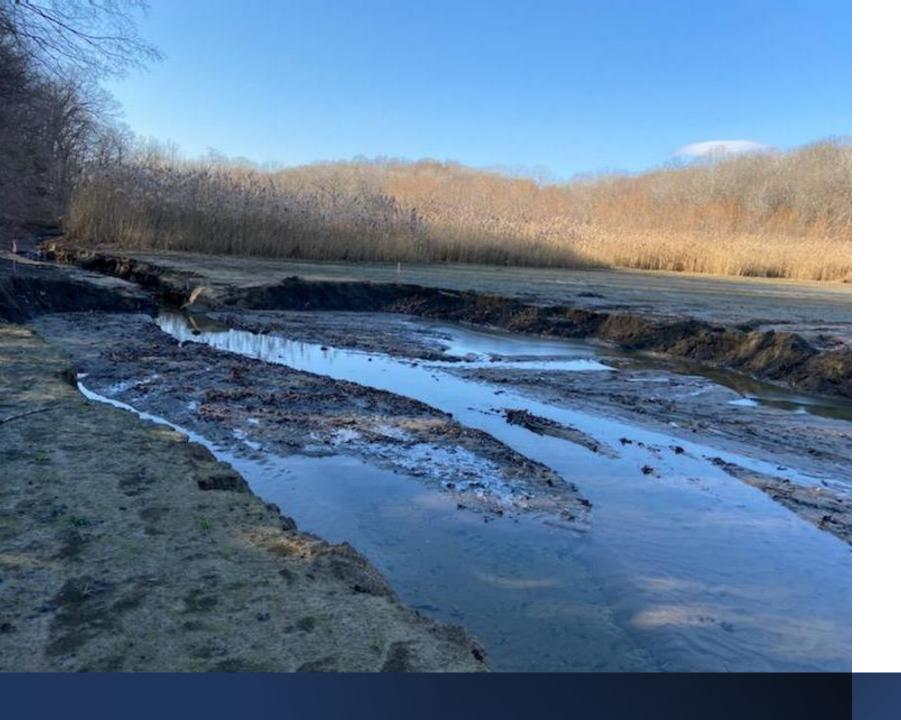
East creek into cove

No visible sediment downstream of the berms
