Design and Implementation of

BMP Monitoring Programs

Hey and Associates, Inc.

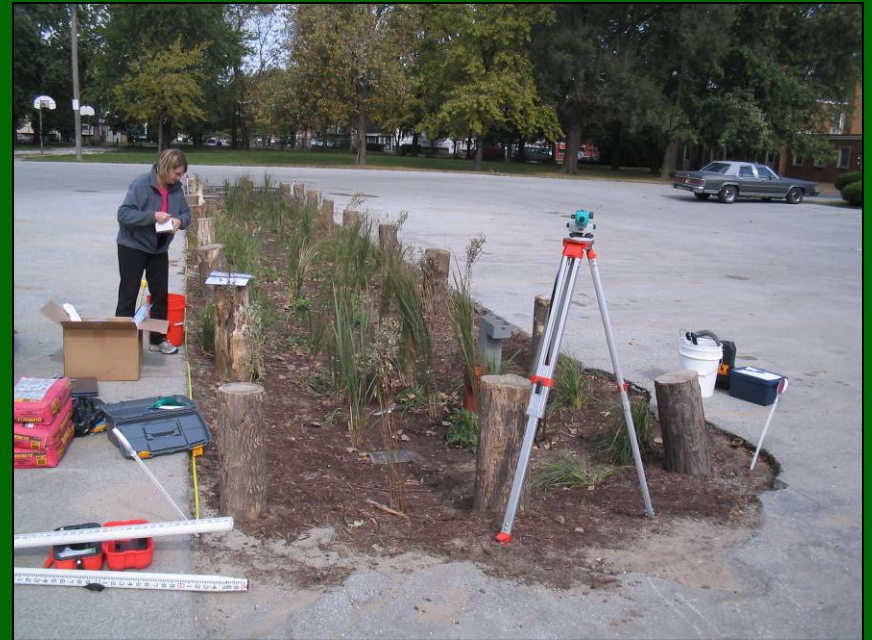
Our Lady Gate of Heaven

- ❖ Located on the south side of Chicago
- ❖ 660 ft² bioswale
- ❖ 12,433 ft² tributary area (parking lot)
- ❖ Construction Design
 - ❖ 12" Gravel
 - ❖ 12" Engineered Soil
 - ❖ Native Plantings

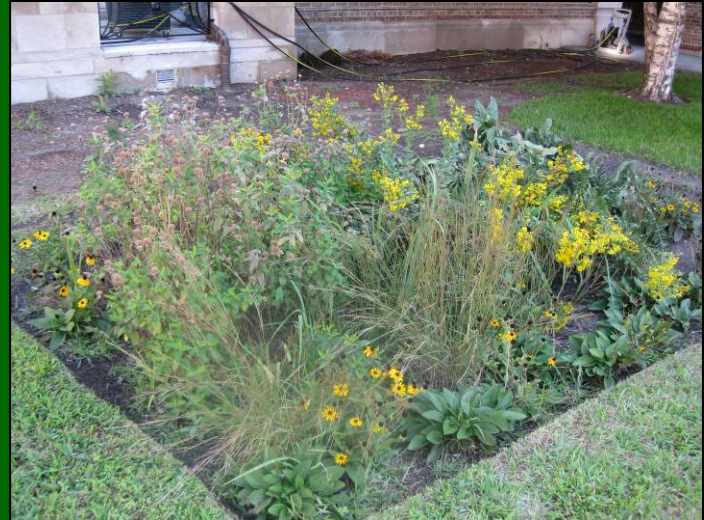
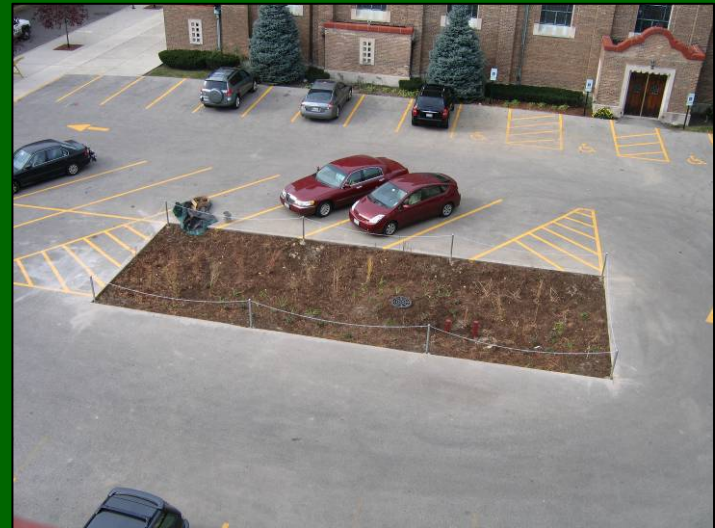
St. Margaret Mary

- ❖ Located on the north side of Chicago
- ❖ Three BMPs
 - ❖ Bioswale
 - ❖ 933 ft² in size
 - ❖ 8,325 ft² tributary area (parking lot)
 - ❖ Two rain gardens
 - ❖ 96 ft² in size
 - ❖ 755 ft² tributary area (roof)
- ❖ Construction Design
 - ❖ 12-18" Engineered Soil
 - ❖ Native Plantings

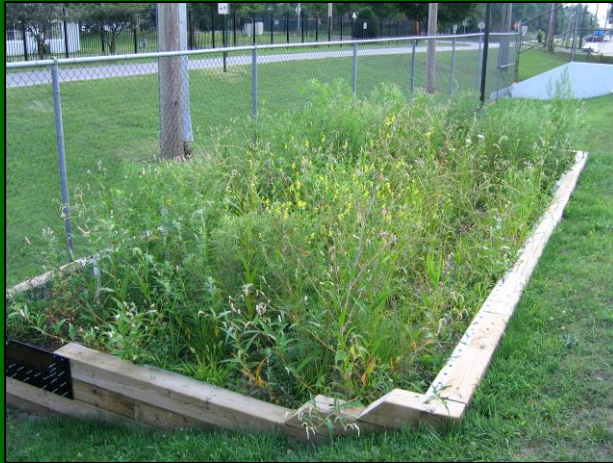
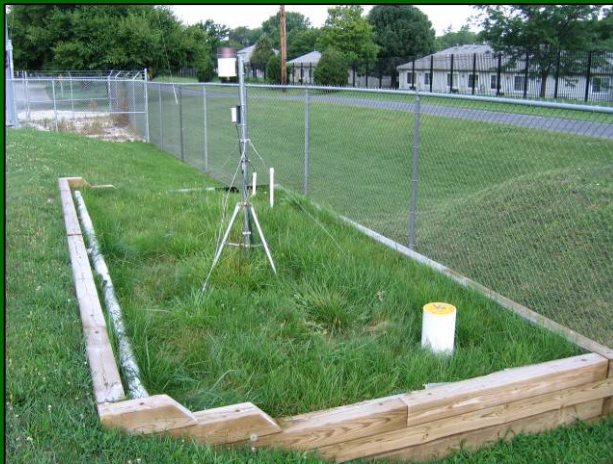
Bellwood Water Department

❖ Two Rain Gardens

- ❖ 230 ft² in size
- ❖ 1,540 ft² tributary area (roof)

- ❖ 220 ft² in size
- ❖ 1,340 ft² tributary area (roof)

- ❖ Elevated Planter Box
- ❖ 24" Engineered Soil
- ❖ Weir

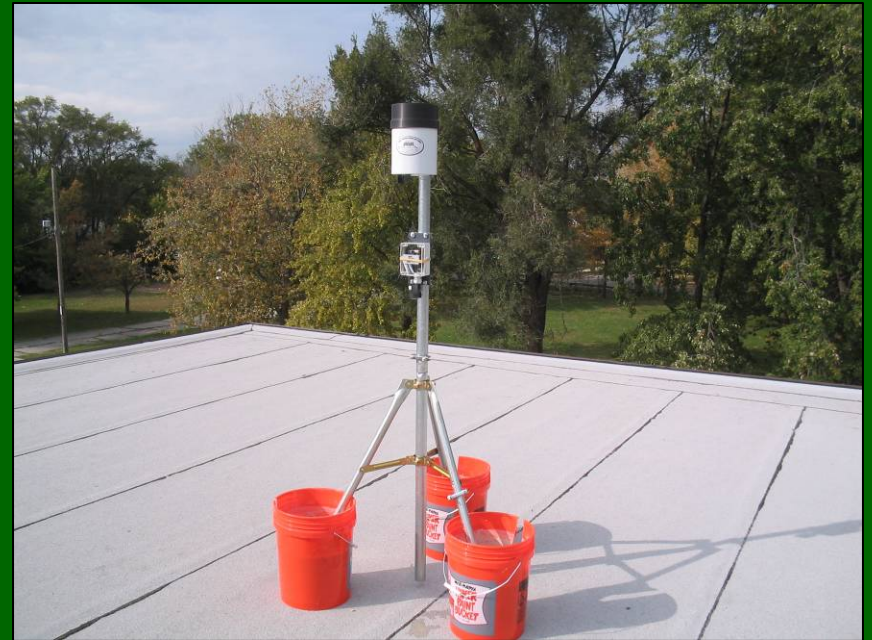
- ❖ Rain Gauge
 - ❖ Hobo Weather Station
Tipping Bucket Gauge
 - ❖ Hobo MicroStation
Data Logger
- ❖ Recorded 5 minute
rainfall

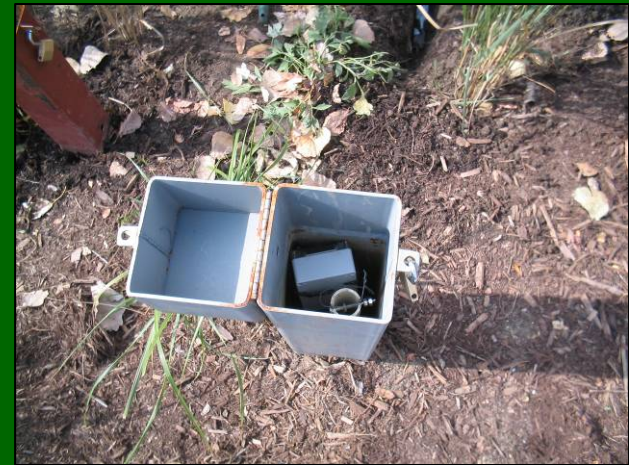
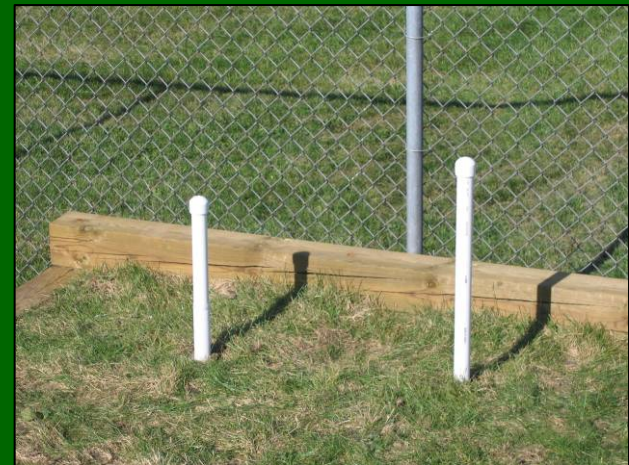
❖ Water Level Meters

- ❖ Hobo 30-foot depth data logger
- ❖ Recorded on a 5-minute interval
- ❖ Requires independent barometric pressure reading

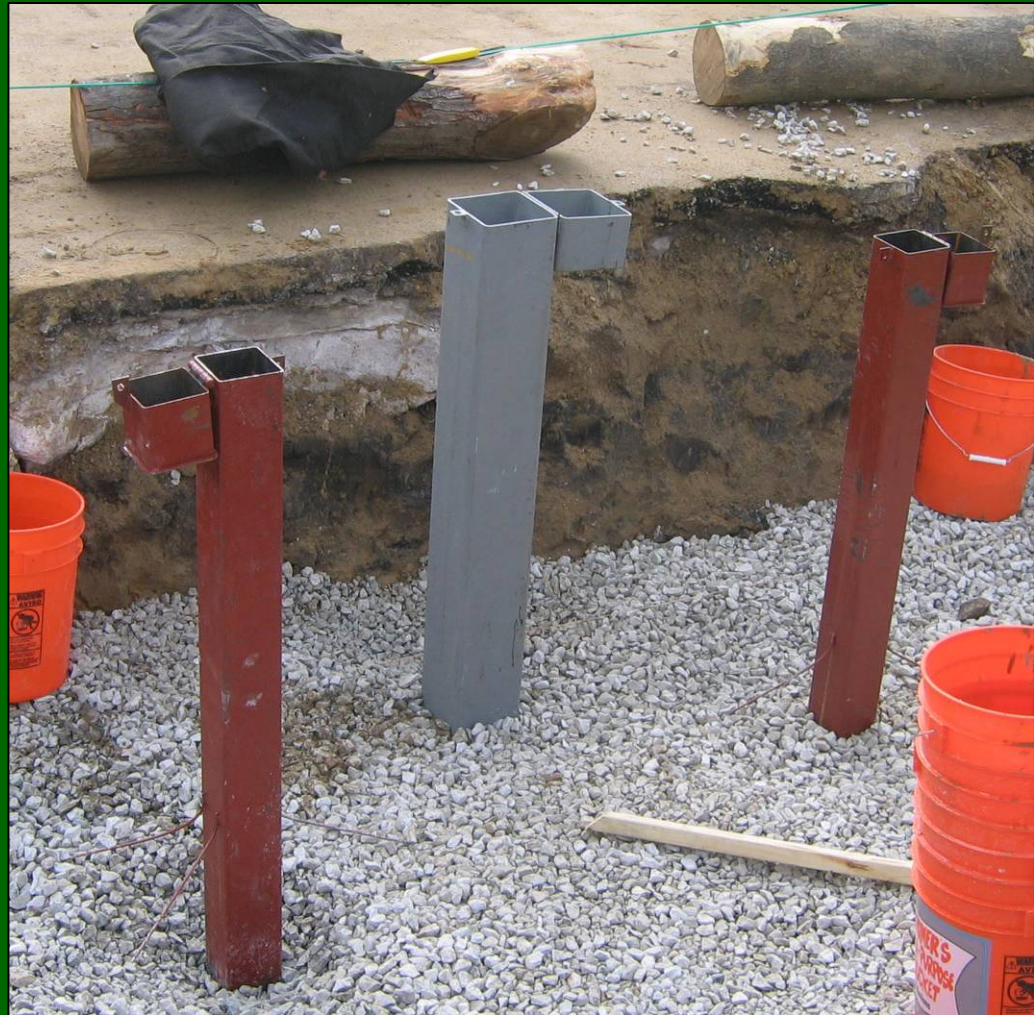
- ❖ Monitoring Well
 - ❖ Metal well covers
 - ❖ PVC well slotted for:
 - ❖ Surface
 - ❖ Engineered soil/aggregate
 - ❖ Subsoil
 - ❖ Bentonite seal
 - ❖ Uniform-grade sand for well pack

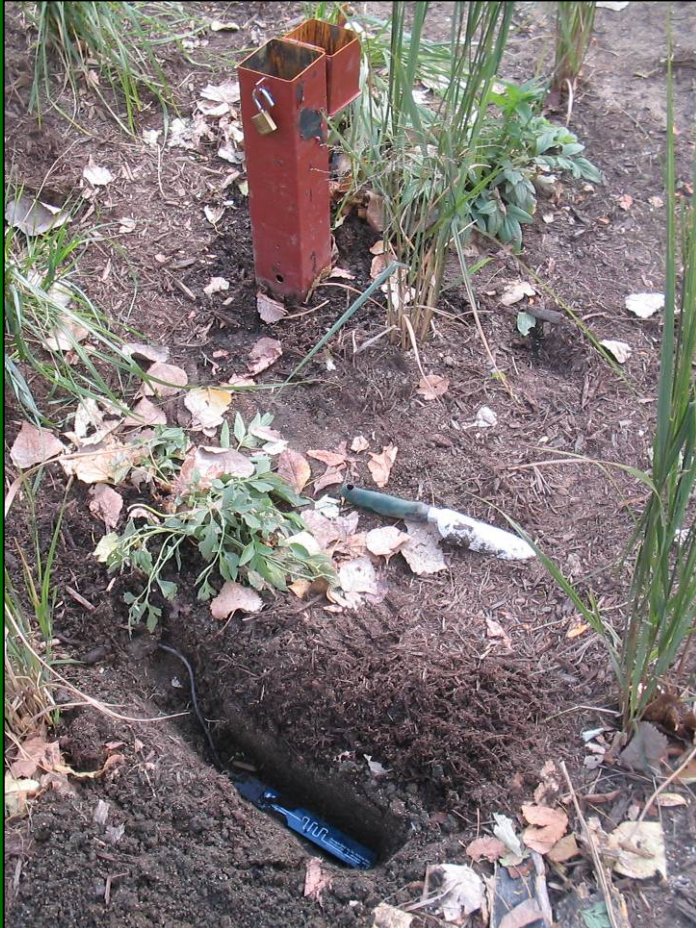
- ❖ Soil Moisture Meters
 - ❖ ECH 2 O Soil Moisture Sensor (dielectric)
 - ❖ Hobo Microstation Data Logger
- ❖ Recorded 5-min soil moisture data
- ❖ In-laboratory soil specific meter calibration
- ❖ Used to determine soil saturation and soil porosity by volume

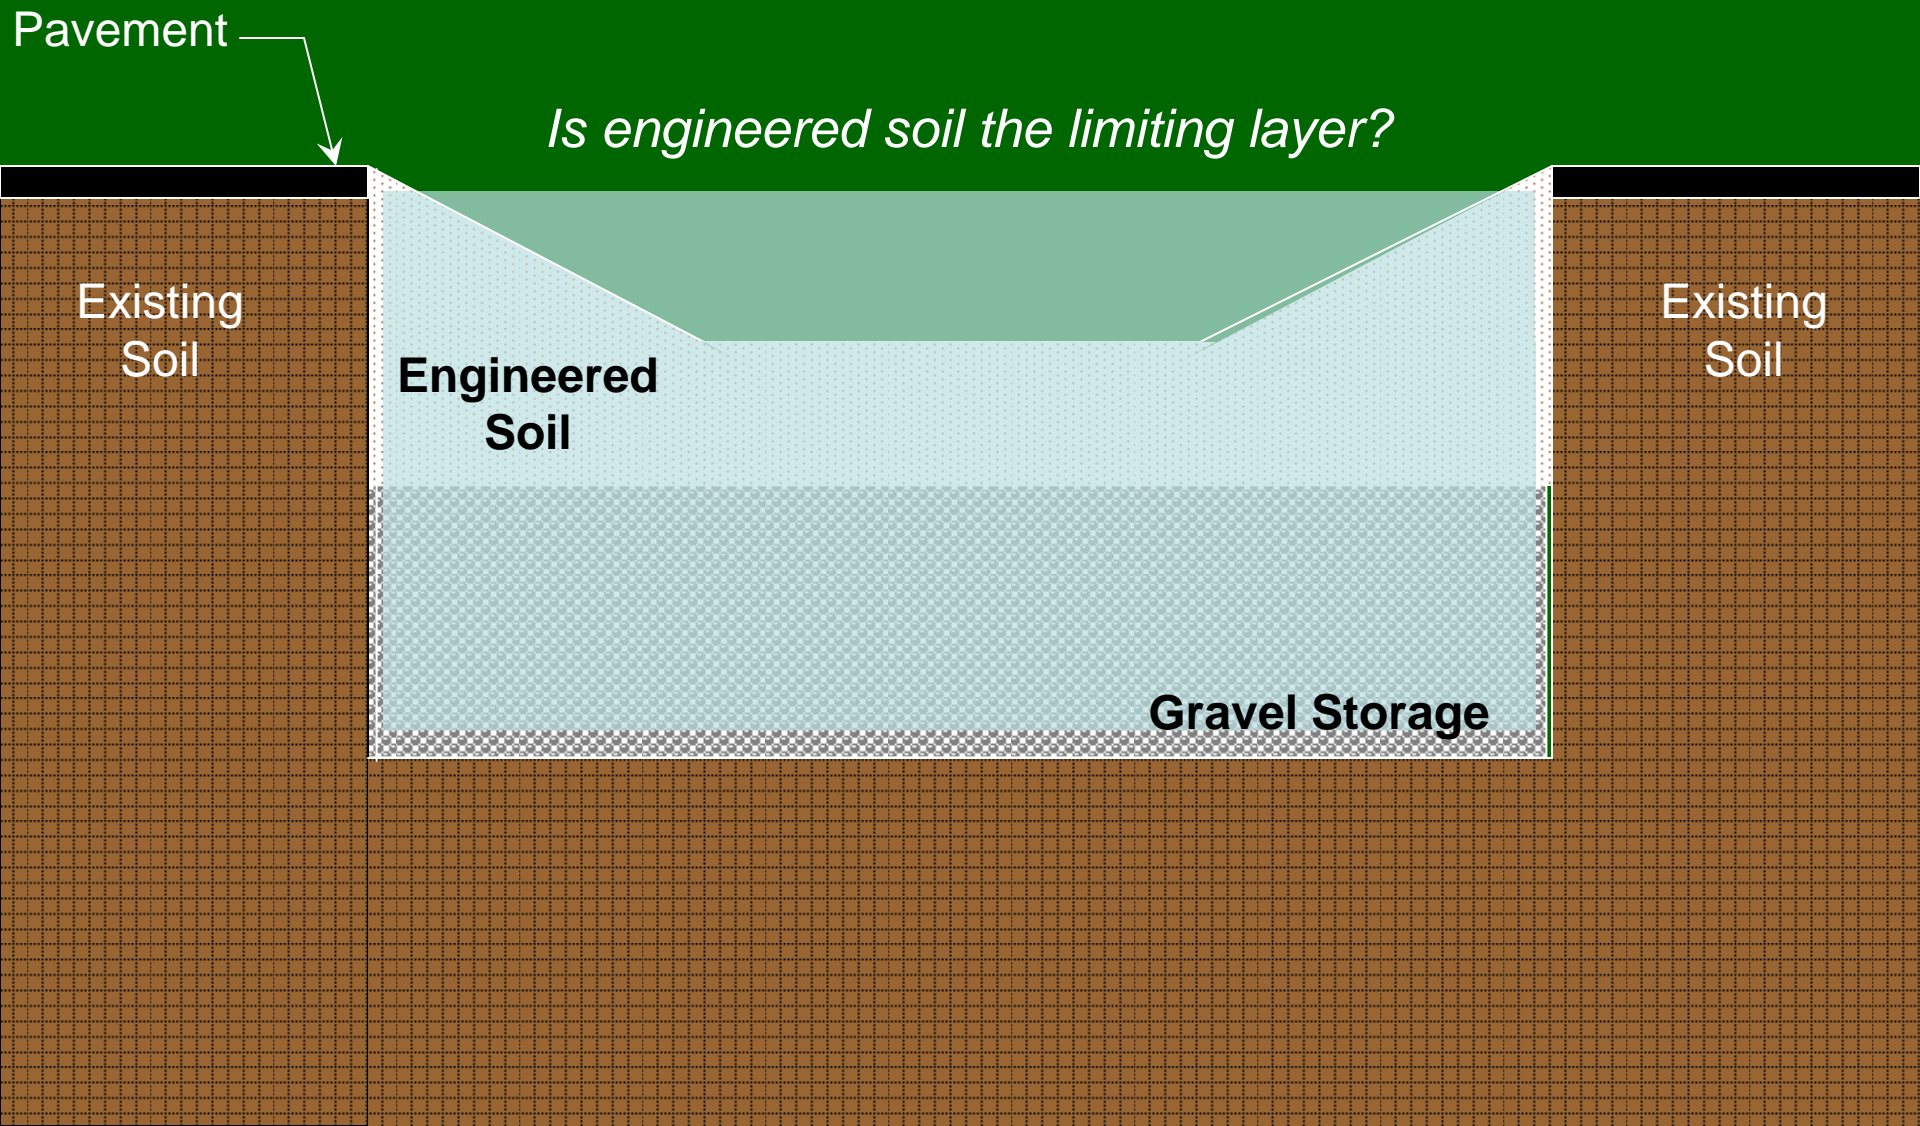
BMP Performance

Is engineered soil the limiting layer?

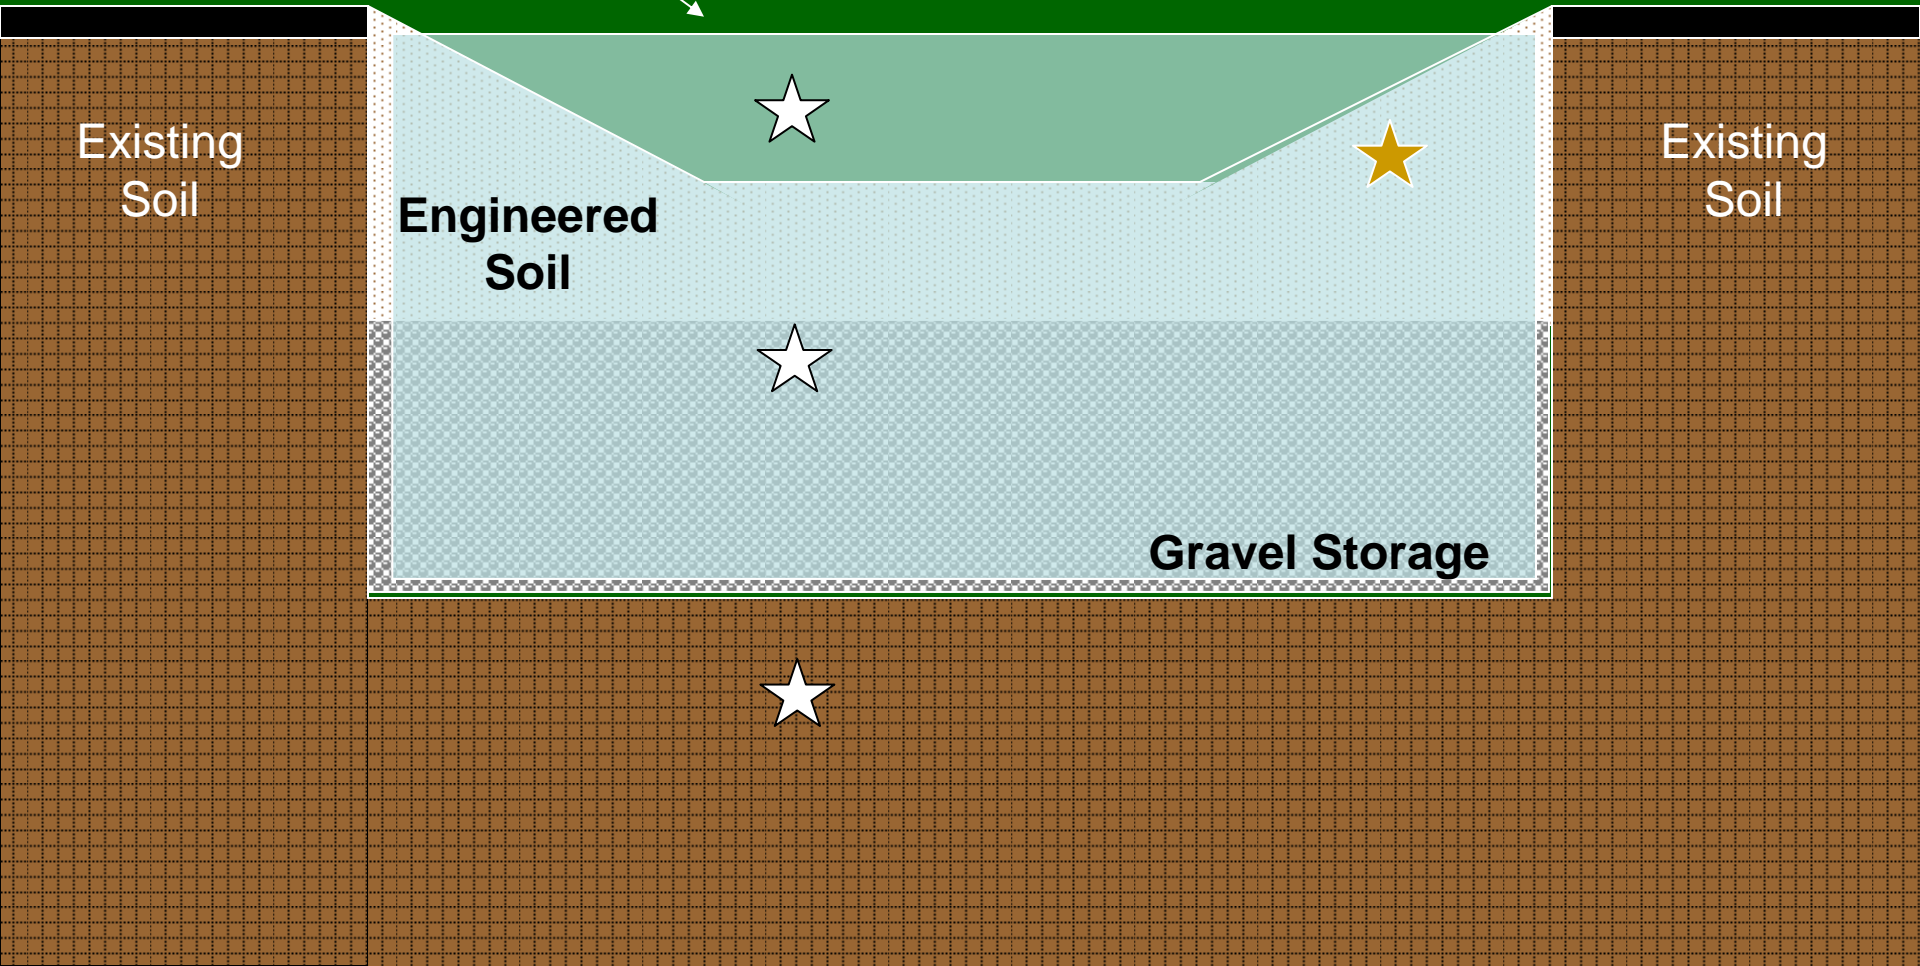
Monitoring Data/Computations

*Runoff computed from Rainfall
and tributary area*

*Outflow
unmeasurable
in 4 of 6 BMPs*
