RICHLAND CREEK MITIGATION BANK

SCI Engineering, Inc.
SCOTT HARDING, CPSS/SC
Vice President

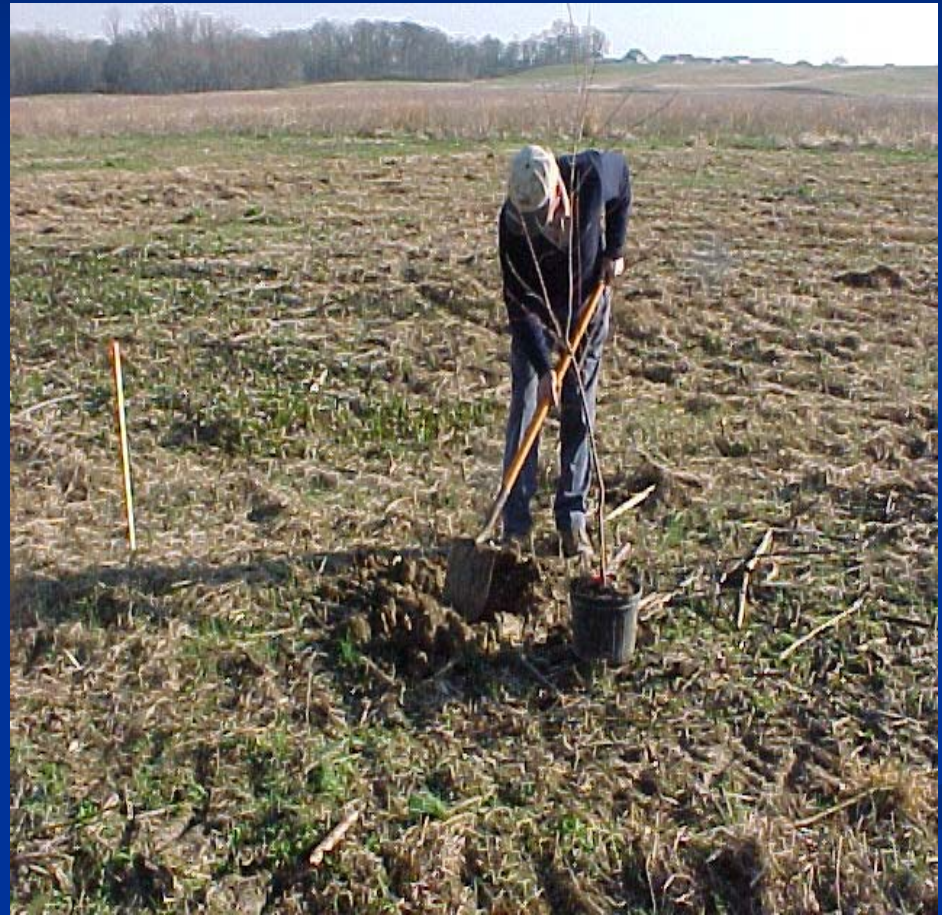
MITIGATION DESIGN

Worked with the Corps to modify tree planting spacing to 30' x 30' per nursery recommendations and therefore decreasing the competition.

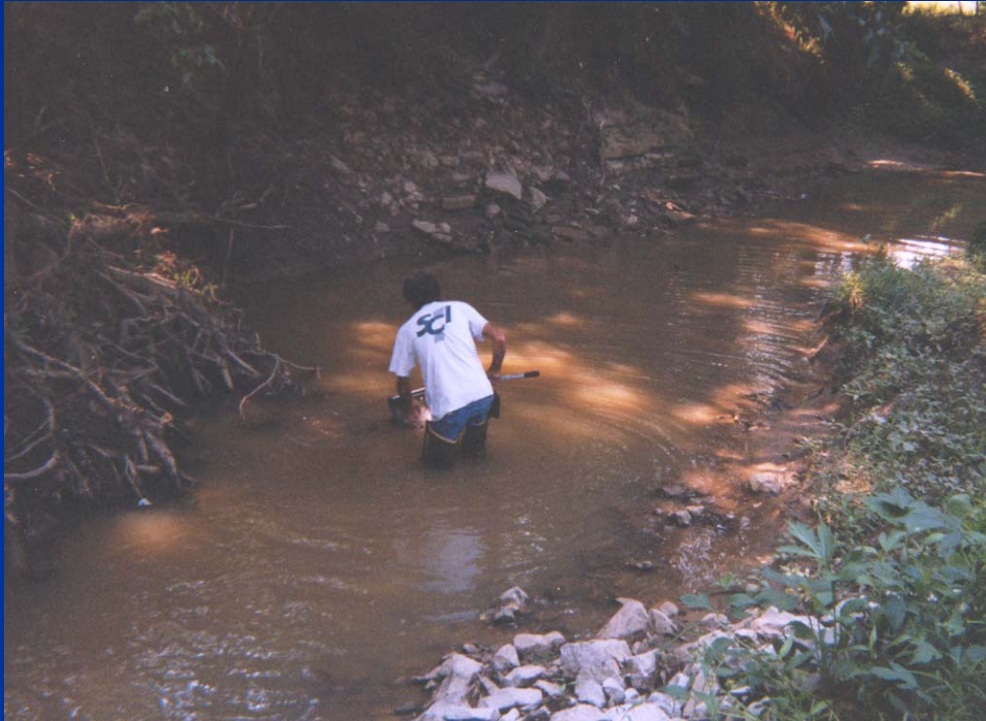
ANNUAL MONITORING

Conducted
annually for 5
years.

Annual monitoring
reports sent to
Mitigation Bank
Review Team
(MBRT).

Standards were met
after 5th monitoring
year.

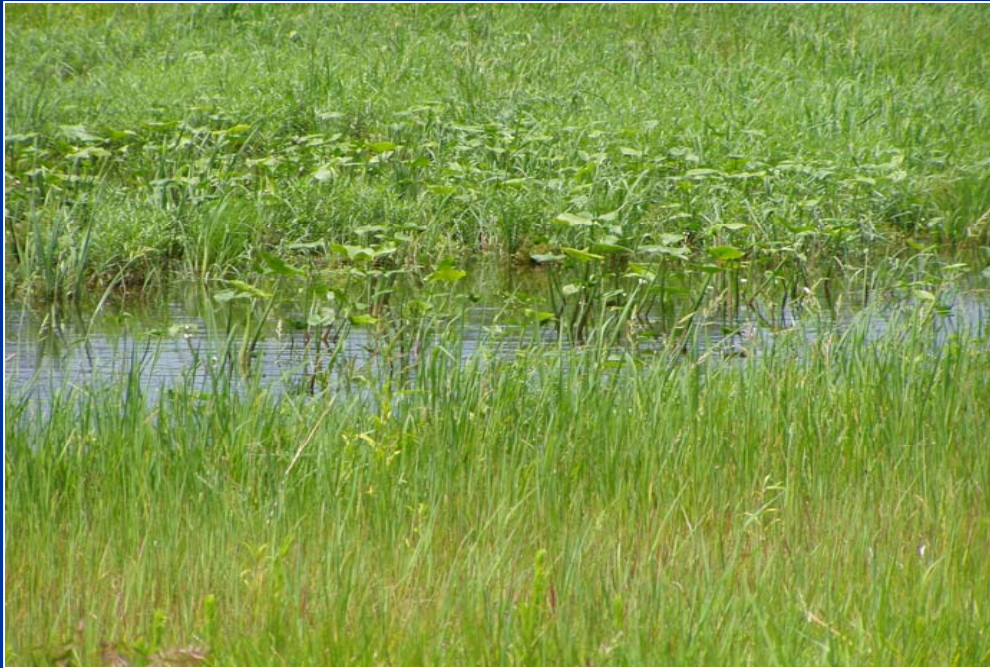
PERFORMANCE

- Planted and natural recruitment of vegetation has successfully progressed from early successional and disturbance species, towards emergent and hydrophytic species.
- Hydric soils and hydrology have developed and are consistent with wetland criteria.

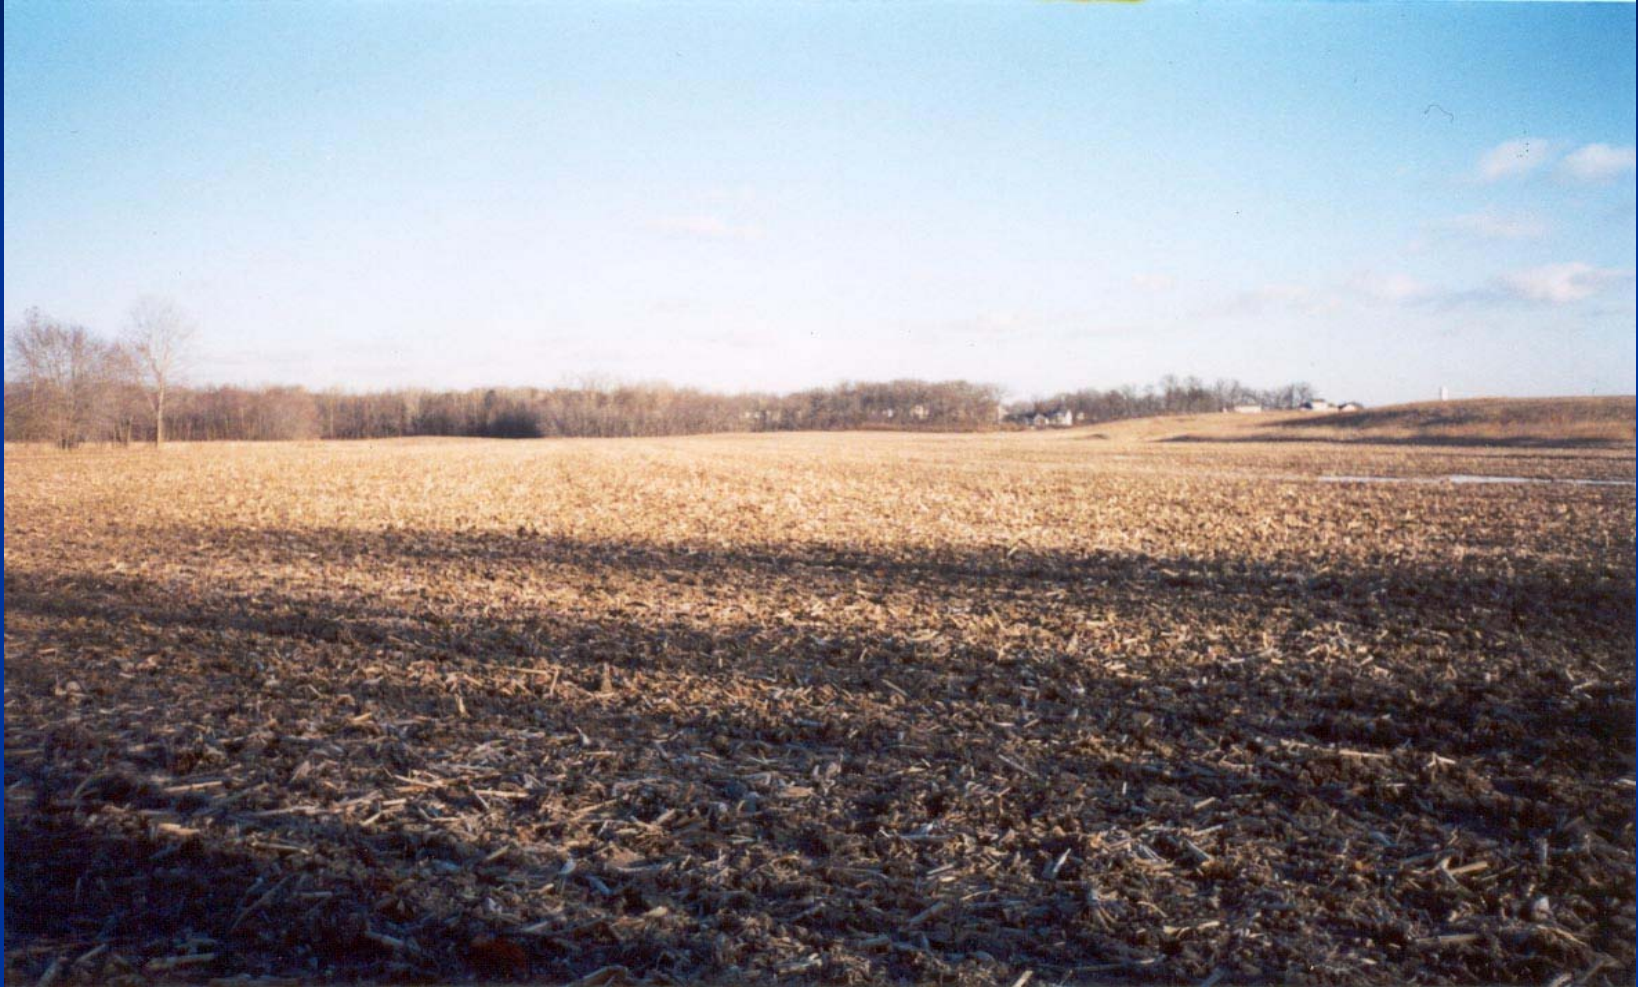
Pre-construction 2002

Wetland Mitigation

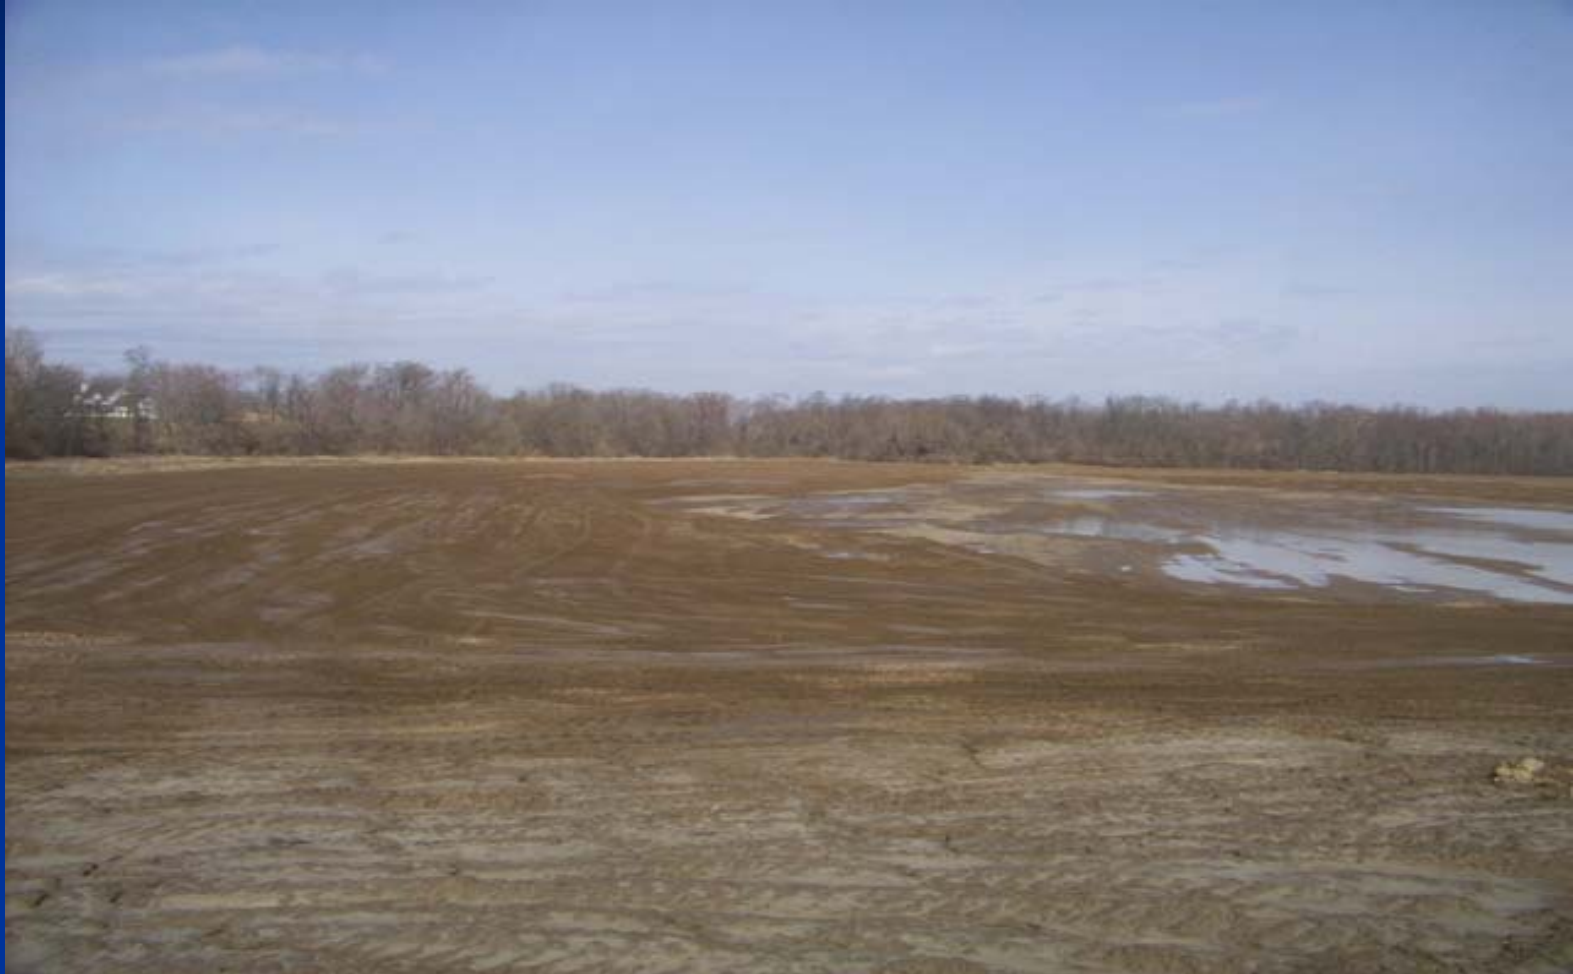
Wetland Construction 2003

Wetland Construction

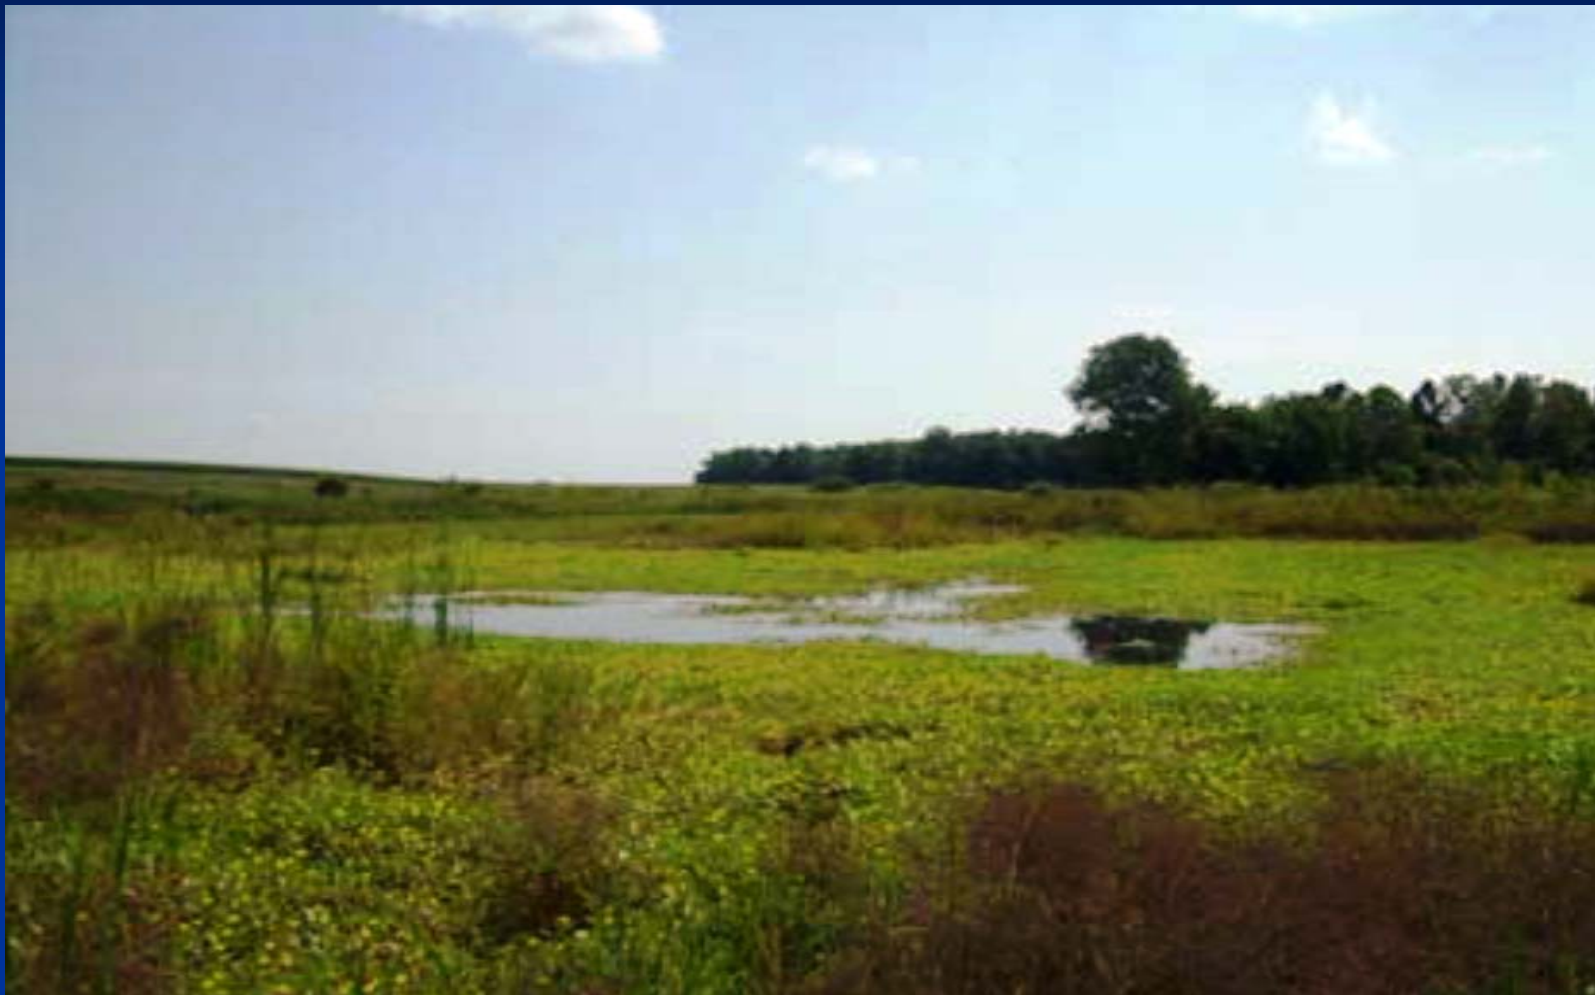
Post Construction 2009

Wetland Mitigation

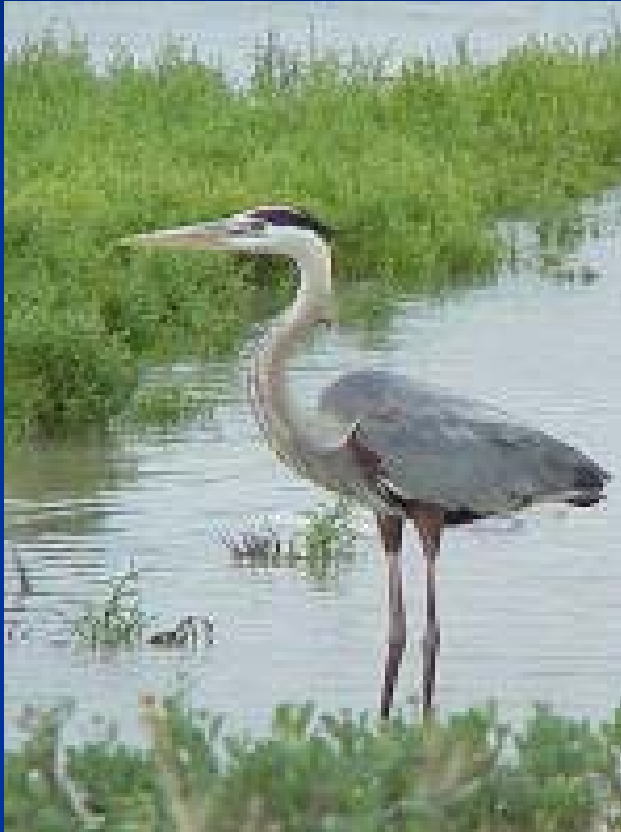
RIPARIAN PERFORMANCE

- The restored riparian corridor planted with trees and shrubs continues to increase in canopy coverage.
- In-stream habitat was monitored and observed to provide habitat for fish and macroinvertebrates.
- Erosion of streambanks and water quality was monitored as well.

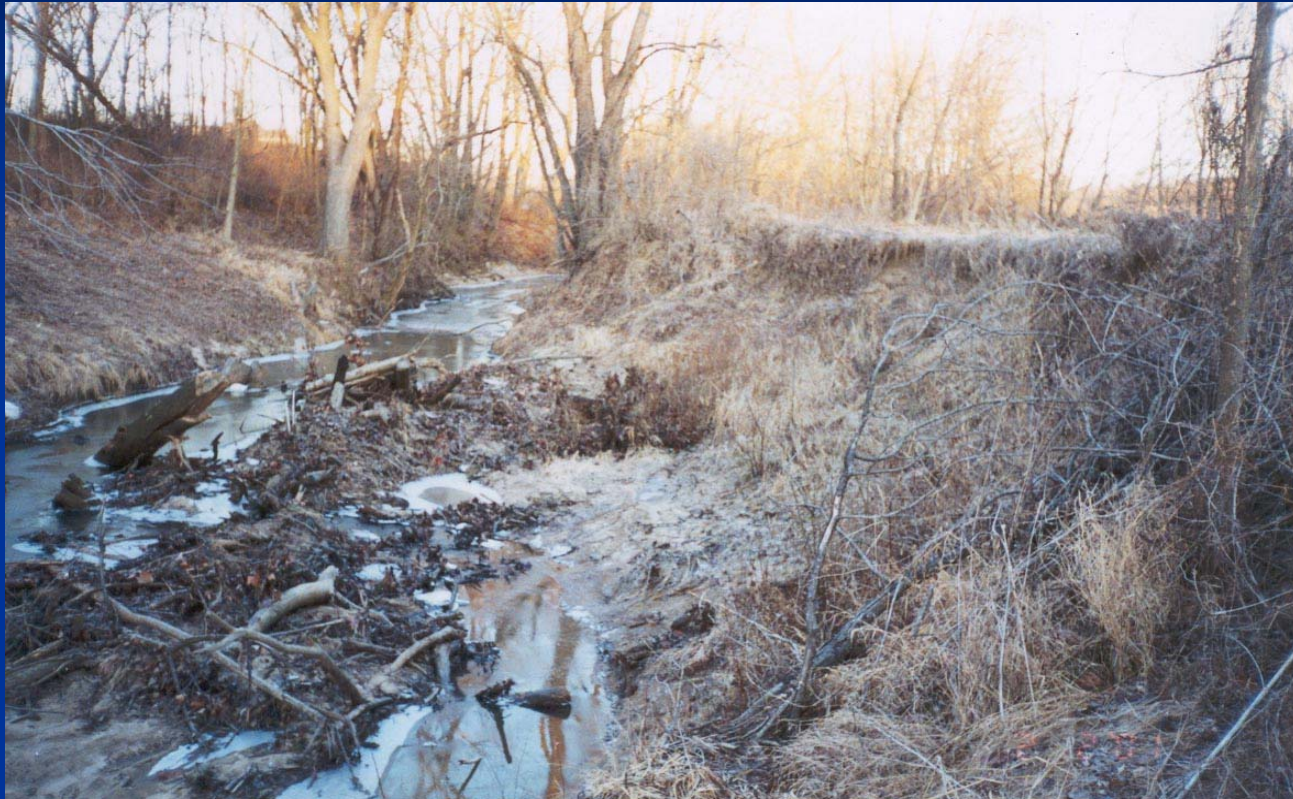
Streambank Stabilization

Annual monitoring in 2006 identified a sloughed bank slope

- The sloughing of the streambank was able to be repaired.
- Grading and additional re-vegetation efforts successfully stabilized the streambank.

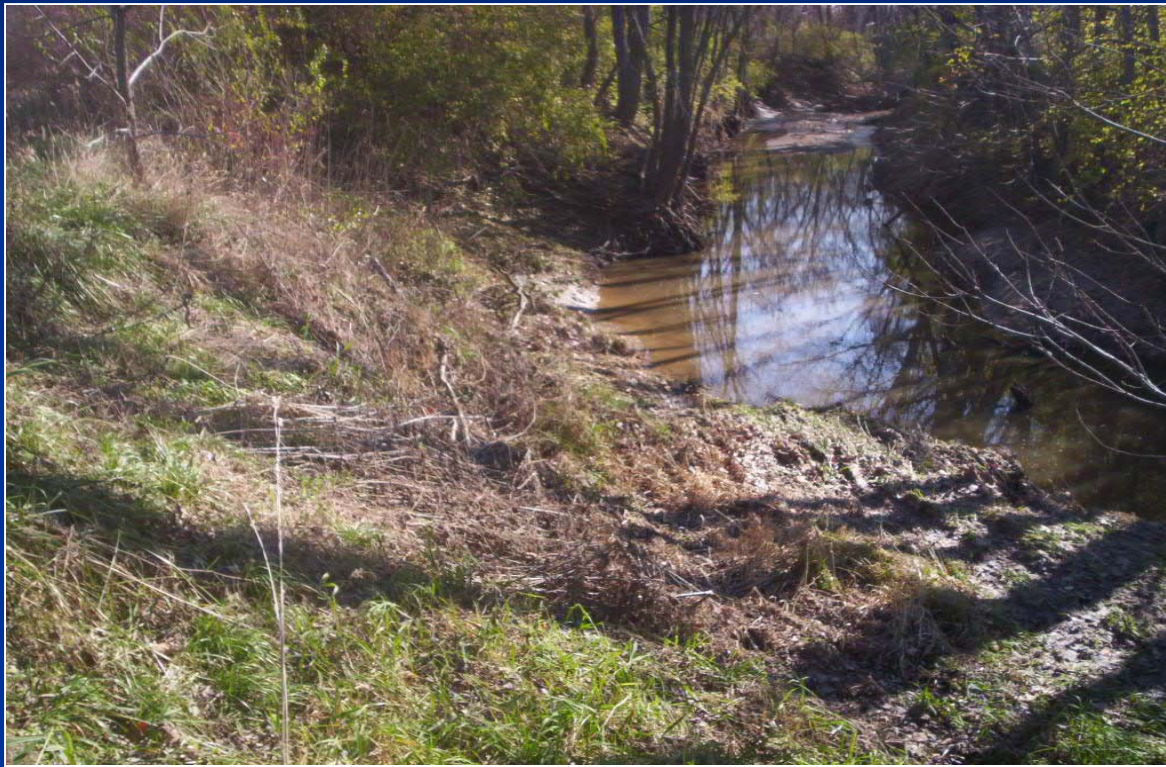
Stabilized bank - 2006

Since streambank stabilization, no further erosion has been observed.

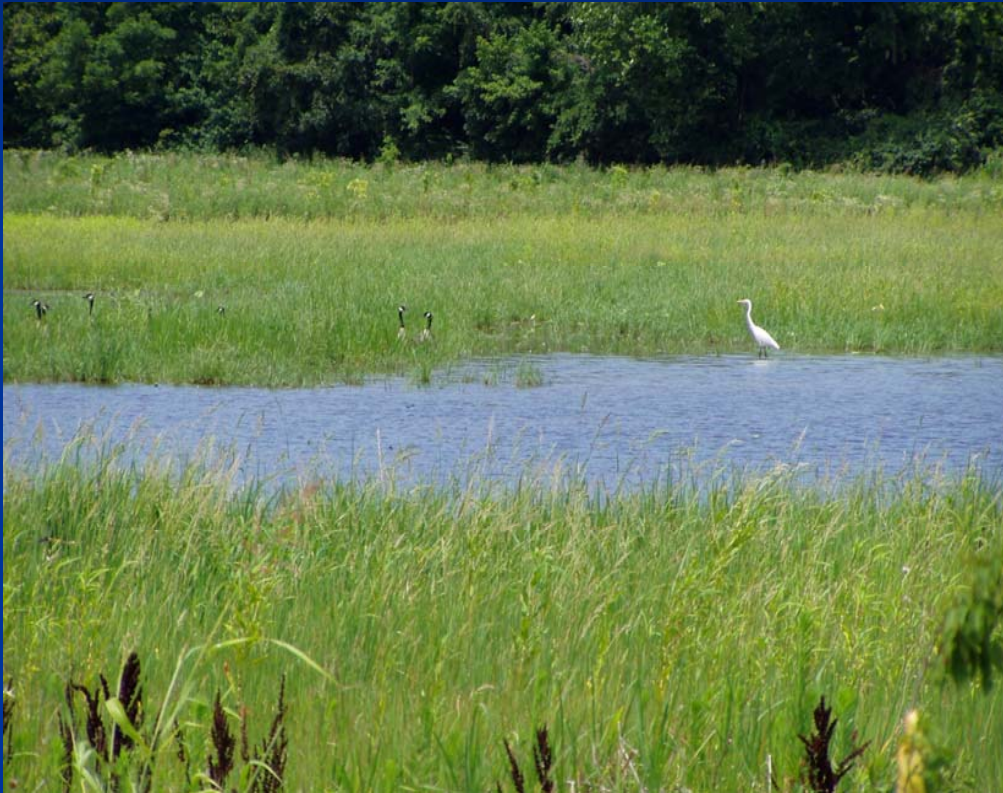
Post Construction Performance

- The site continues to attract waterfowl such as herons, ducks, shorebirds, egrets and geese.
- Amphibians and other wildlife have been observed as well.
