LAKE WEE-MA-TUK DAM

**PLANNING, DESIGNING AND FUNDING THE CONSTRUCTION
OF AN AUXILIARY PRINCIPAL SPILLWAY FOR THE
WEE-MA-TUK HILLS DRAINAGE DISTRICT**

**Prepared for the Illinois Association of
Floodplain and Stormwater Management
Annual Conference: March 11-12, 2009**

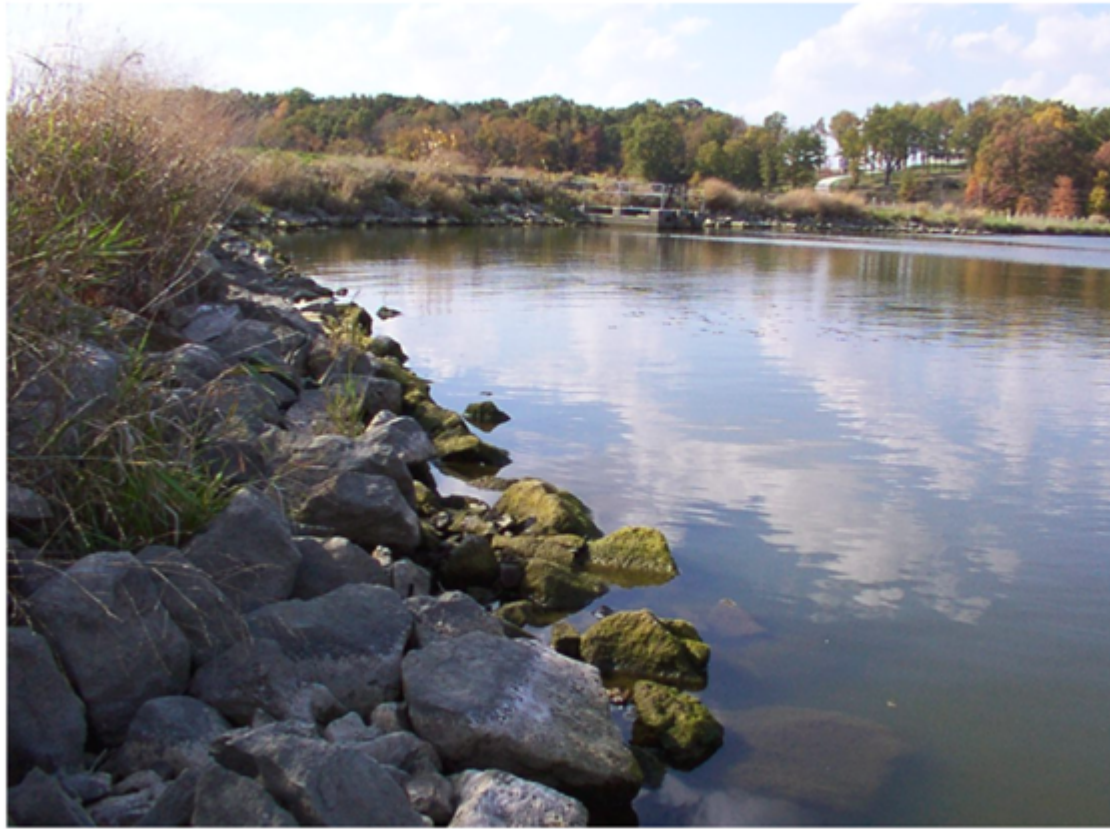
**Existing Lake Wee-Ma-Tuk Dam
at normal pool in 2004**

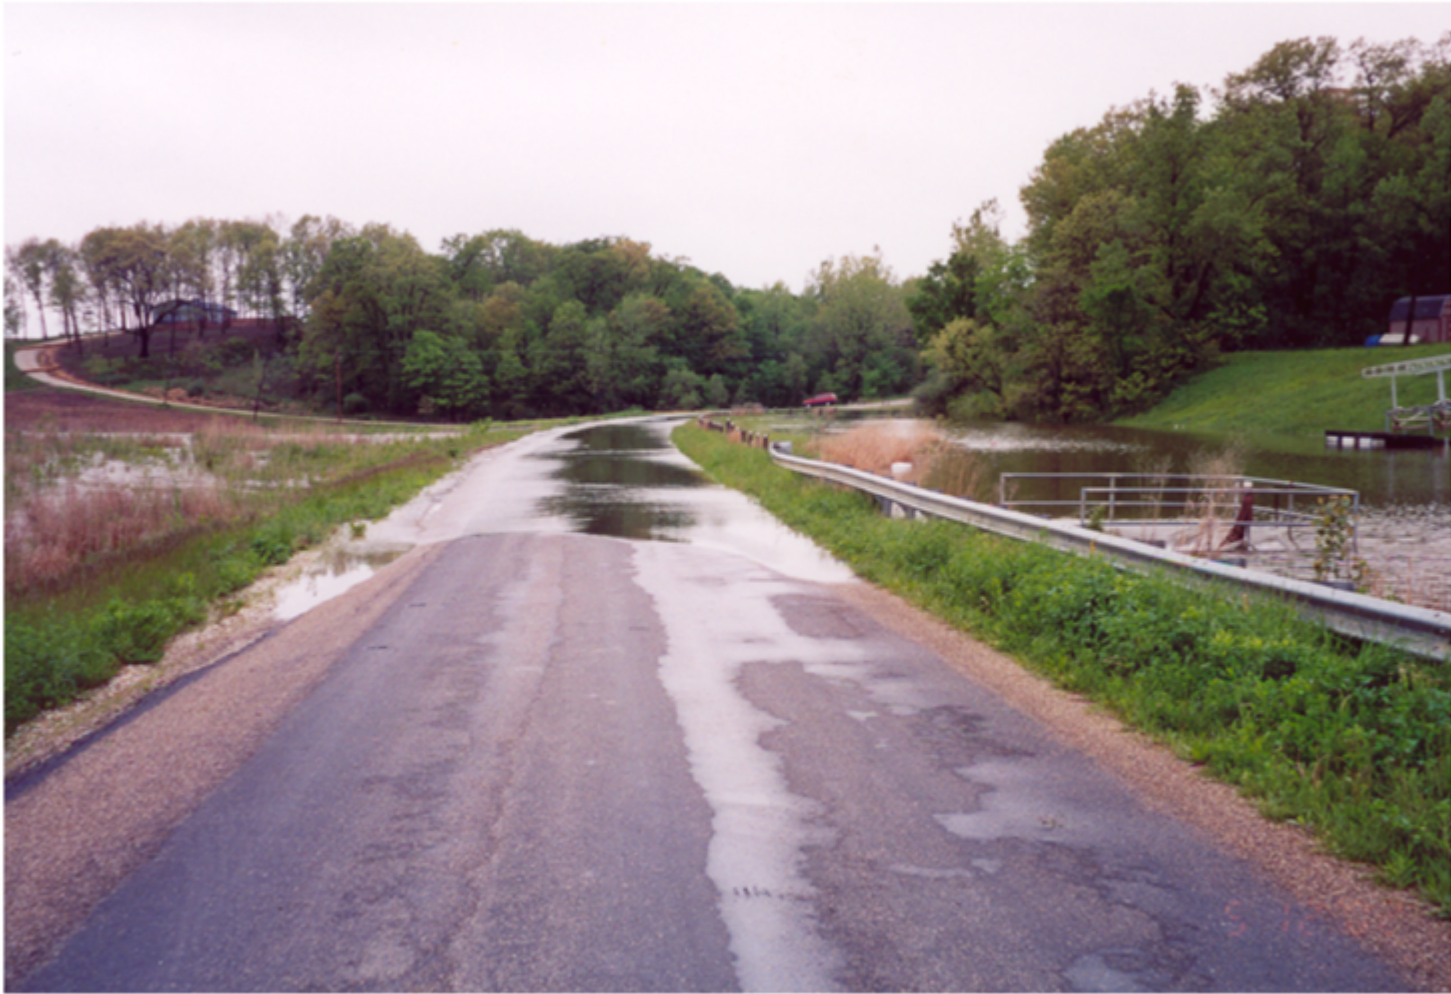
August 1, 2003

- Between 1991 & 2003, emergency spillway (ES) topped three times
- Roadway and gabion slope protection damaged
- Local engineer is hired, but scope is limited to evaluating & mitigating damage
- CMT asked to provide second opinion
- Repairing damage did not get to the root of the problem
- Review of the 1990 HEC-1 model revealed inflow to principal spillway (PS) significantly underestimated; capacity only 10% of required

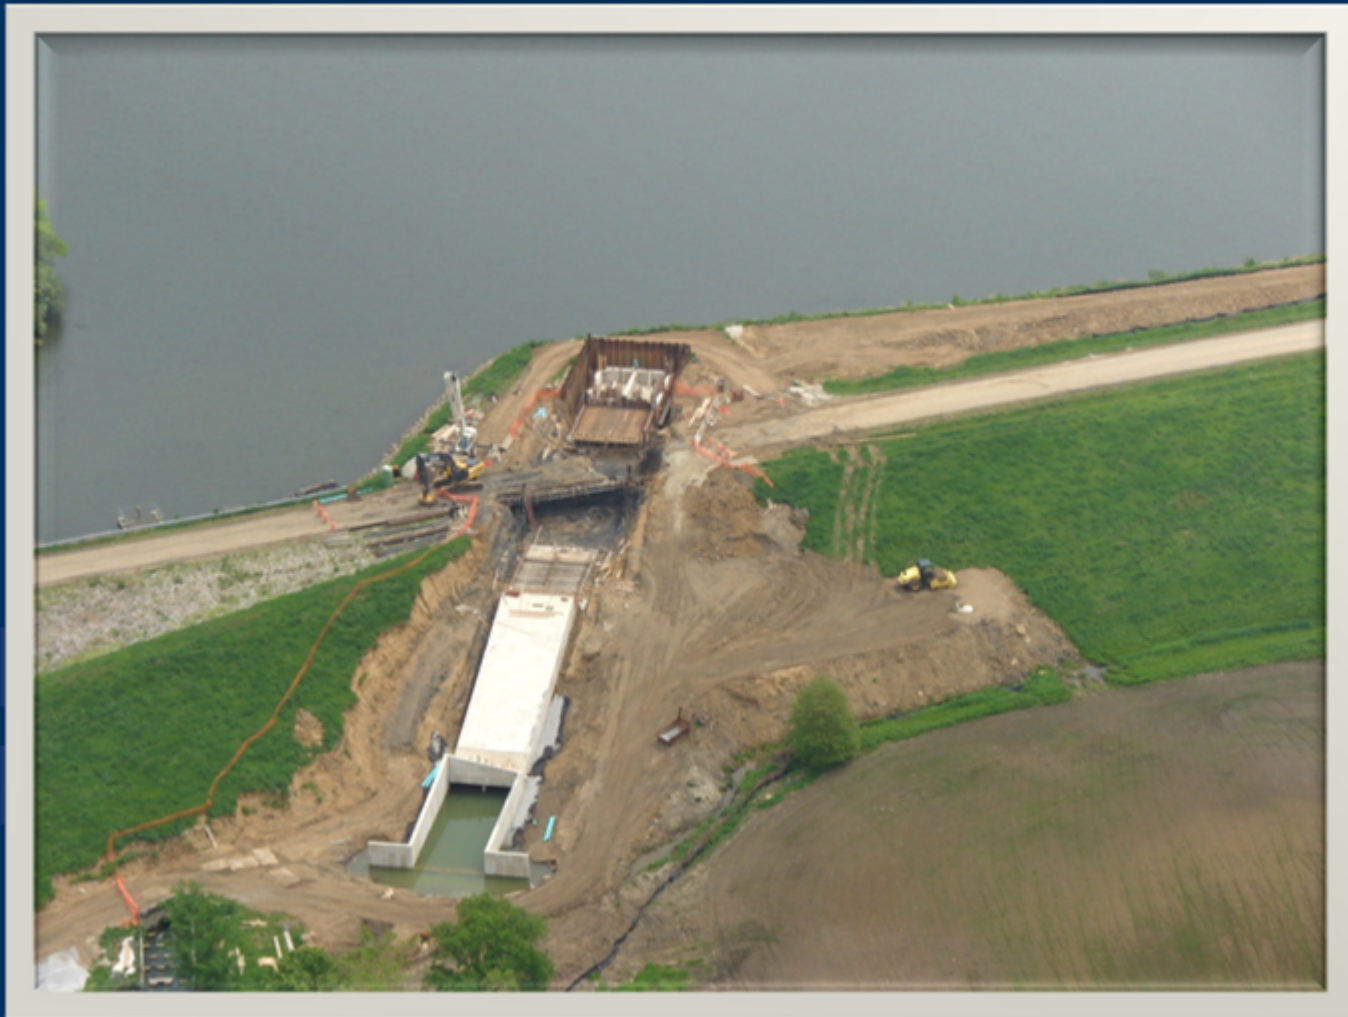
APS Intake Structure

Utilized existing embankment and piling to construct intake, stockpile area also

- With APS located in lake, wanted to minimize dimensions by utilizing enhanced weir shape
- Research yielded a rounded (1/4 round) crest on the approach side, 7 inch radius, increasing flow by 10% – 15%
- Inserted weir breaks to avoid turbulence at corners and chamfered edges

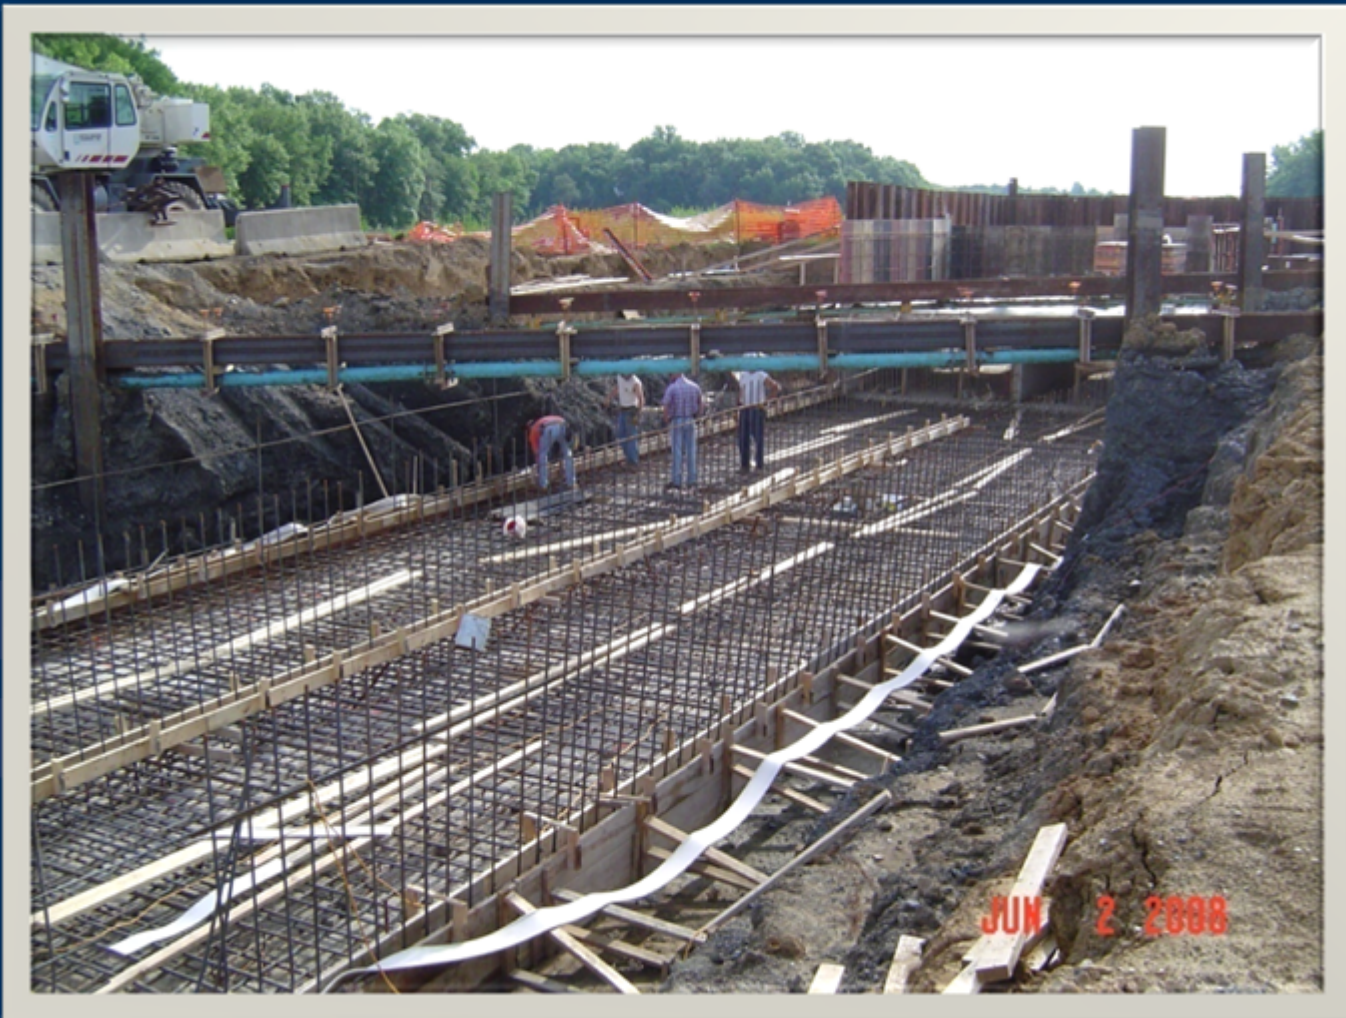
Spillway conduit under Arrow Road

Note gas and water main protection

- Used flat slope (0.87%) from APS to other side of roadway to reduce excavation and provide clearance under existing gas and water mains
- Gas and water service protected; no interruptions allowed
- Used steep slope (25%) from edge of roadway to energy dissipator
- Township and county approval required to raise Arrow Road
- Strike a balance between township requirements for road fill and IDNR-OWR
- Updated construction cost estimate: \$1,139,000

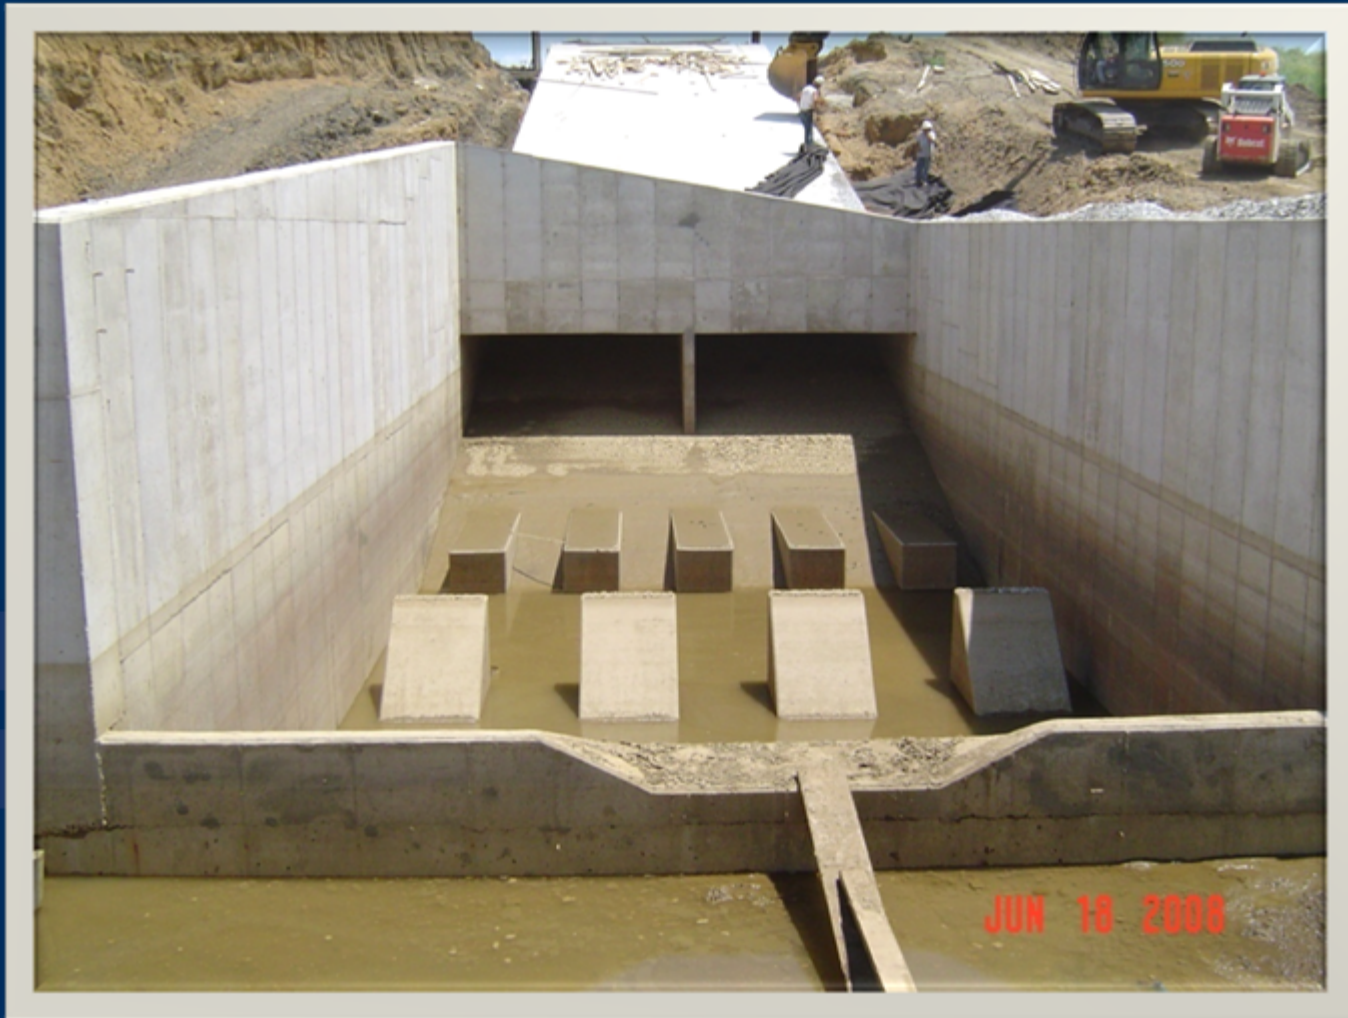
USBR Type III Energy Dissipator

Note baffle blocks and low flow outlet

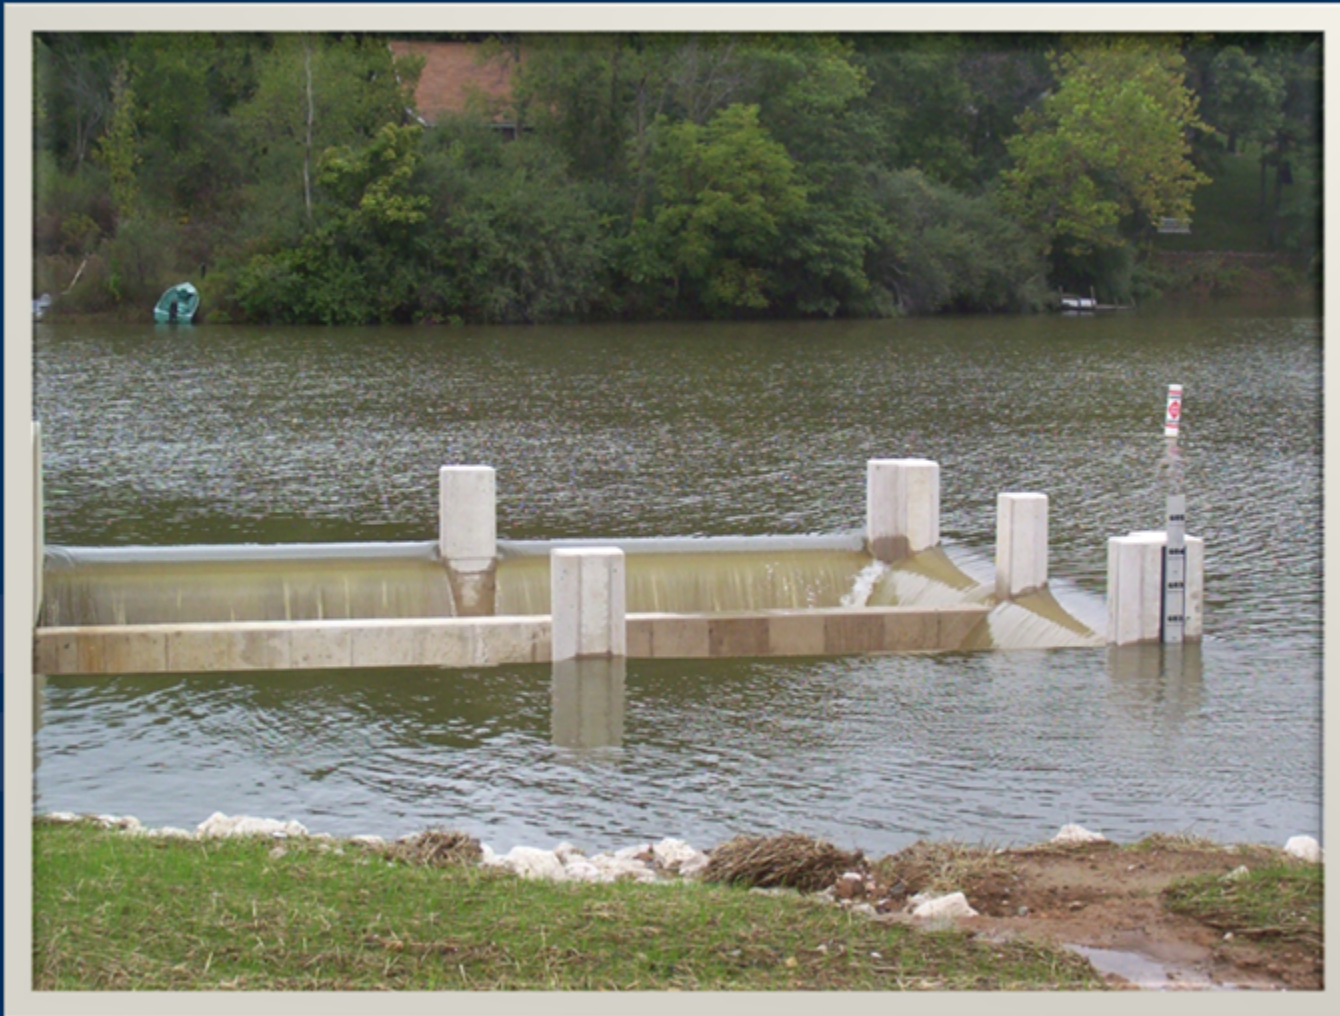
APS Intake
Flowing on September 14, 2008

- Heavy rainfall from Hurricane Ike In September 2008 tested the APS
- Rainfall amount comparable to three previous overtopping storms
- APS performed as expected and did not overtop the emergency spillway (Arrow Road)

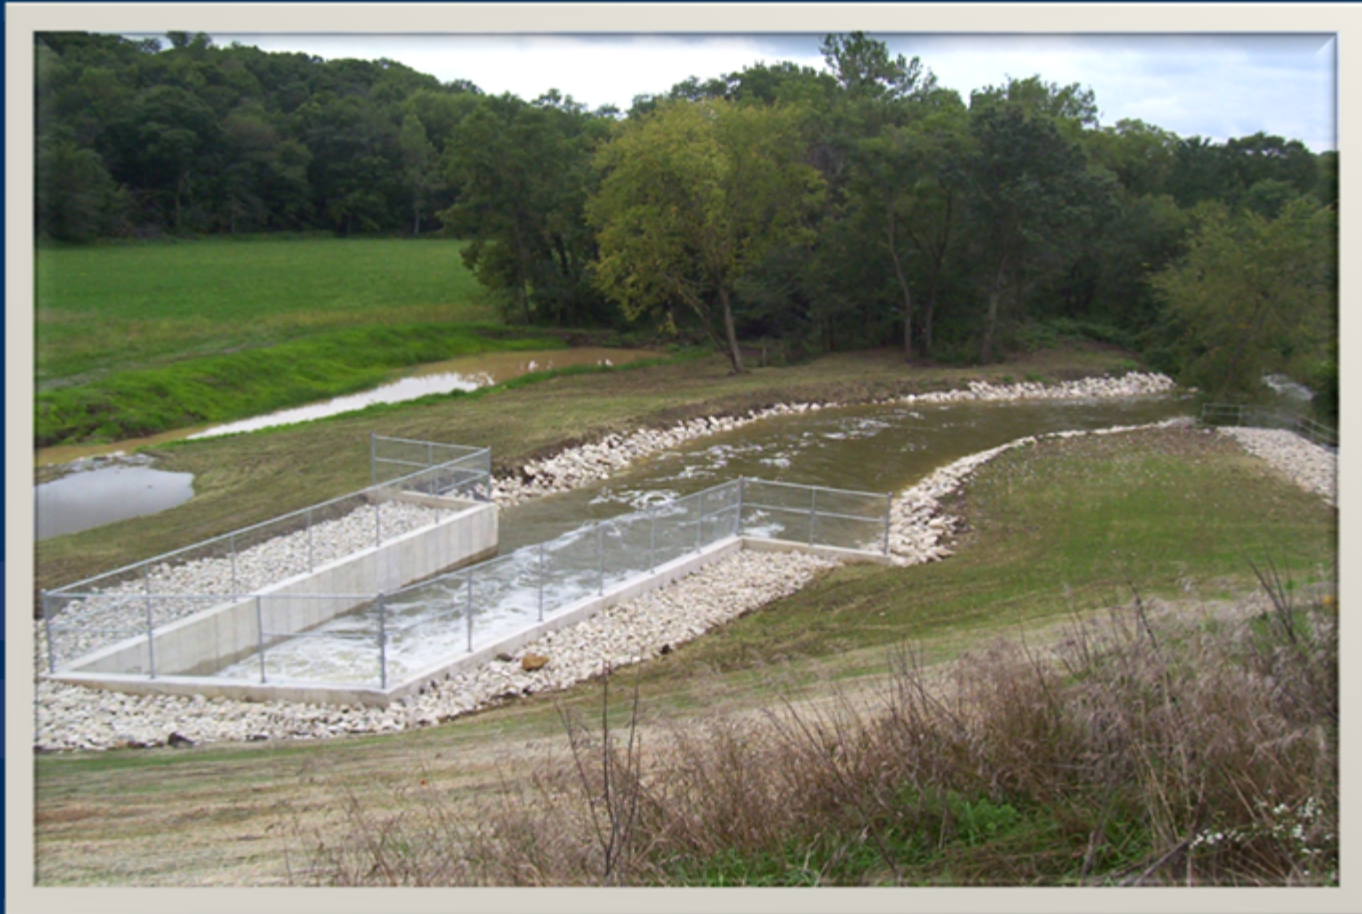
Energy Dissipator
Discharging on September 14, 2008

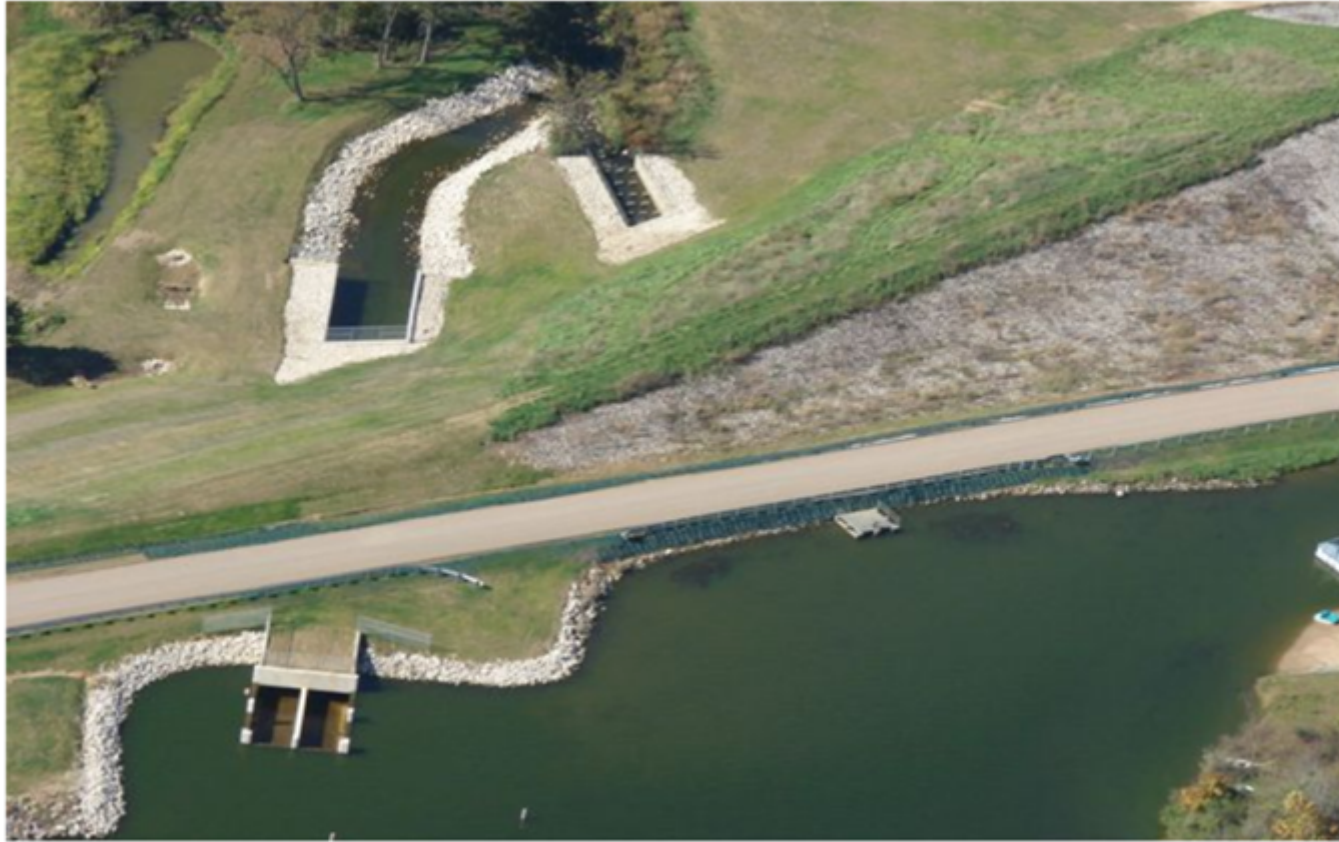
Lake Wee-Ma-Tuk Dam
Improvements Complete: October 10, 2008
