# Ravine 8 Ecosystem Restoration Project

# Project Details

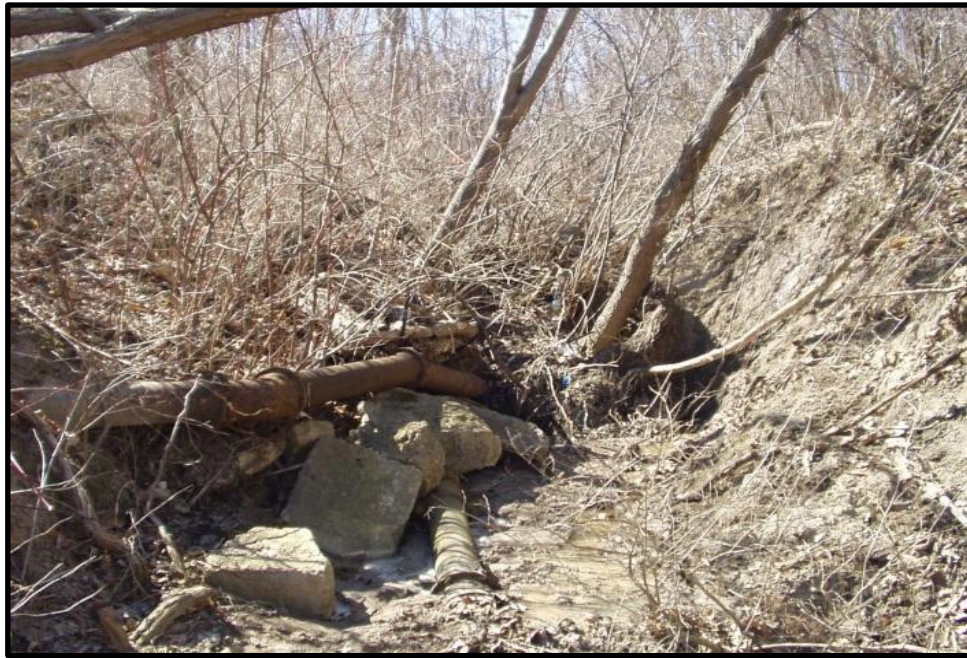
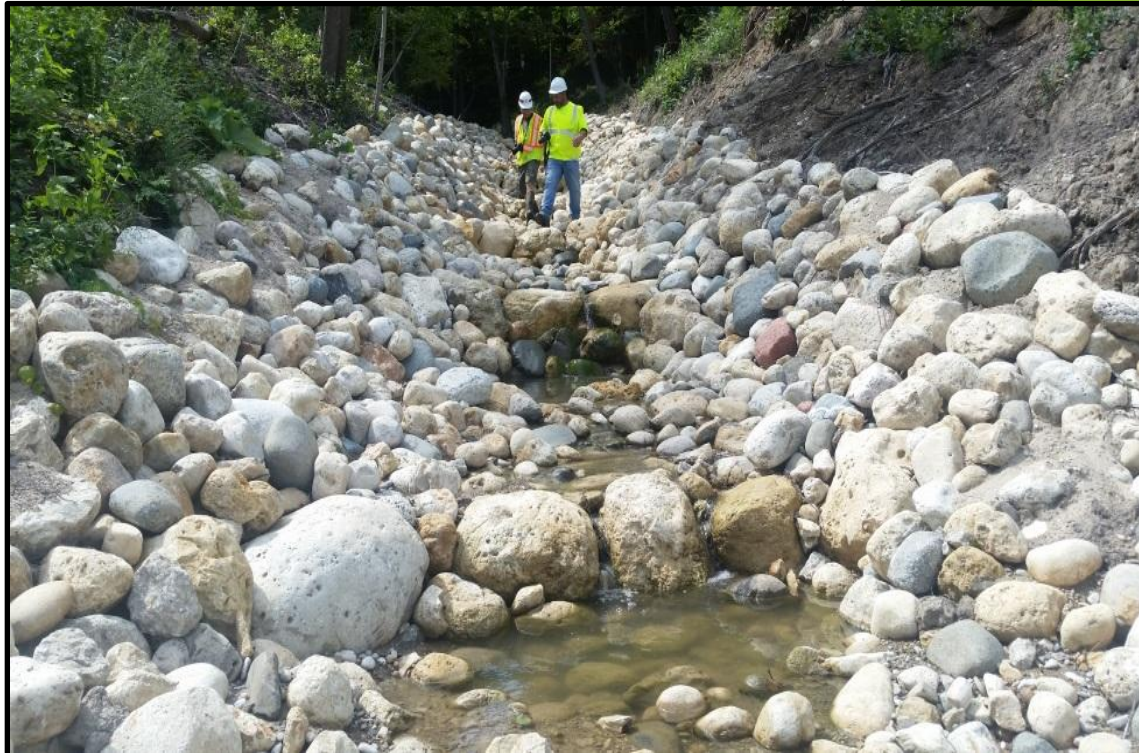
Collapsed Ravine Toe/  
Distressed Utility Lines  
(Before)

Restored Step Up  
Pool (After)

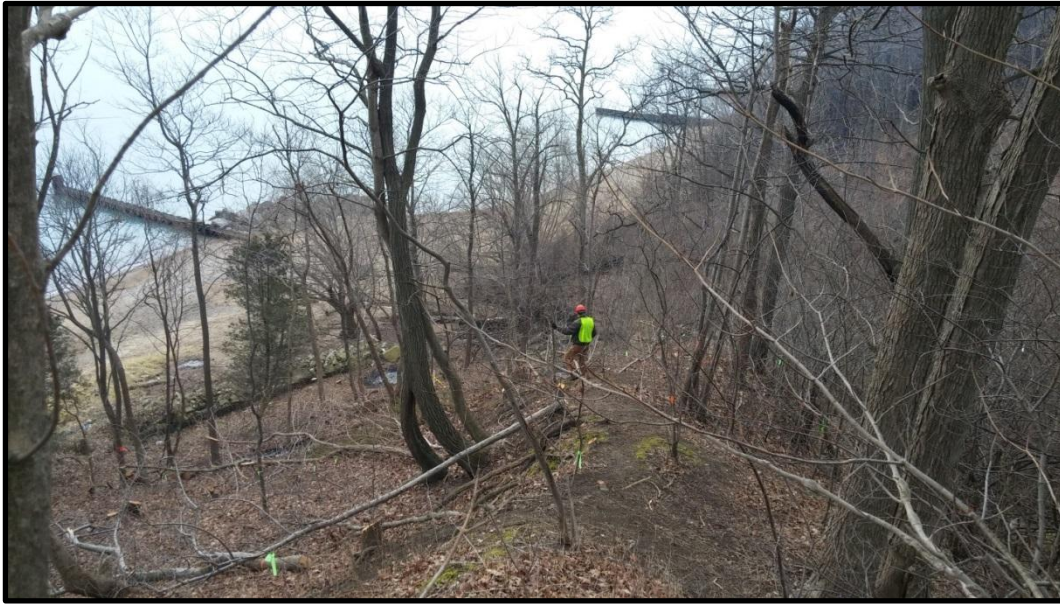
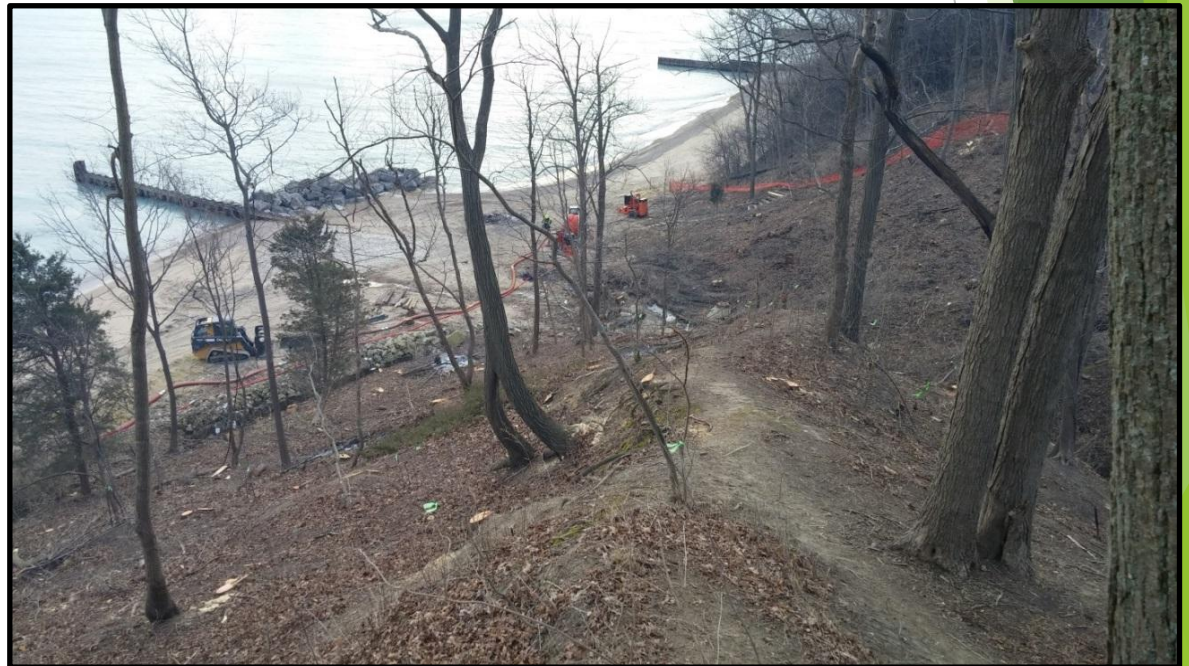
Bluff Restoration  
(Before)

Bluff  
Restoration  
(After)

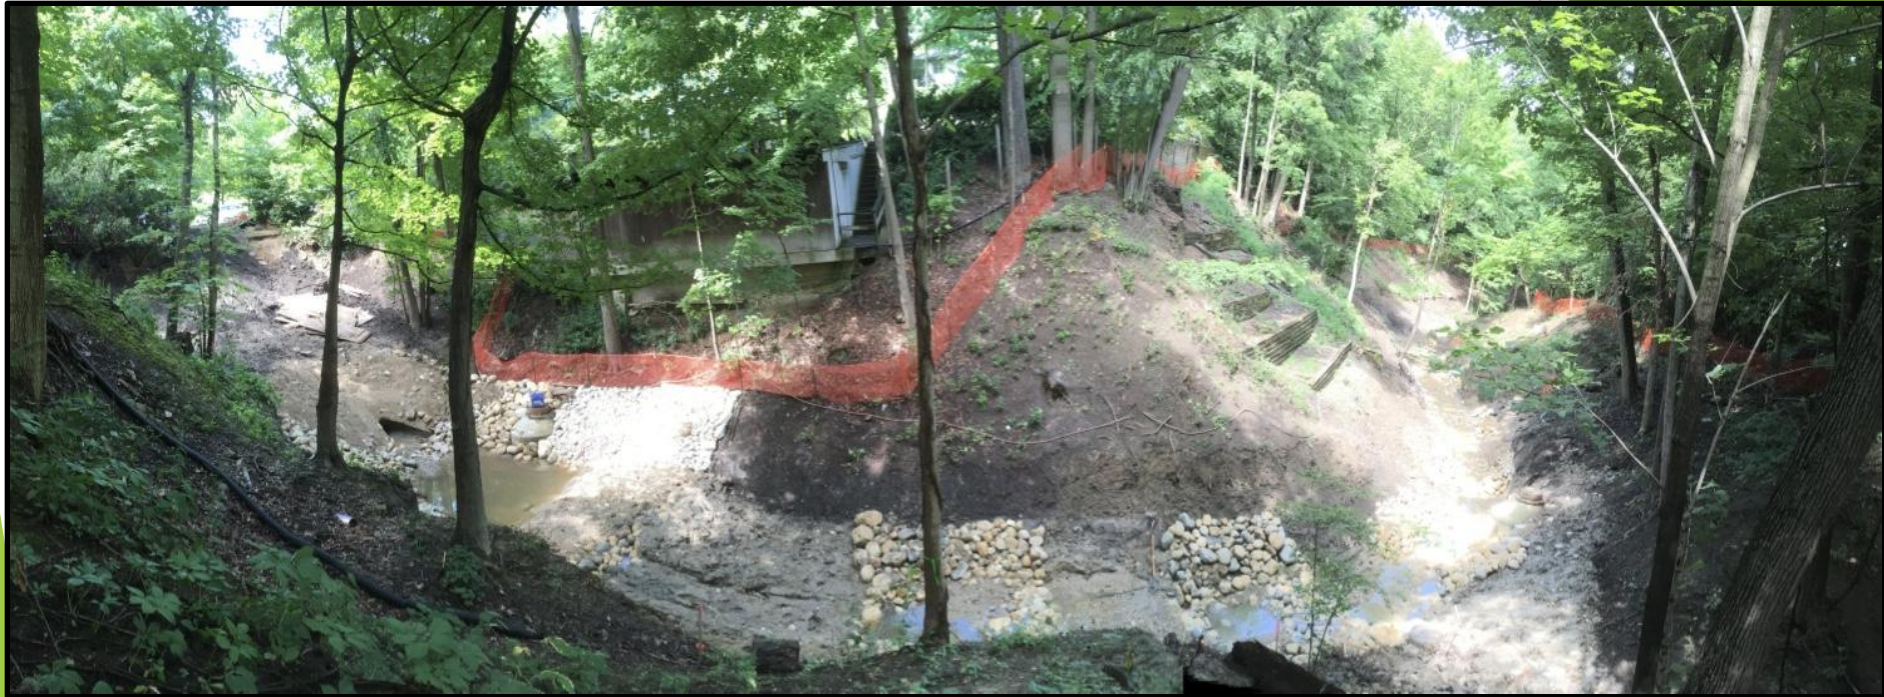
## Upstream Plunge/Step Pool-Riffles Under Construction, 2016 (Panoramic View)

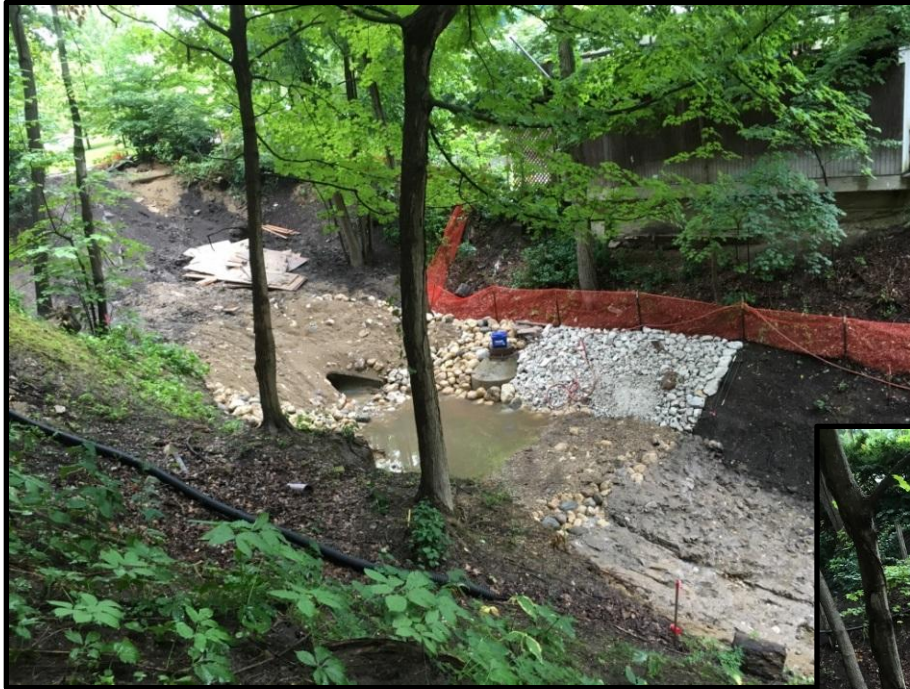
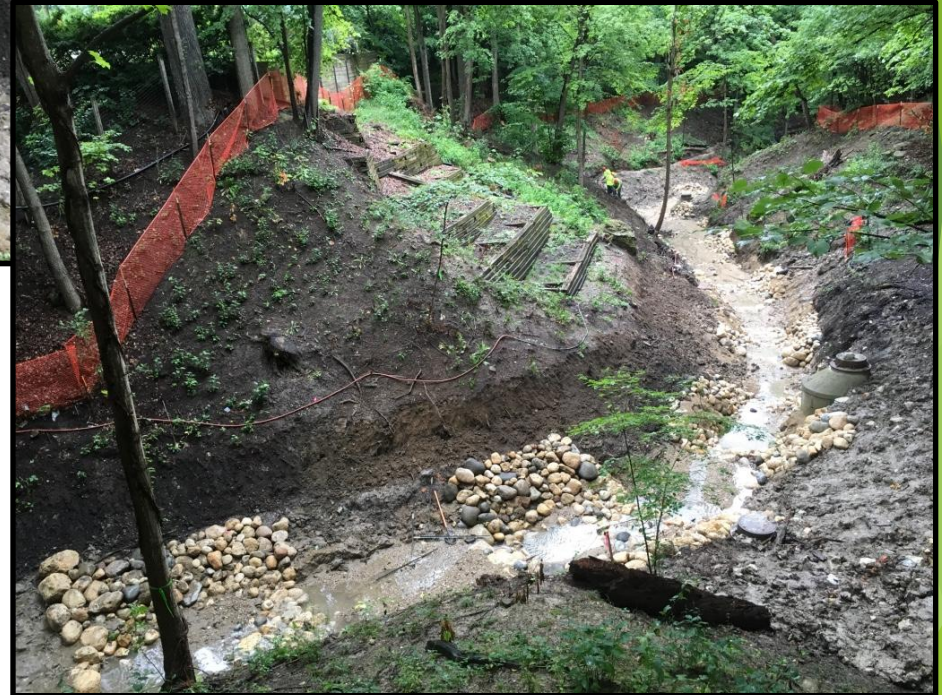
# Upstream Pools and Riffles Under-Construction

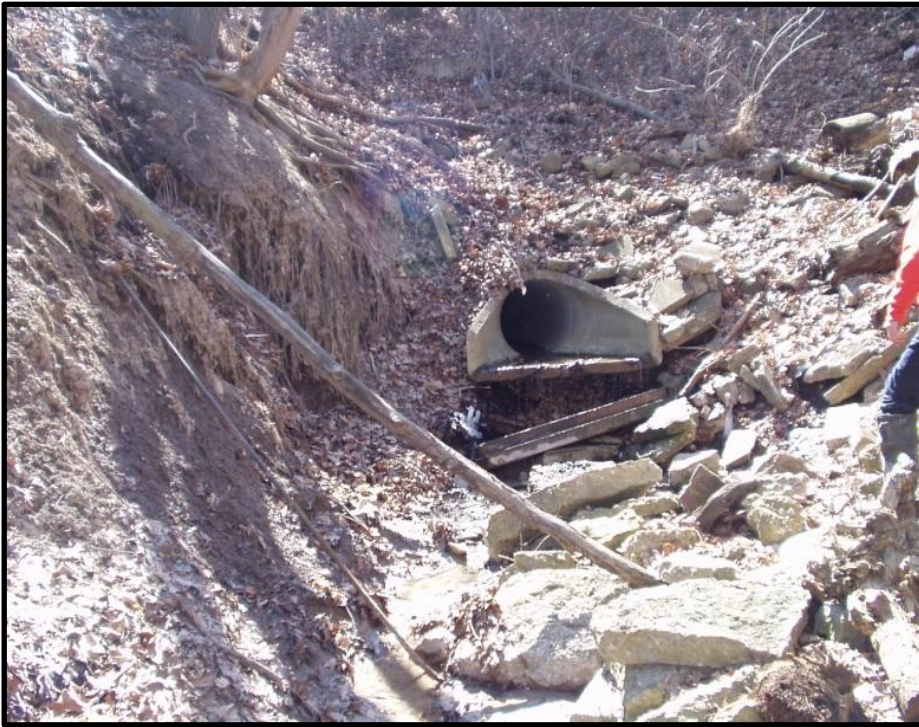
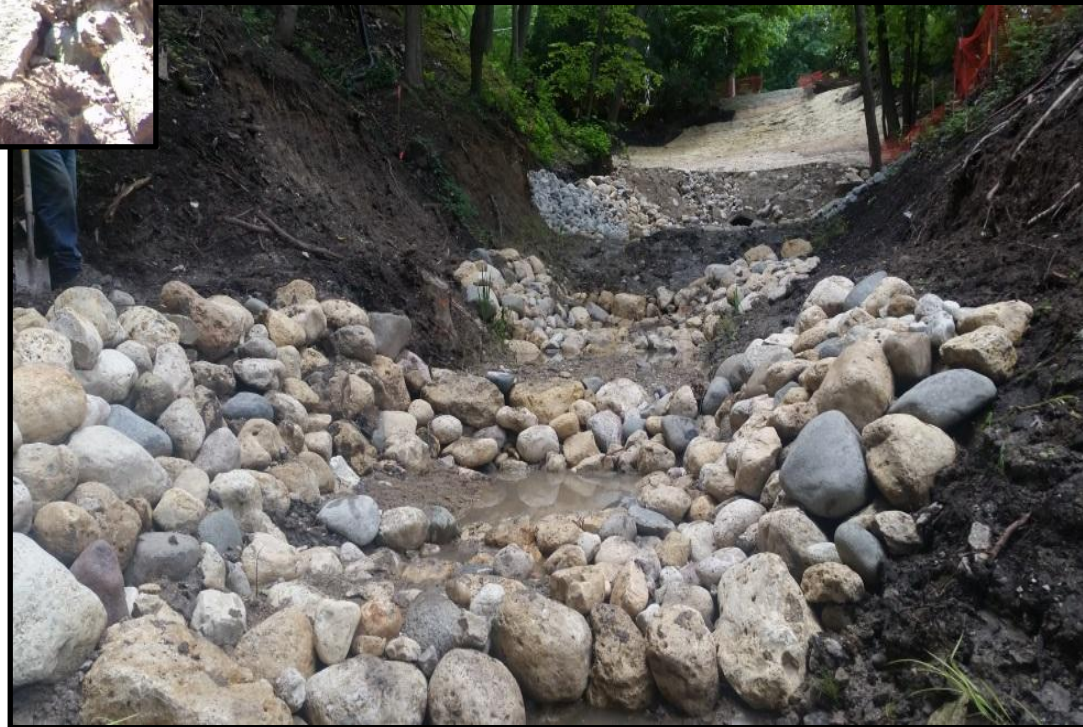
Lake Avenue Outfall  
(Before)

Restored Plunge Pool  
Outfall (After)

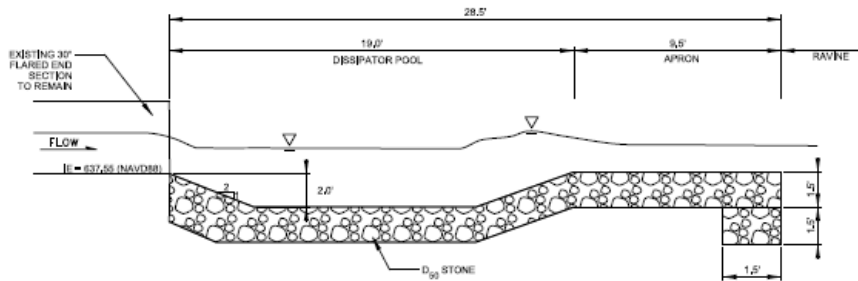
PLUNGE POOL AT RAVINE HEAD - SECTION DETAIL

1. BOULDERS TO BE USED FOR PLUNGE POOL SHOULD HAVE DIAMETERS BETWEEN 1 FT AND 2 FT.
2. A DECREASE OF 6" IN ELEVATION FROM THE TOP OF OUTSIDE BOULDERS TO THE MIDDLE BOULDERS IS REQUIRED.
3. END BOULDERS KEYED INTO RAVINE SLOPE TO FUNCTION AS RETENTION CUTOFF.

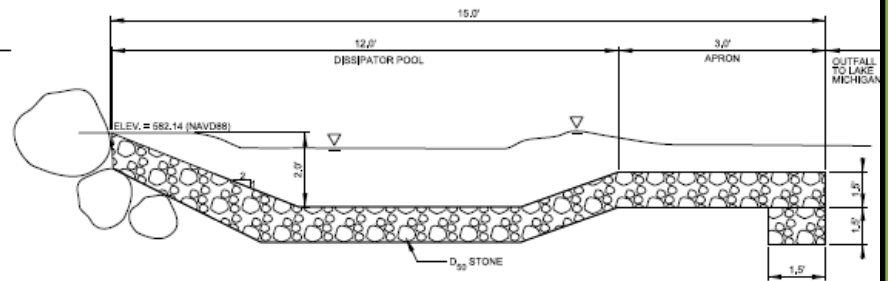
PLUNGE POOL AT RAVINE MOUTH - SECTION DETAIL

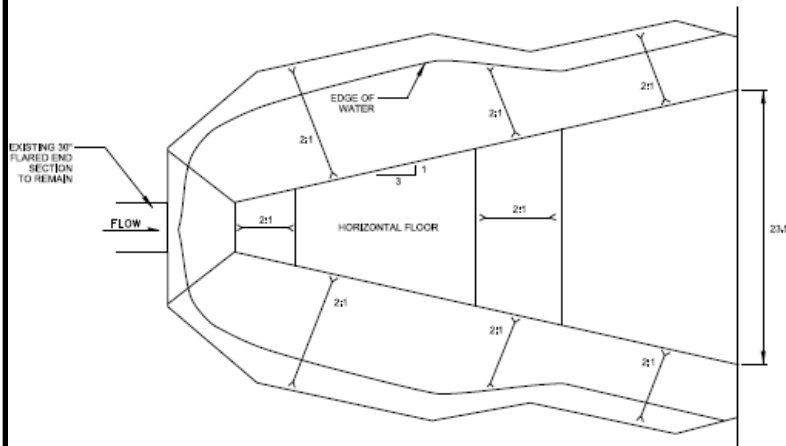
PLUNGE POOL AT RAVINE HEAD - PLAN VIEW

END BOULDERS KEYED INTO RAVINE SLOPE TO FUNCTION AS RETENTION CUTOFF.

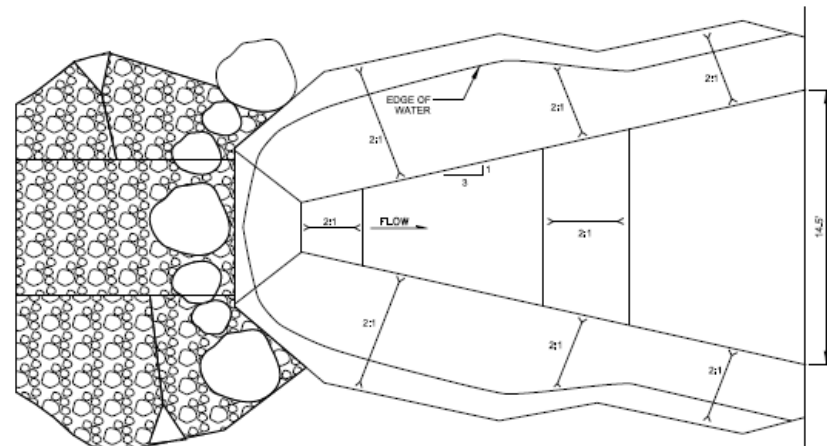
PLUNGE POOL AT RAVINE MOUTH - PLAN VIEW

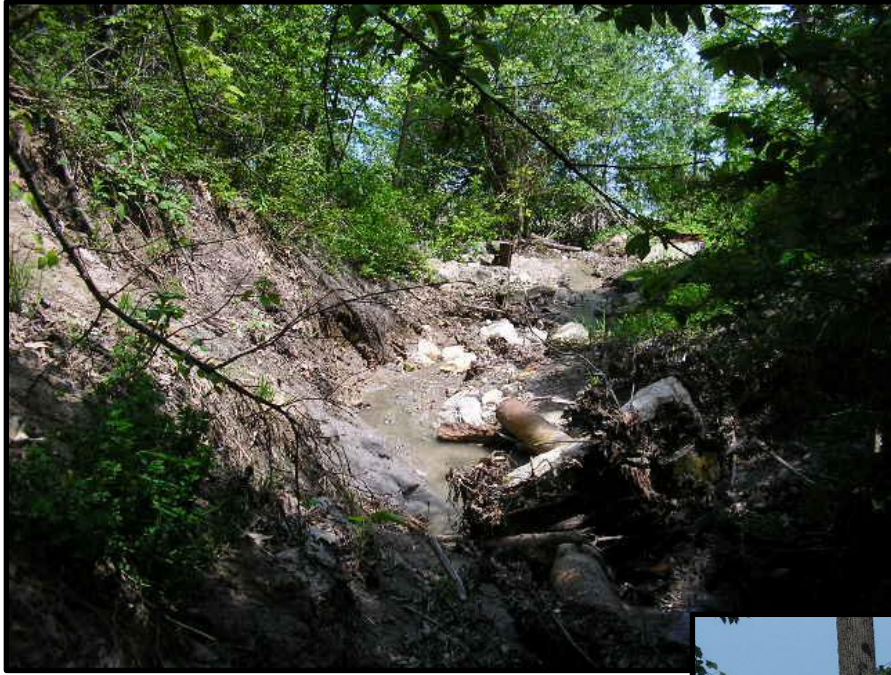
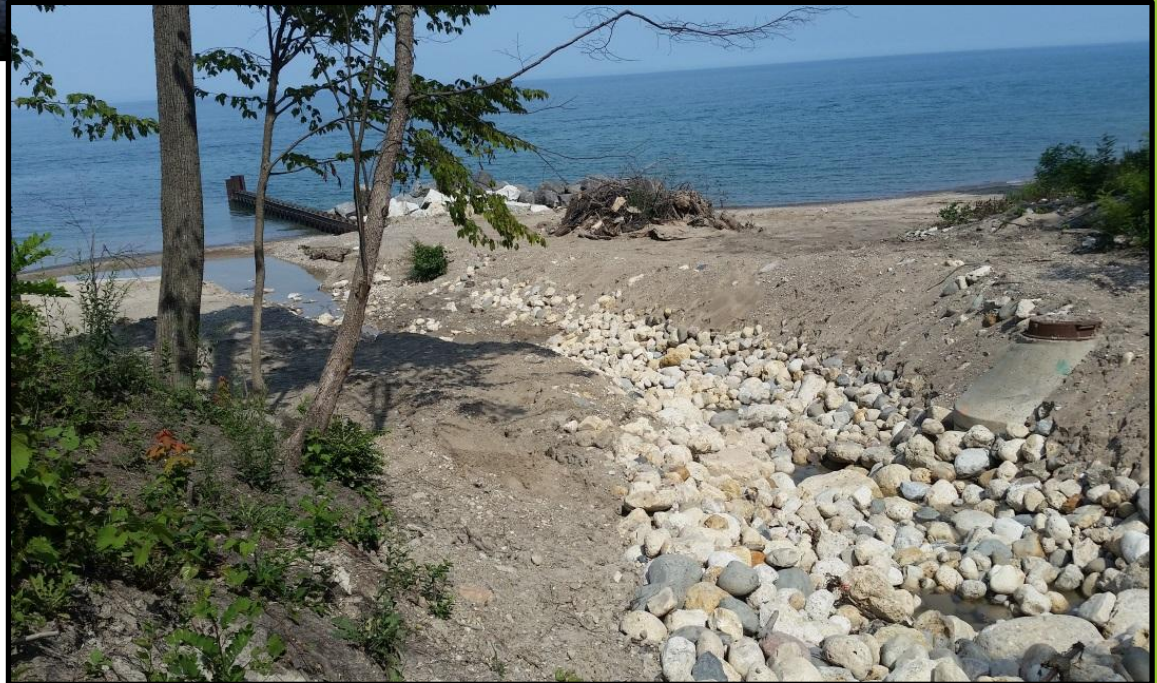
Collapsed 8 Toe  
(Before)

Armored Step-Up Pool/  
Ravine Toe (After)

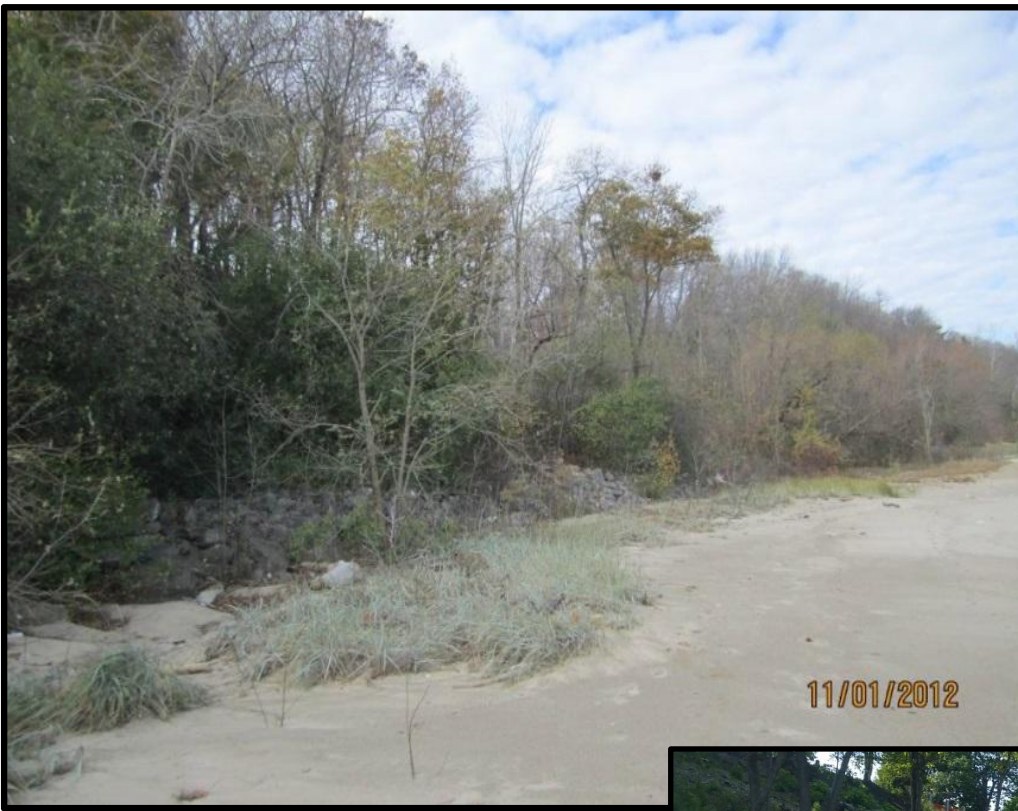
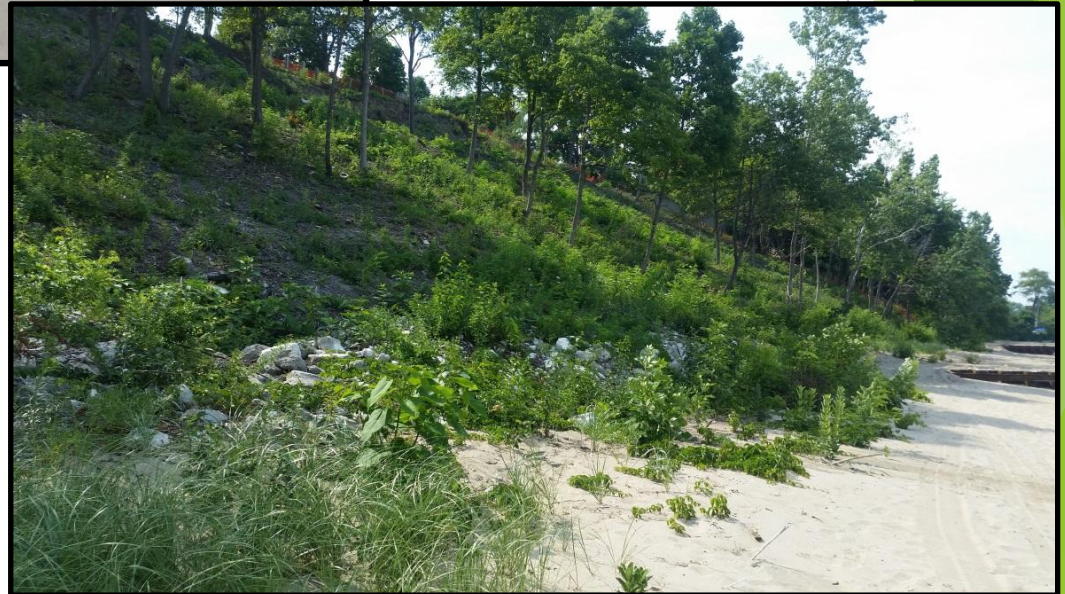
Ravine 8 North Bluff/  
Sand Dunes (Before)

Ravine 8  
Completed North  
Bluff/  
Sand Dunes (After)

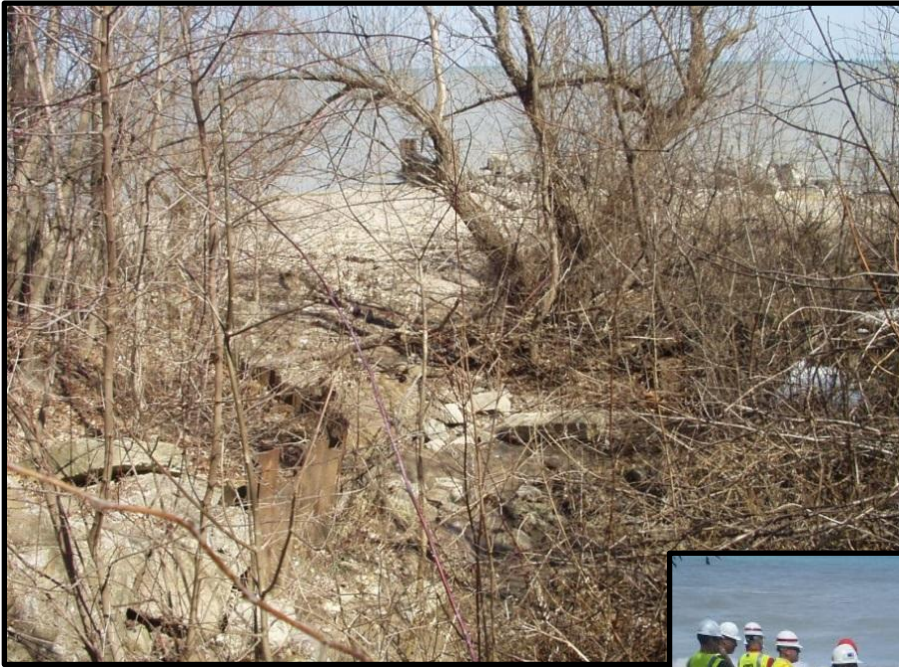
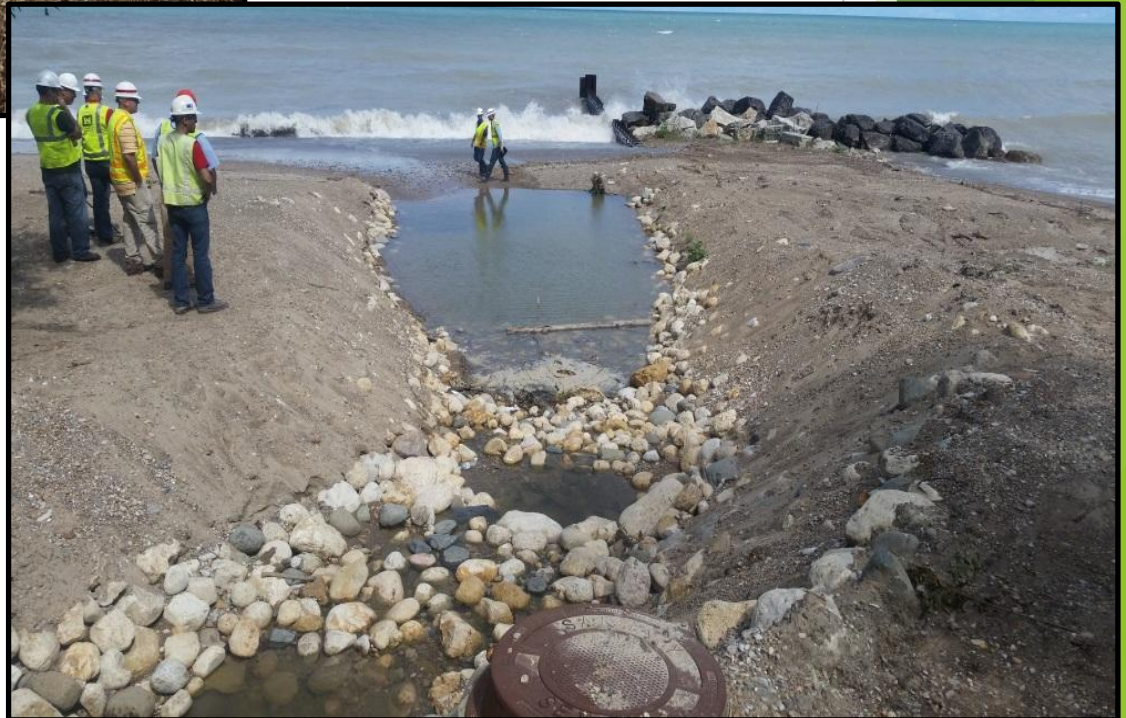
Ravine 8 Obstructed  
Shoreline Outfall  
(Before)

Ravine 8 - Opened  
Shoreline Plunge Pool  
(After)
