Las Cruces Guatemala Post-Flood Analysis and Mitigation: Part 2

Jeff Macke EIT CFM Water Resources Engineer Patrick Engineering Inc in association with Engineers Without Borders USA Chicagoland Professional Chapter

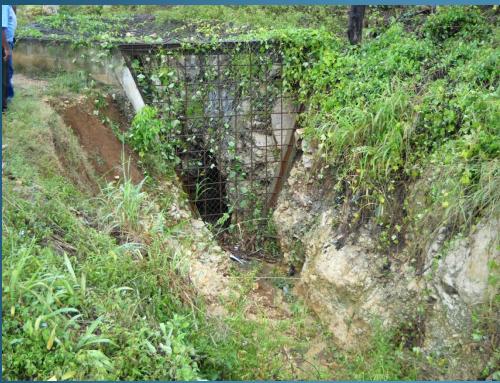
El Tragante

- Karst cavern
- Only known outlet

- 24" equivalent diameter
- Also waste outlet

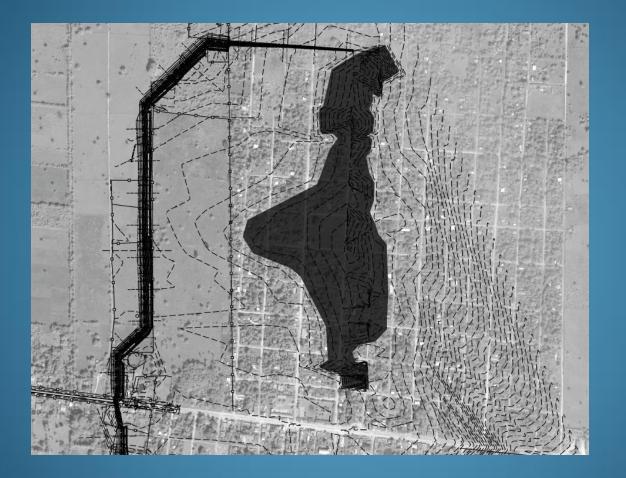
Inundation – Post-Construction

Post-Construction Flood Limits – 2010 Storm
