Harrison Park Detention Pond Failure – Lessons Learned

2022 IAFSM Conference – March 8, 2022

Harrison Park Detention Pond Failure

June 19, 2009

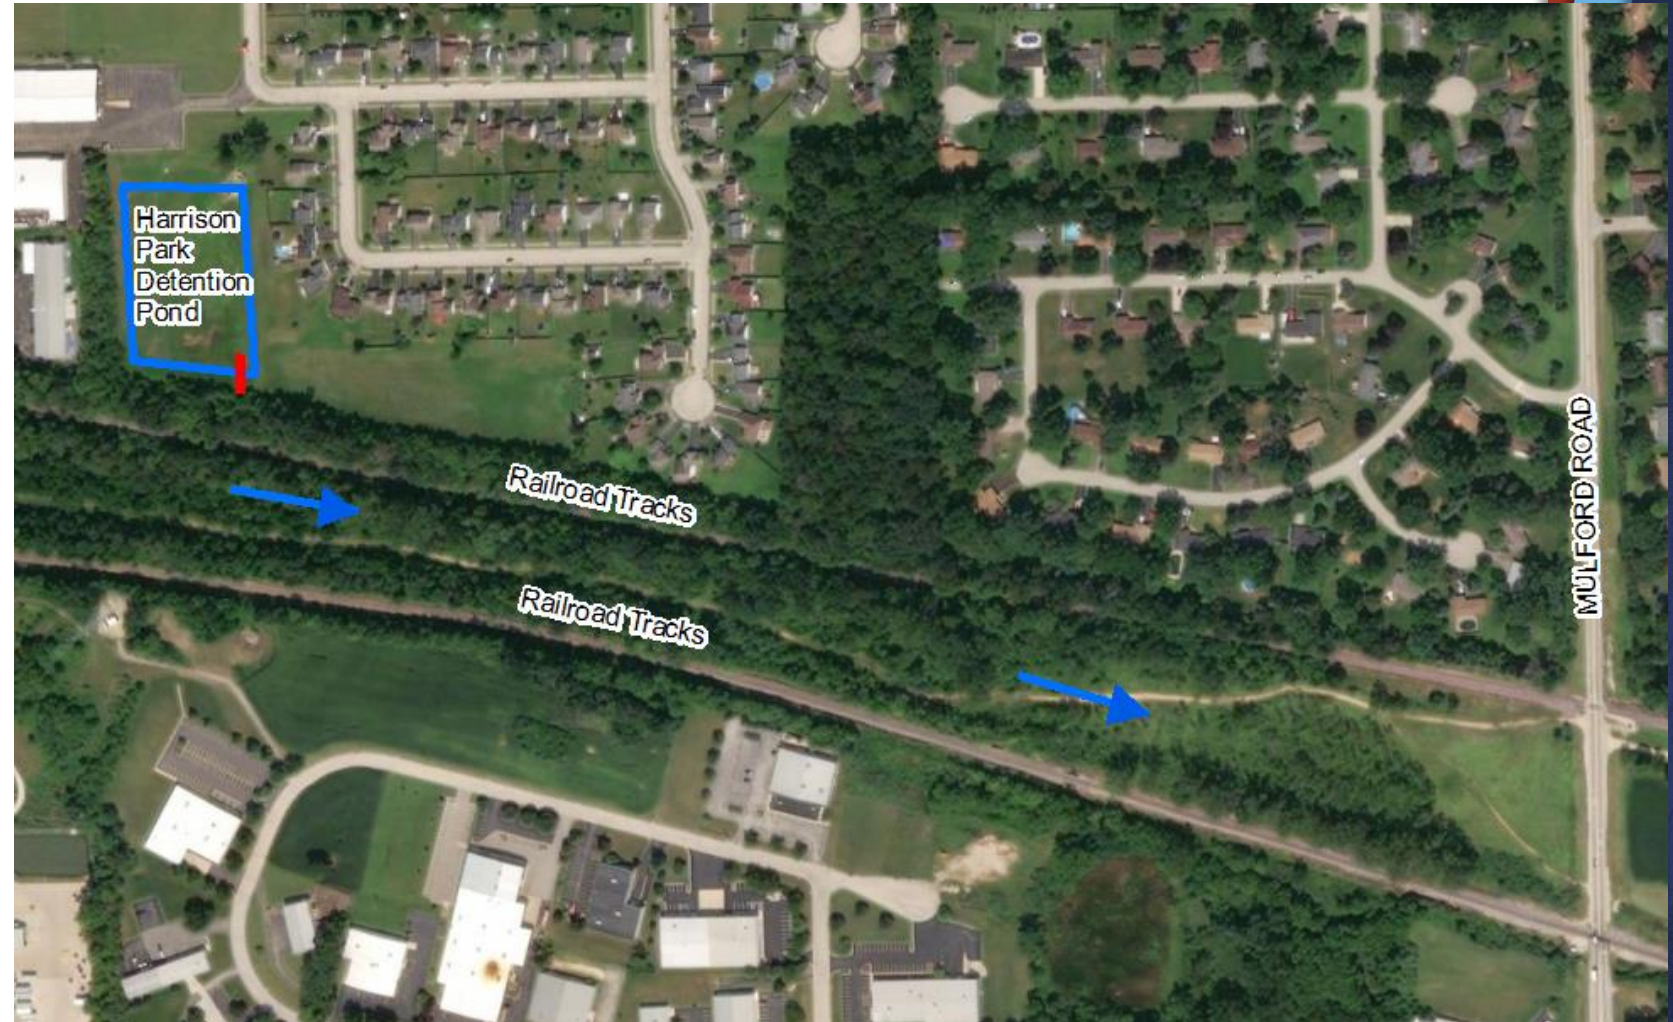
Harrison Park Detention Pond

- Plans dated June 1997.
- 458-ft x 306-ft.
- 11.5 feet tall.
- Dry bottom detention.
- Reported 100-year design capacity.
- Primary outlet is 27-inch RCP.
- 40-foot wide emergency spillway with rock protection.
- Hazard Classification?

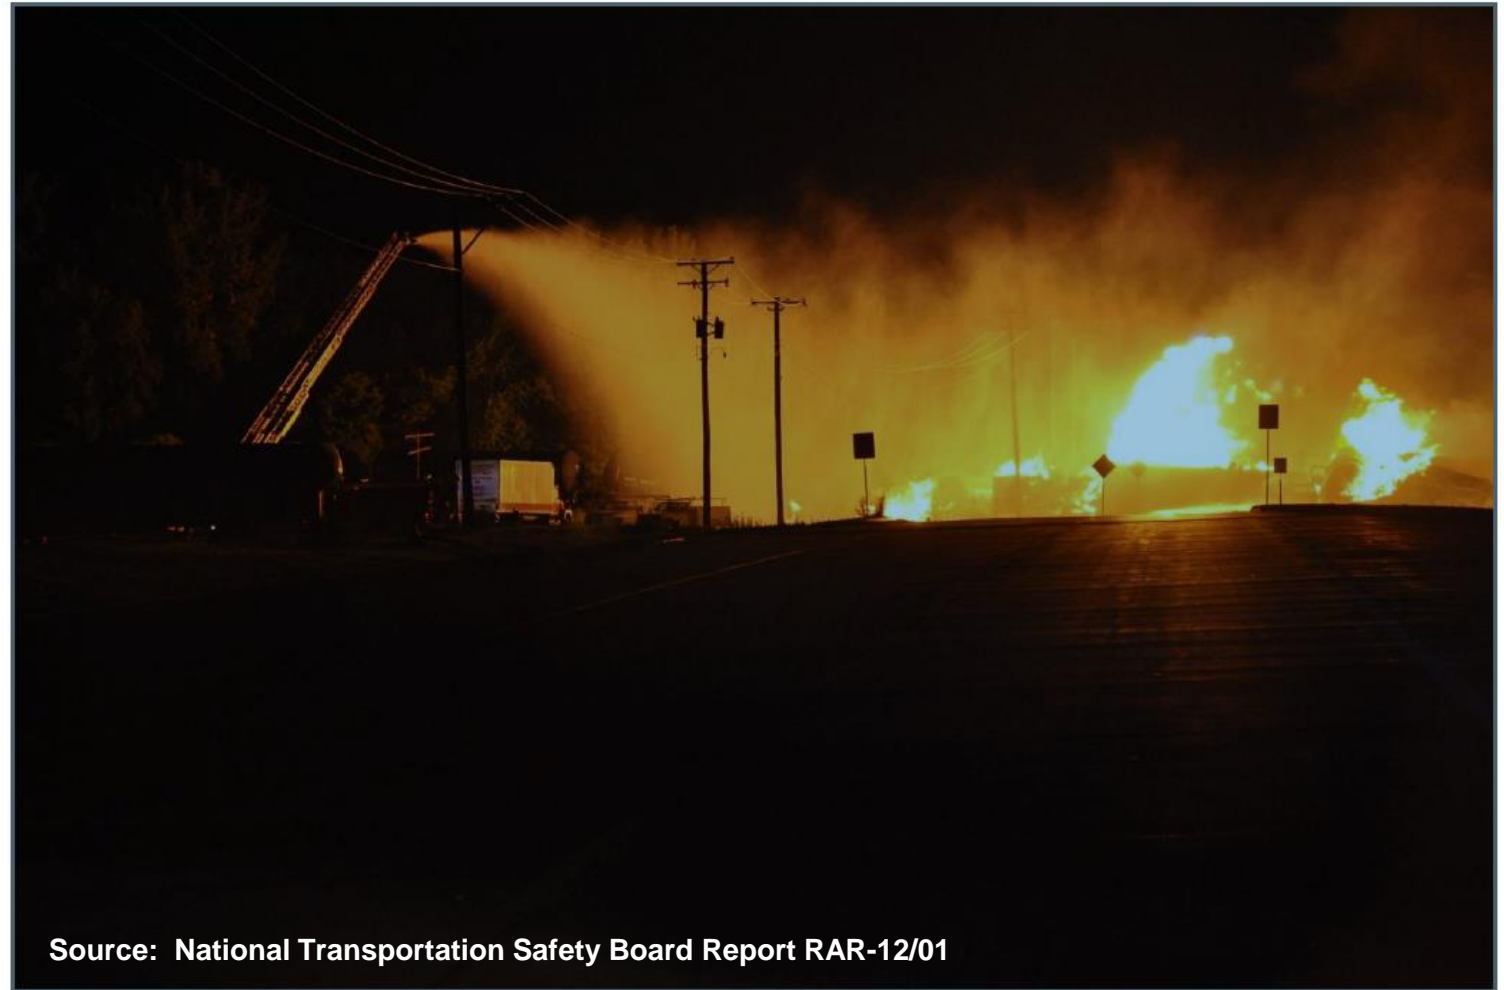
Figure 4. Looking north along Mulford Road toward burning tank cars at crossing.

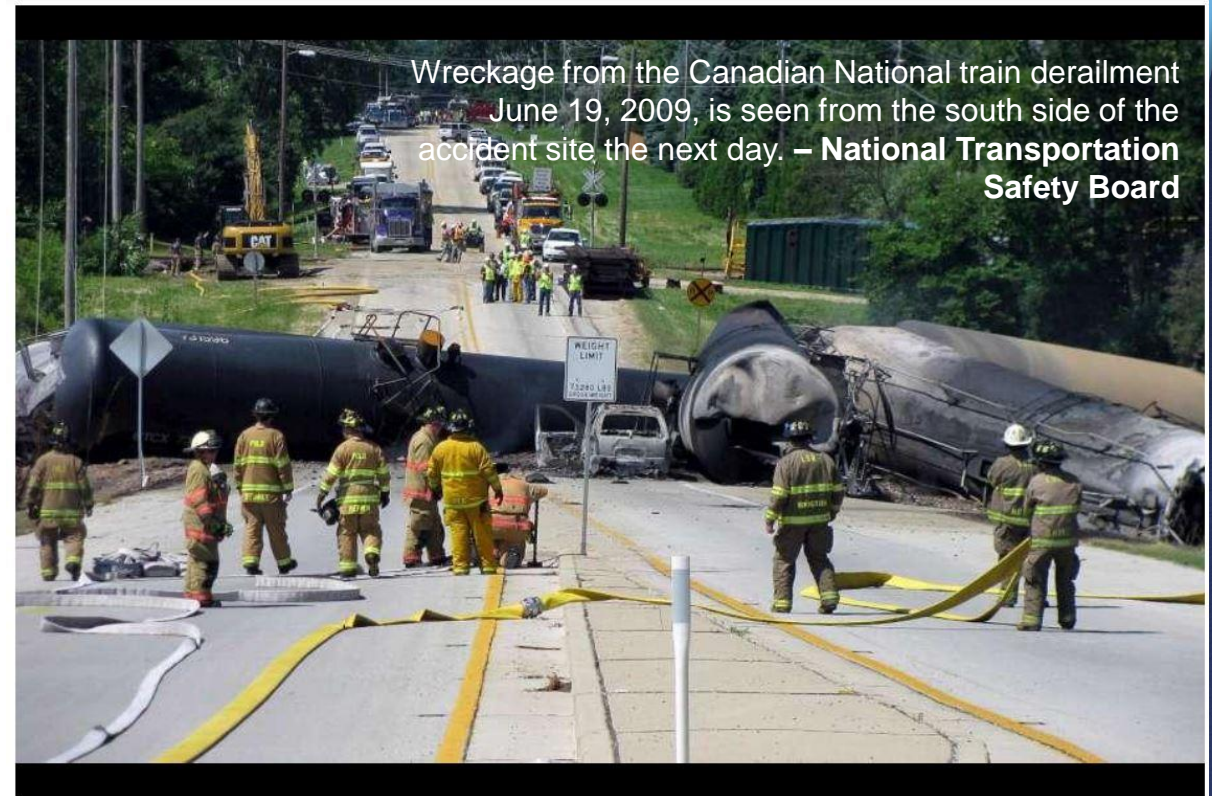
Wreckage from the Canadian National train derailment June 19, 2009, is seen from the south side of the accident site the next day. – National Transportation Safety Board

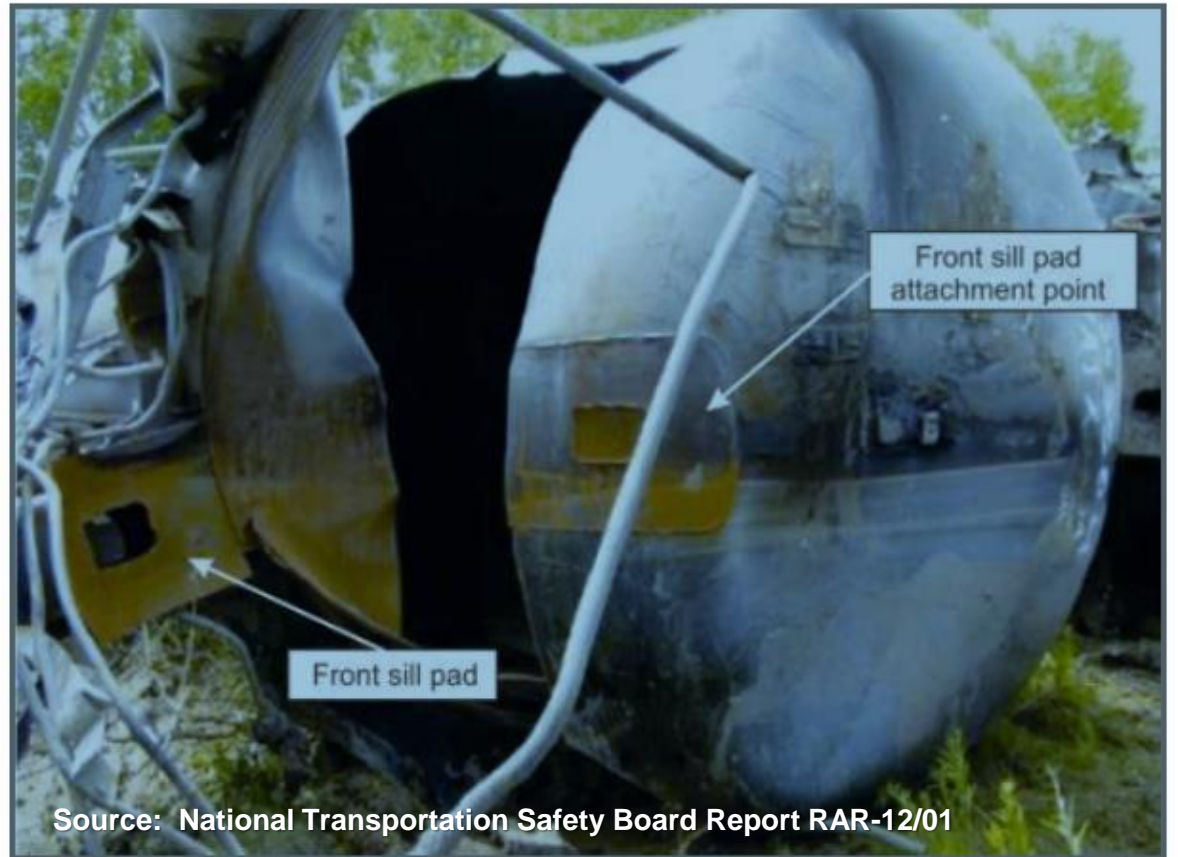
Figure 20. B end of car NATX 303504.

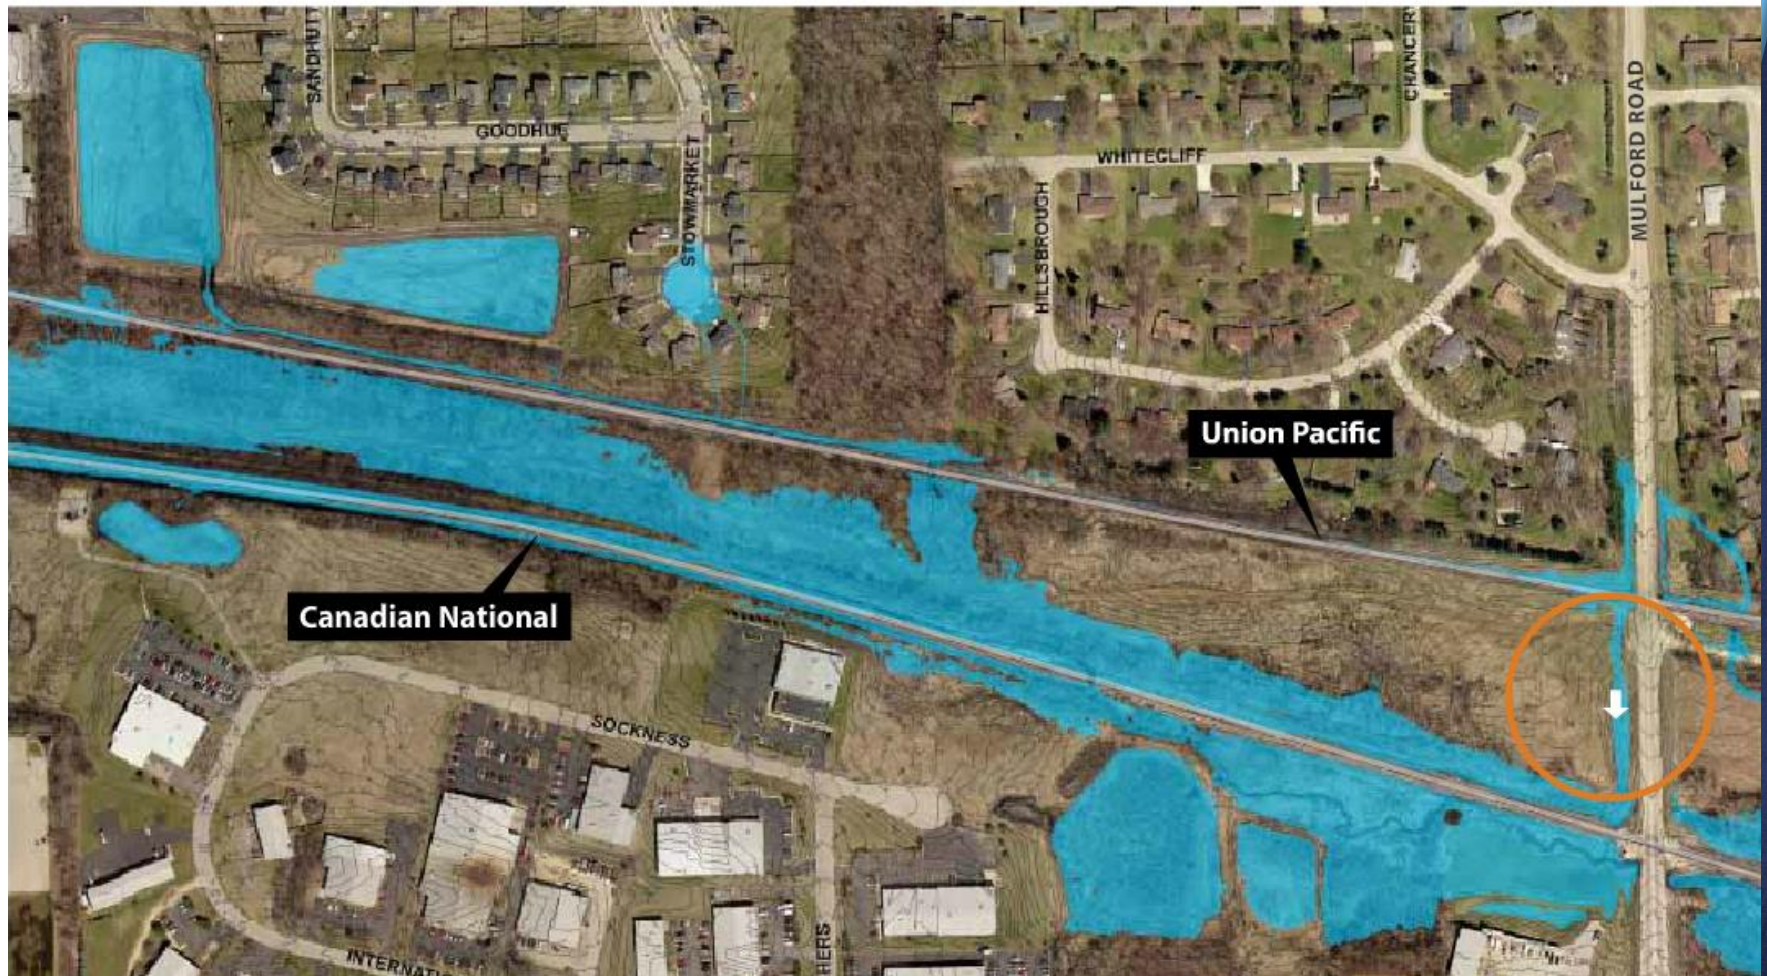
7:01 p.m. Water flow increases along the west side of South Mulford and heads south toward tracks used by Canadian National Railroad.

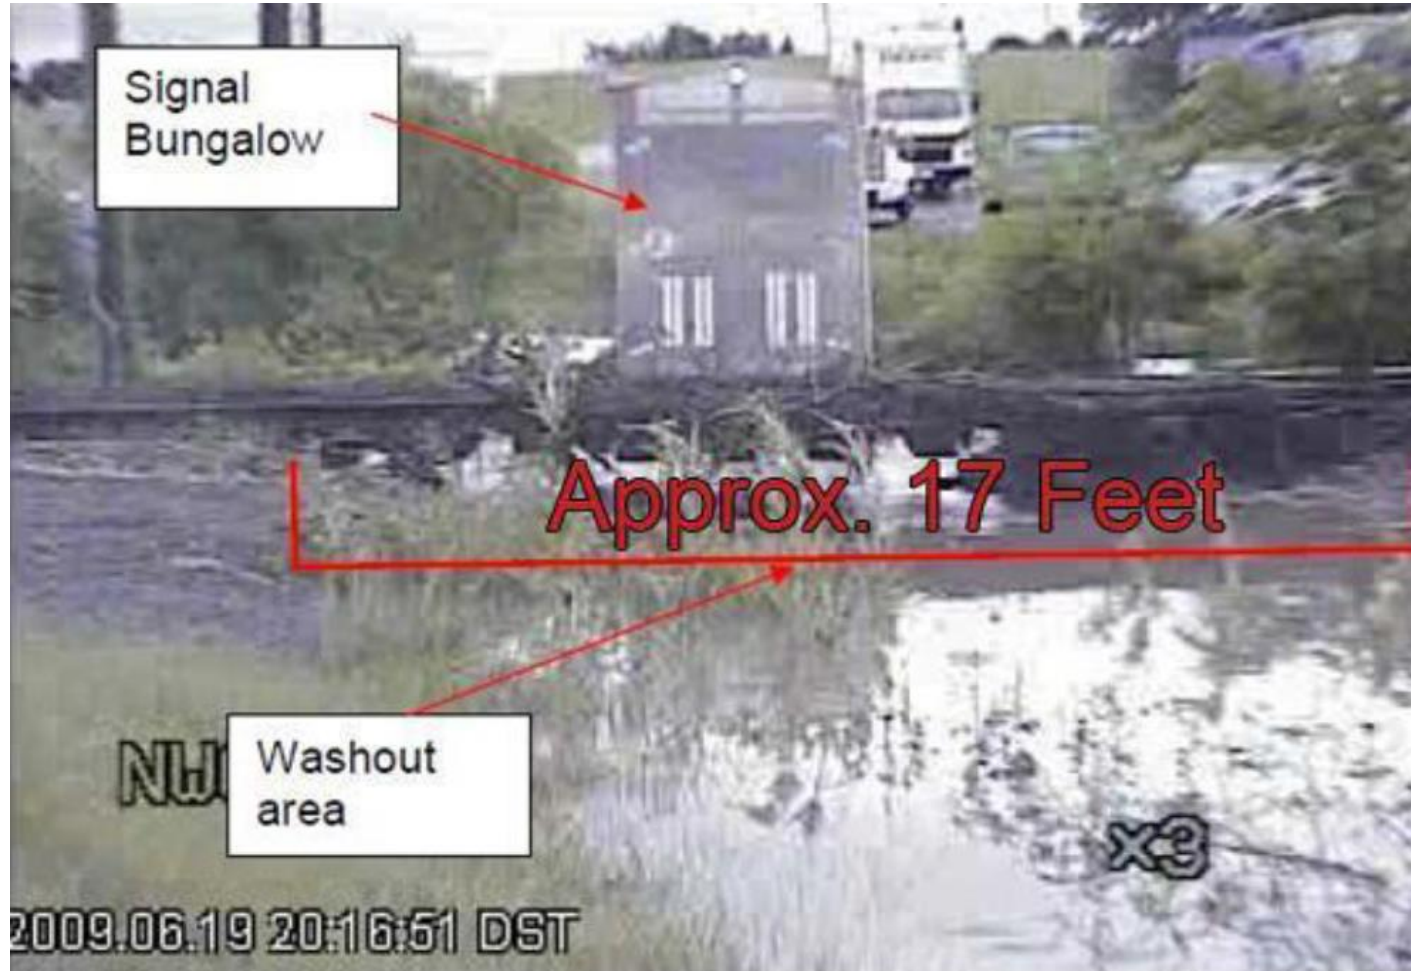
Figure 2. A still image produce from deputy sheriff's dashboard video recorder looking from a point on west berm of Mulford Road facing south.
