Conducting BMP Inspections During the Pandemic

Saya Hickey, PE, Jacob Cantor, PE, Madison Gleason, EI

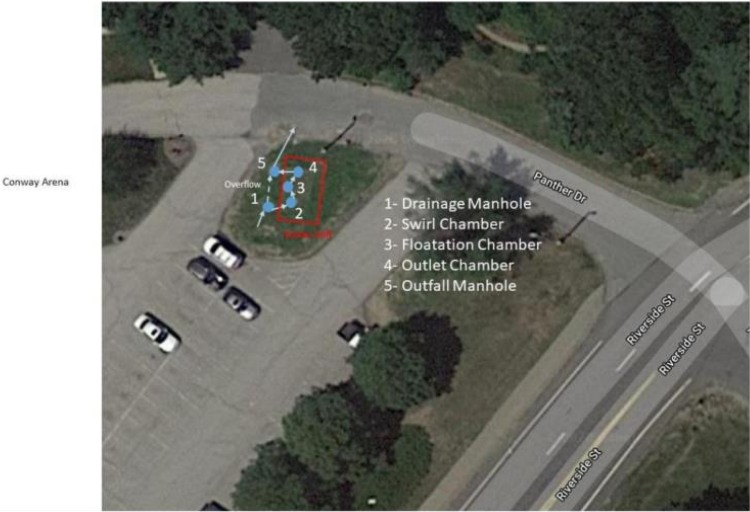
C. BMP Diagram

Trash, debris and sediment was found inside the swirl chamber, floatables chamber and outlet chamber. It is recommended to removal these materials.
