Illinois Floodplain and Stormwater Managers Association  
2009

## Improving Illinois Dams: Alpine Dam Rehabilitation Project

Michael A. Hrzic  
HNTB FSC  
Chicago, IL

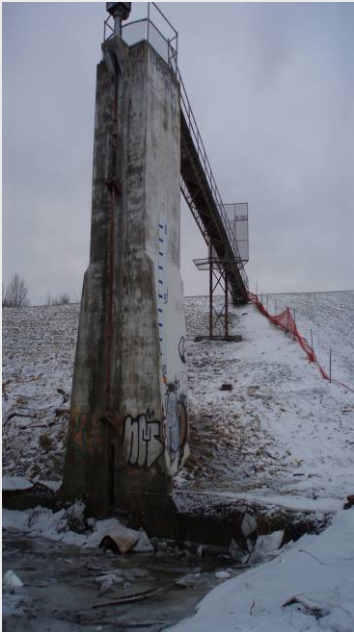
## ALPINE DAM: BACKGROUND

## Built in 1942

**Length - 600 ft**  
**Width -48 ft**

**Storage Capacity**  
**2100 acre-ft**

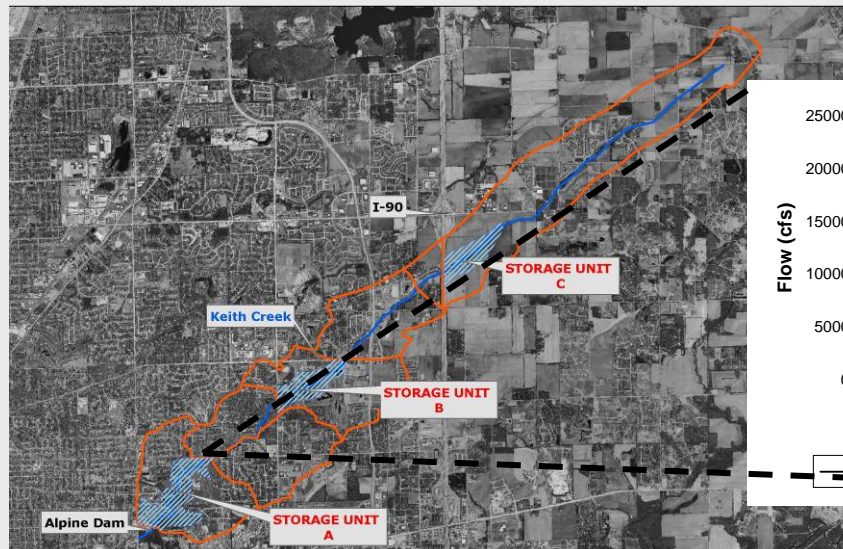
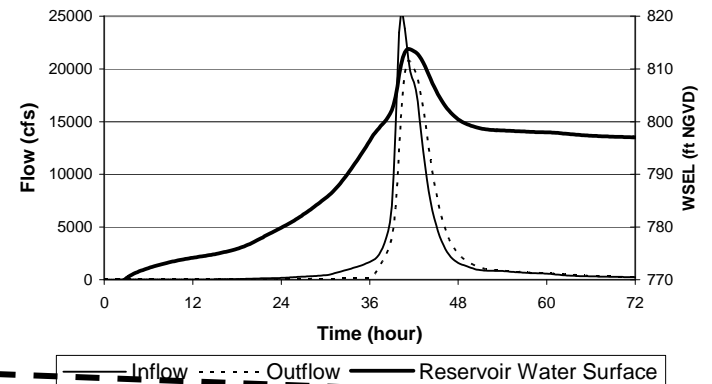
# ALPINE DAM: PMF DETERMINATION

## Method of Analysis

### 1. Probable Maximum Storm

- i. Hydrometeorologic Report 51 (NOAA 1975)
- ii. HEC HMR 52

### 2. Probable Maximum Flood

- i. HEC HMS

100-Year  
2,200 cfs

0.6 PMF  
13,100 cfs

PMF  
25,300 cfs

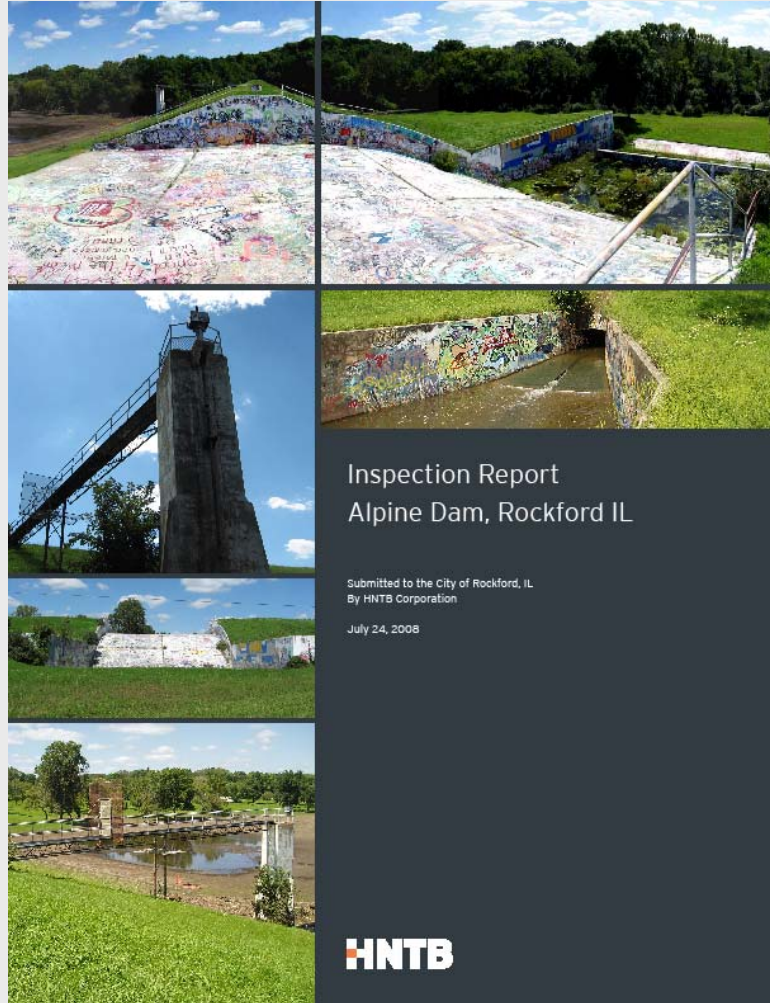
Inspection Report  
Alpine Dam, Rockford IL

**Current Capacity**  
0.8 PMF

**Spillway**  
Unacceptable

**Low Flow Intake**  
Minimally Acceptable

**Monitoring Capability**  
None

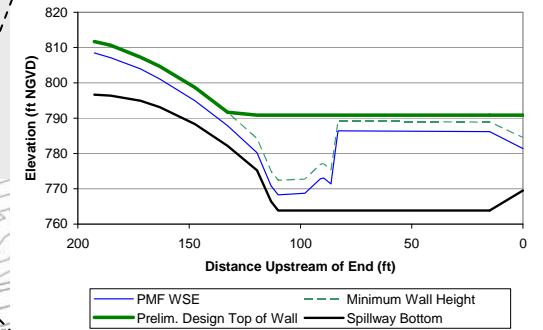
# ALPINE DAM: DESIGN

1. PLAN TAKEN FROM 1940 CONSTRUCTION DRAWINGS AND SURVEY PERFORMED 2/08
2. CONTOUR ELEVATIONS AS SHOWN ARE NGVD DATUM. TO CONVERT TO CONVERT ELEVATIONS TO ROCKFORD DATUM SUBTRACT 603.66 FEET.
3. CONTOURS SHOWN ARE IN 2' INCREMENTS AND GENERATED FROM SURVEY PERFORMED 2/08
4. ACCESS BRIDGE TO INTAKE TOWER NOT SHOWN FOR CLARITY
5. CENTERLINE OF BEAM IS APPROXIMATE AND TAKEN FROM 1940 CONSTRUCTION DRAWINGS
