Camp Creek: Tackling Erosion and Improving Water Quality in a Recreational Playground Mitchellville, Iowa

Rachel Conrad, PE, CFM

IAFSM March 10th, 2016

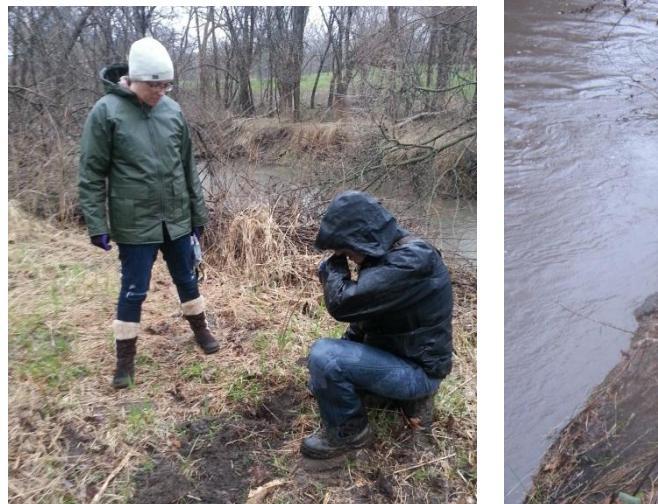
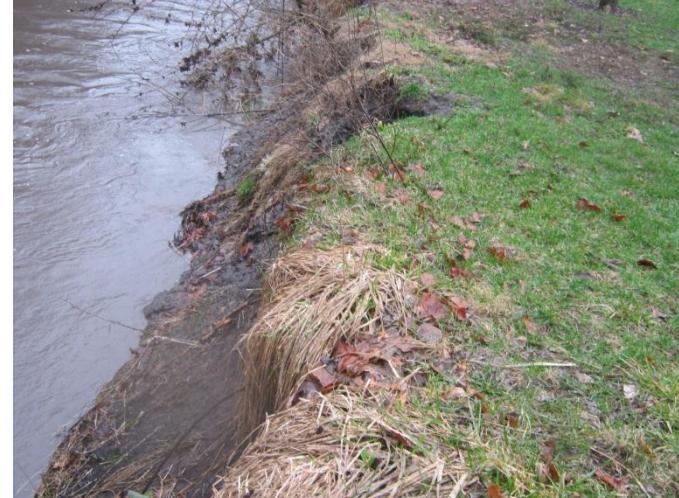
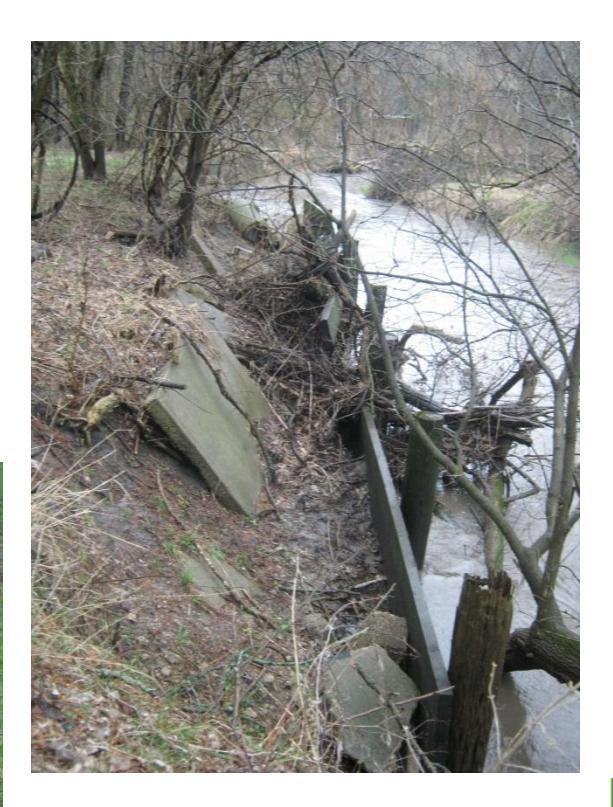
Creek Assessment – April 2013

- Creek bed seemed stable due to NRCS designed riffle structures
- Previous efforts to stabilize banks not working
- Bank erosion throughout park

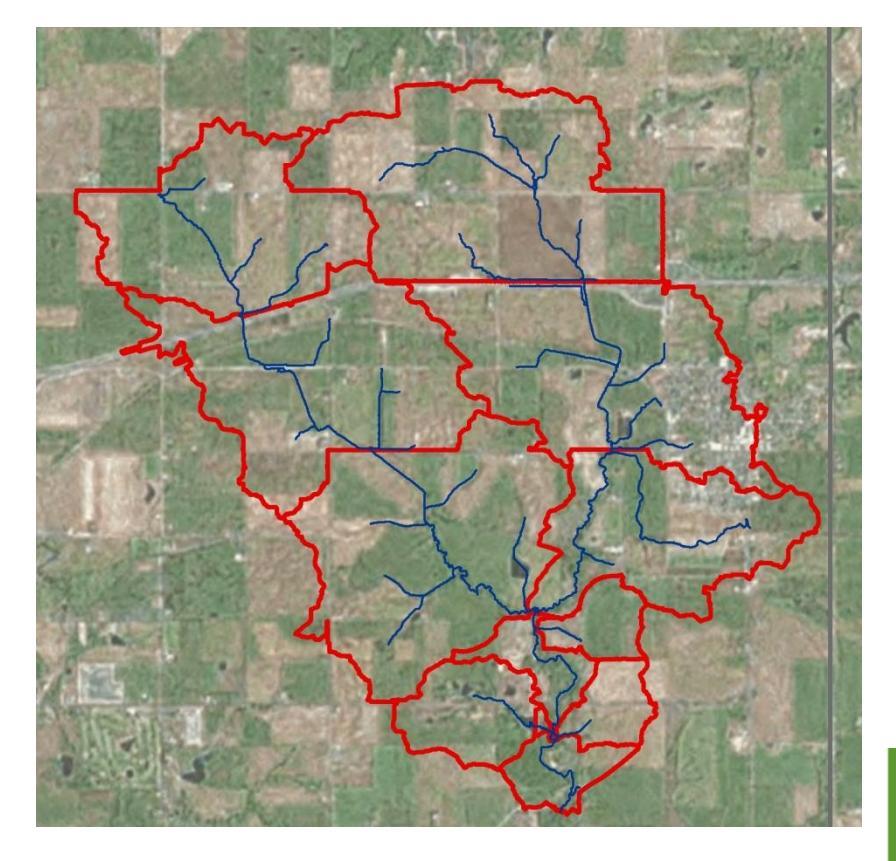
Hydrology

- A HEC-HMS model was created using HEC-GeoHMS
- 2-, 5-, 10-, 25-, 50-, and 100-year peak flows were determined
- Checked flows against StreamStats –much lower
- County staff were consulted
- Higher HEC-HMS flows used as they more closely matched staff accounts of HWLs

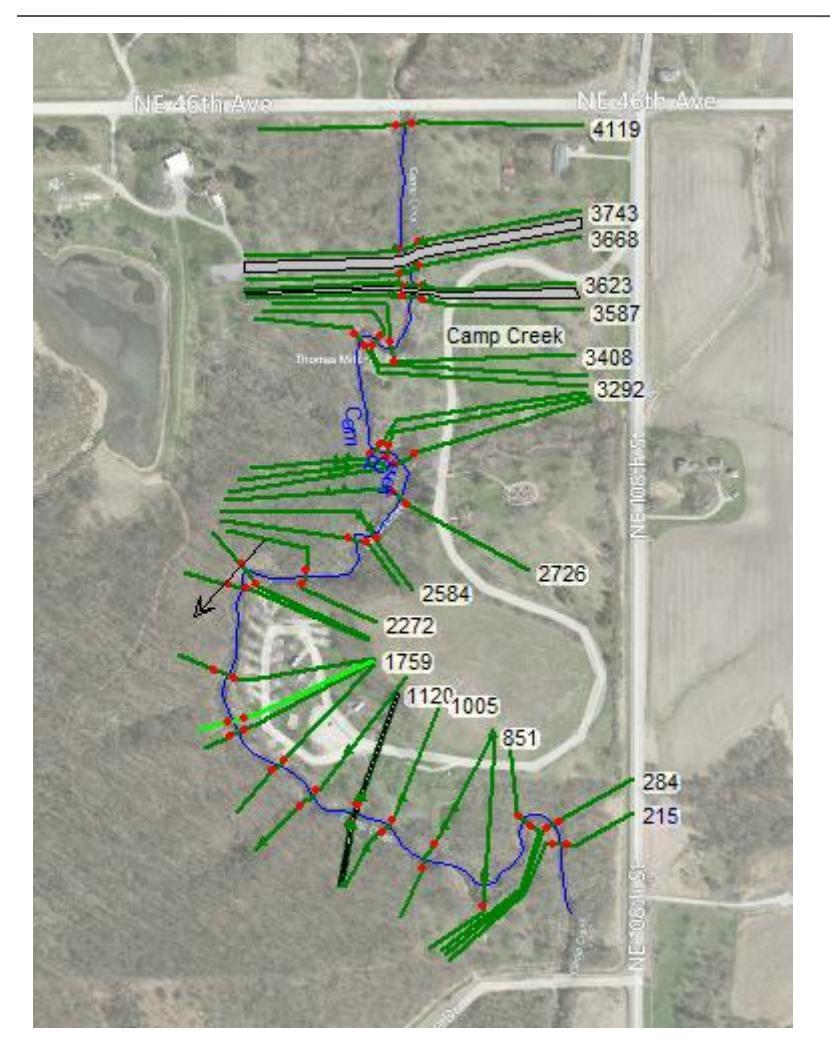
Hydraulics

- HEC-RAS model covered reach from NE 46th Ave to almost NE Devotie Dr
- Two peak flows U/S and D/S of pond tributary
- Existing and multiple proposed conditions modeled to determine created head of crossing options

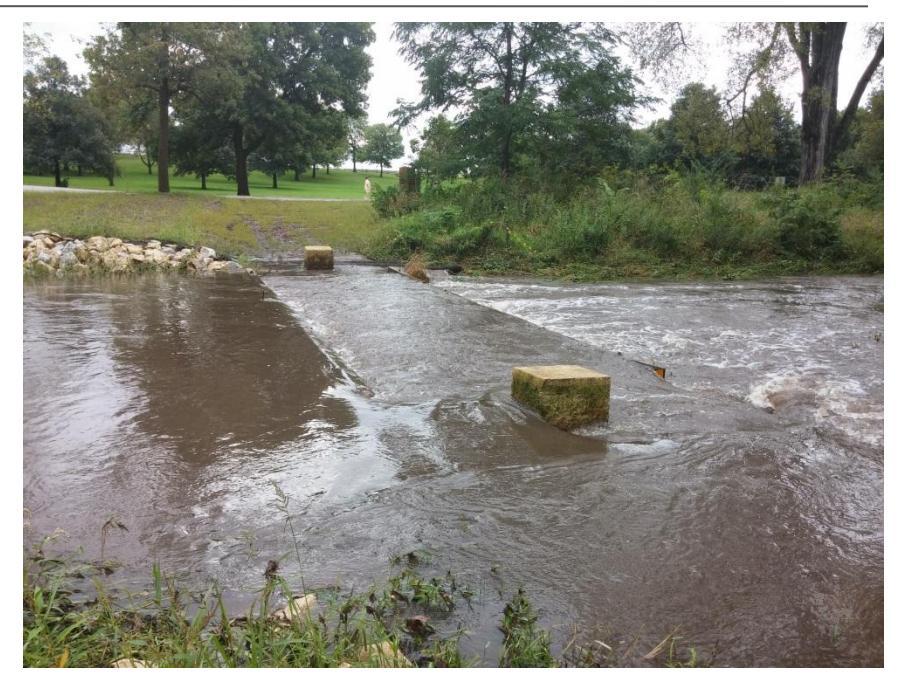
Results

- Existing Creek crossing floods in very small storms (~100 cfs)
- 100-year water surface elevations showed flooding of much of the park, confirmed by County Staff
- Large bridge needed to pass the 100-year storm without significant backwater effects
- High shear stresses and velocities in various locations

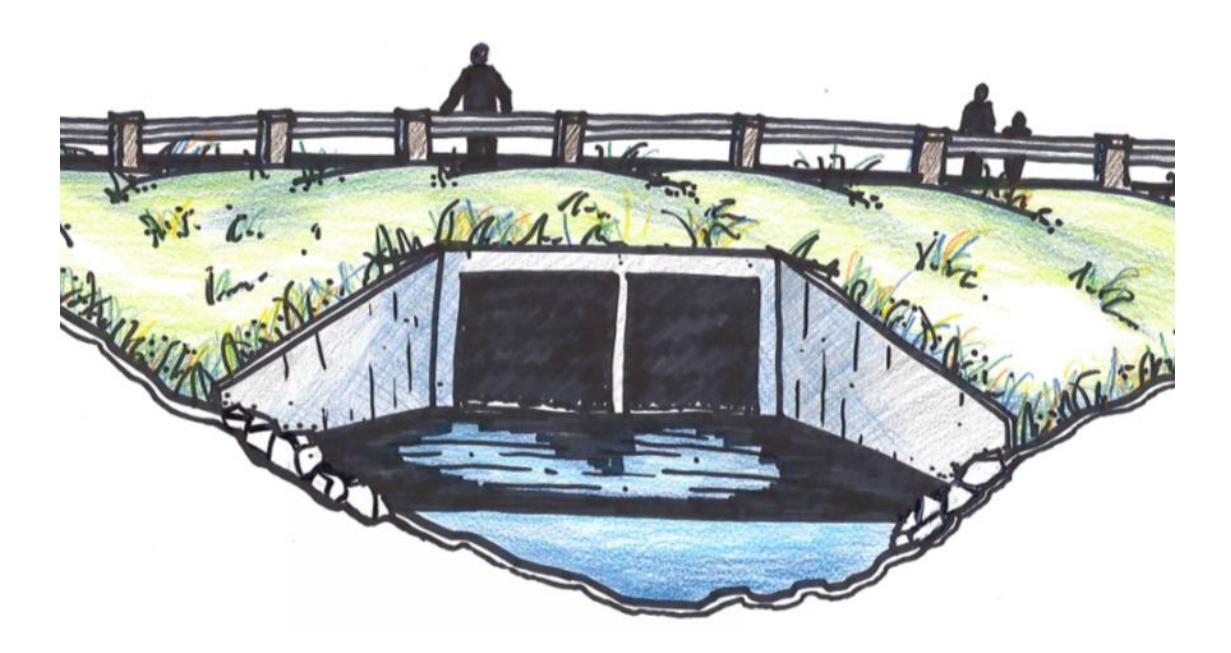
Creek Crossing Recommendation

- Twin 12'x7' RCB
- Carries roughly 2-year storm
- Doesn't cause backwater effects for large storms
- 40-ton load capacity

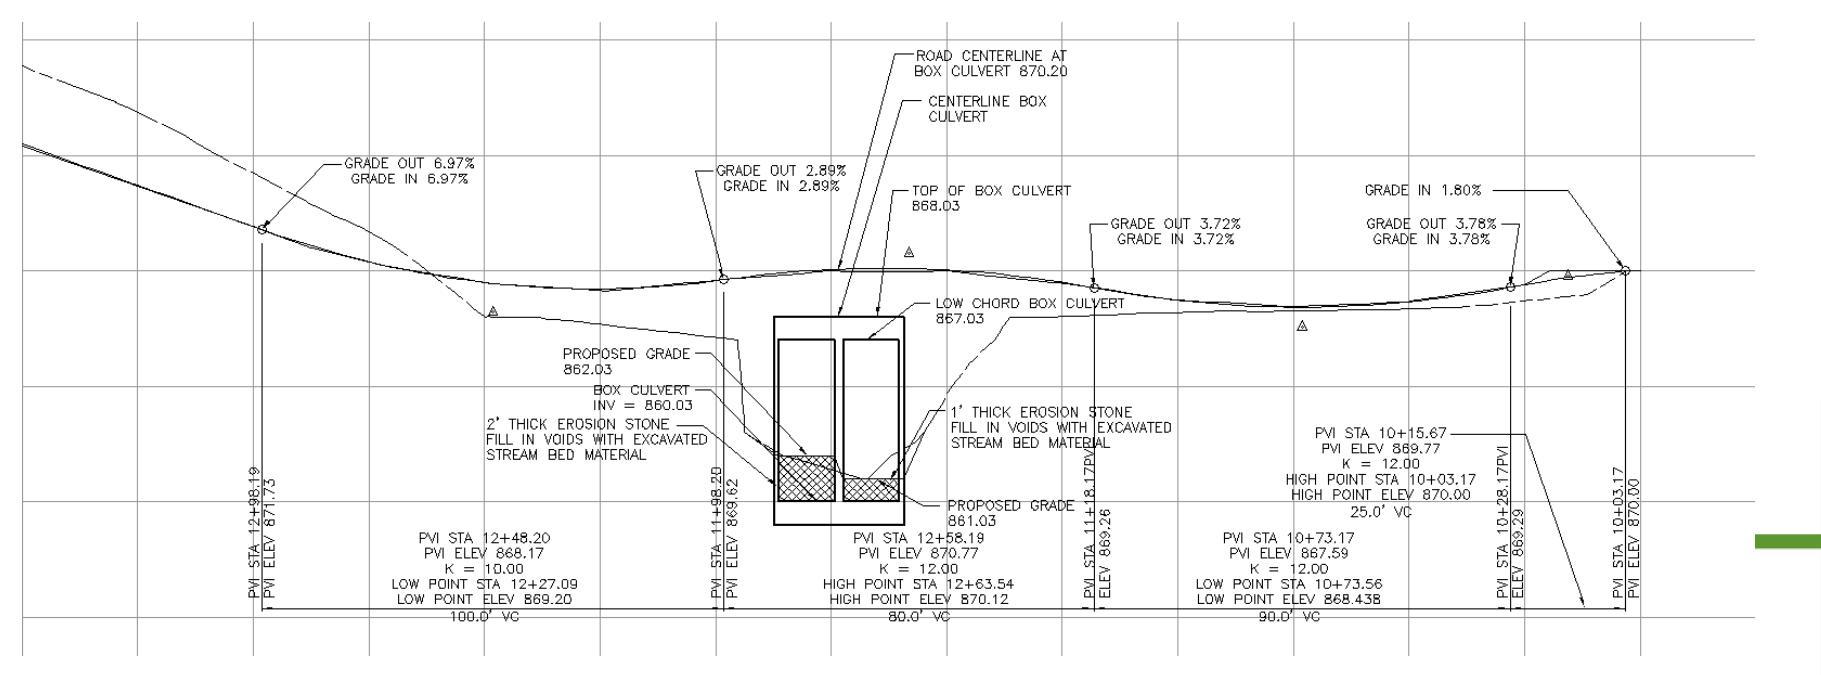
Creek Crossing Recommendation Cont.

- Mitigate impacts of road overtopping using:
 - Low points in road on either side of culvert
 - Inverted curb at downstream end of road
 - TRM within flooding limits
- Recess RCB into creek bottom for fish passage

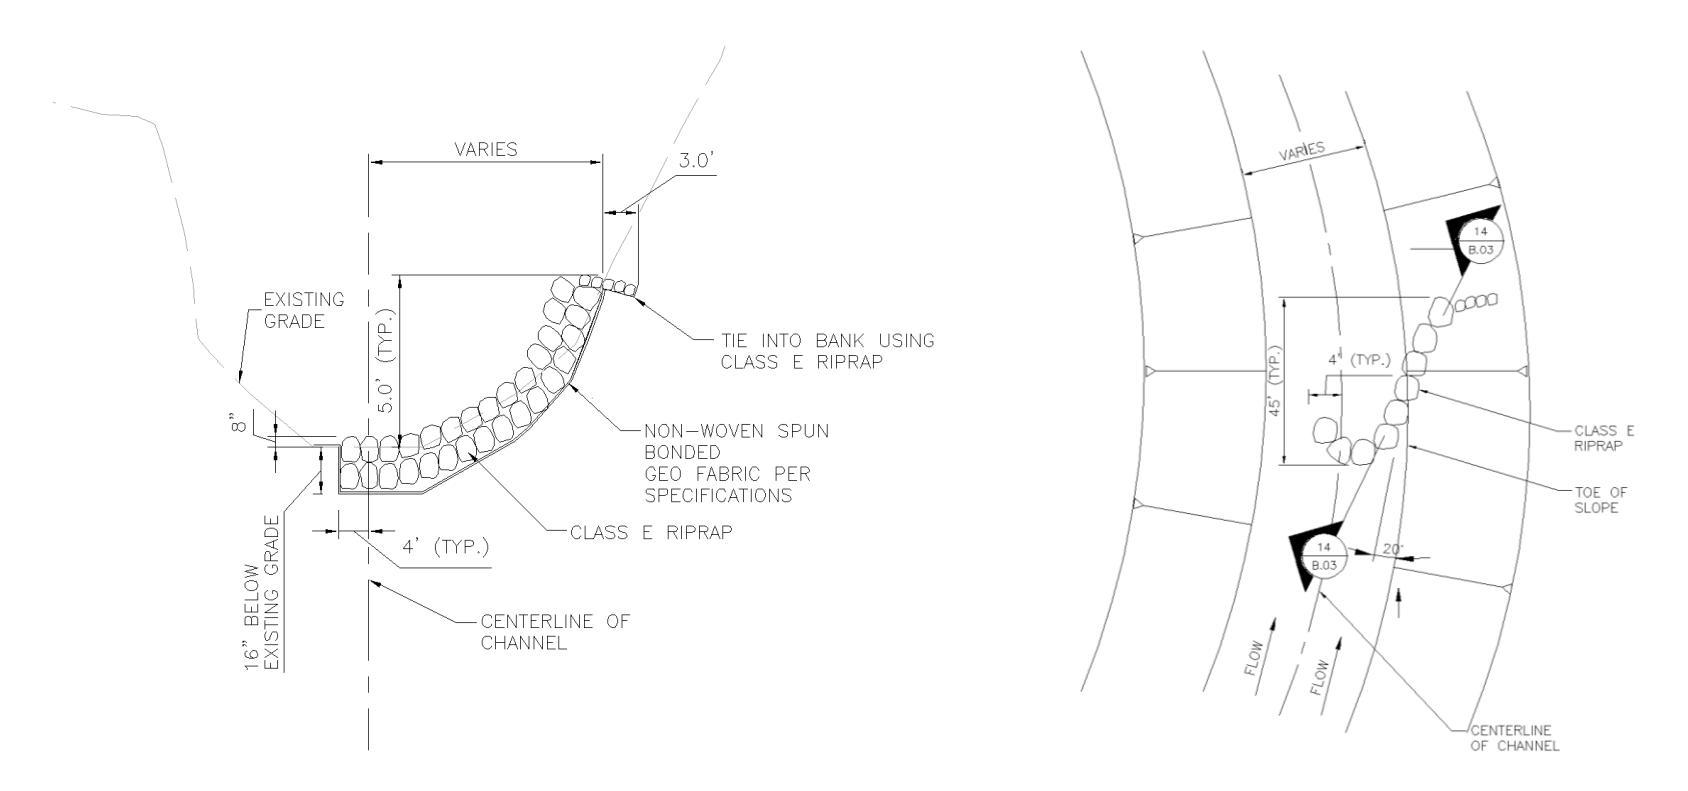
Divert Thalweg – J-Hook Bends

- Three prong approach
 - Divert thalweg away from outer banks
 - Hard armor where needed
 - Bioengineering: coir fabrics and native vegetation
- Leave banks alone where possible to prevent vegetation loss
- Grade banks to a stable slope: 3:1

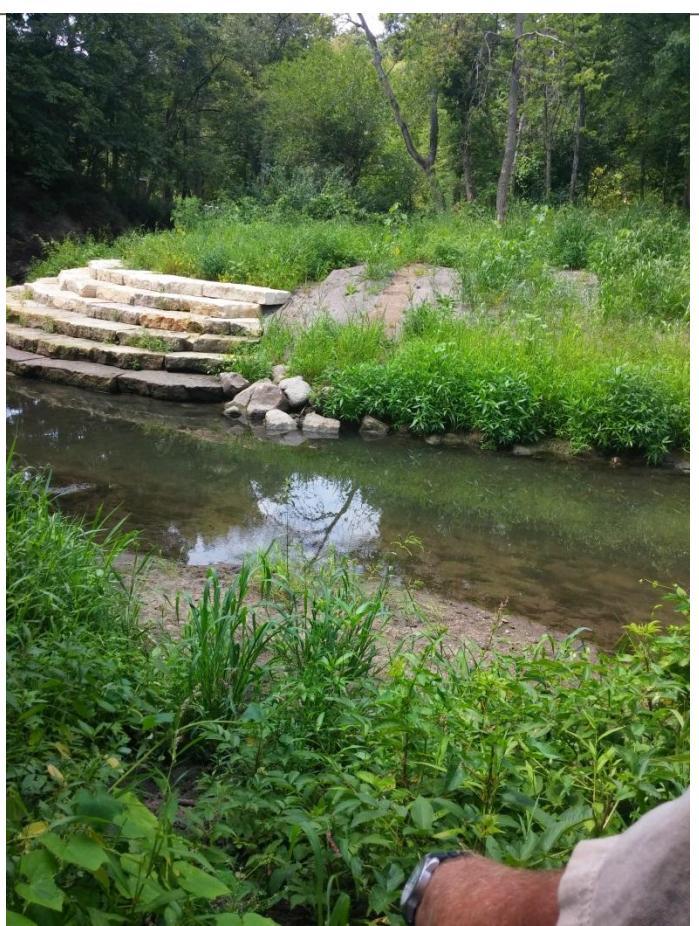
Hard Armor and Recreation

- Rough-hewn limestone steps to serve dual purpose:
 - Allow easy creek access at defined points to protect native vegetation
 - Protect banks with high shear stresses

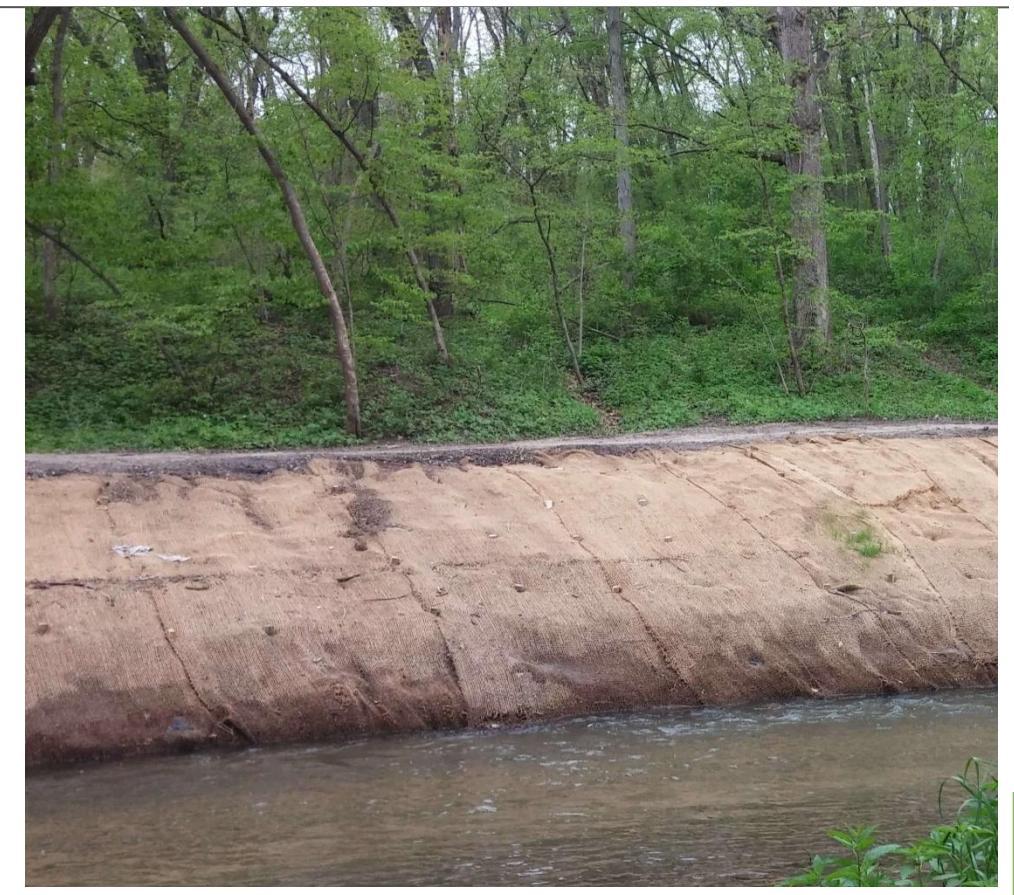
Bioengineering Approach

- Two layers of Coir Fabric:
 - Inner layer nonwoven burlap to hold soil and seed in place
 - Outer layer High strength woven mat with 0.5" x 0.5" openings
- Customized native seed mix selected by PCC

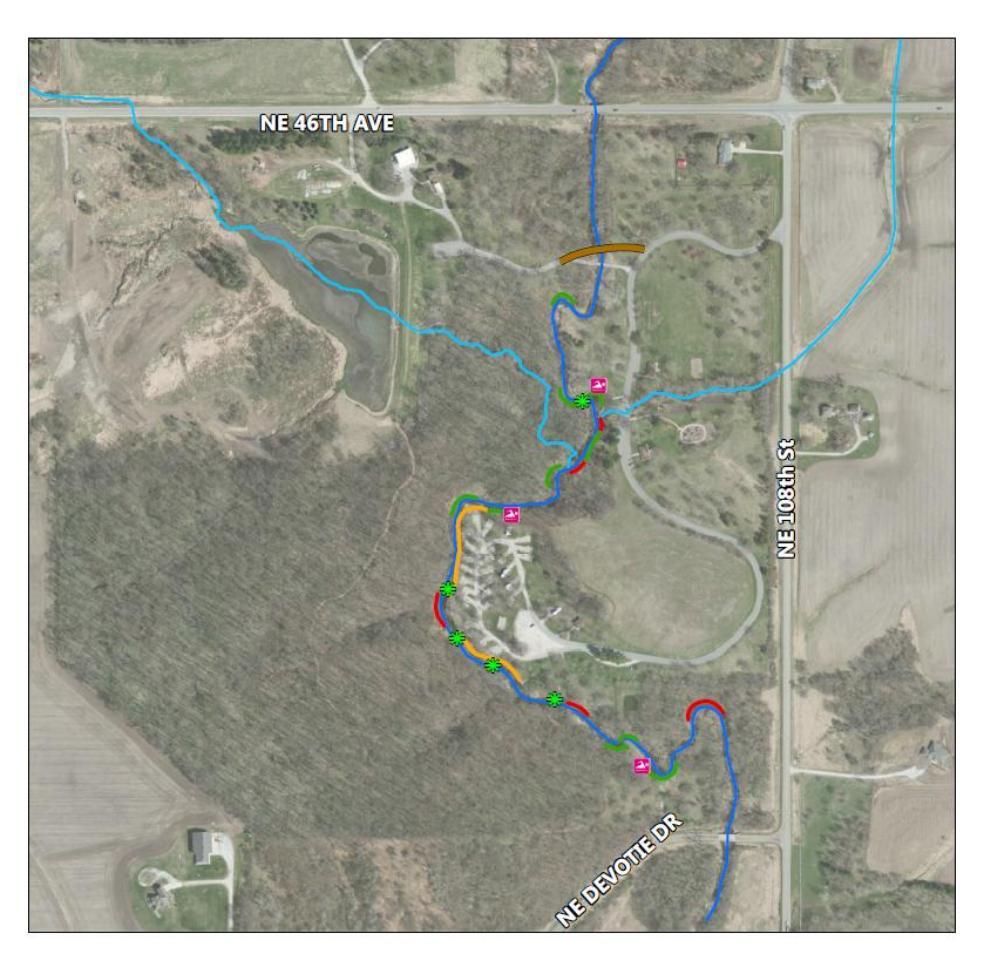
Conceptual Plan

-600 LF of toe protection -750 LF of limestone protected banks -1100 LF of additional bioengineered banks -3 stone-lined access points in addition to limestone campground area -Road crossing w/culvert
