# VILLAGE OF ORLAND PARK, COOK COUNTY, IL

## POND EVALUATIONS

**Jedd M. Anderson - PWS, CPESC, CWS**  
**Vice President – Environmental Resources Dept**

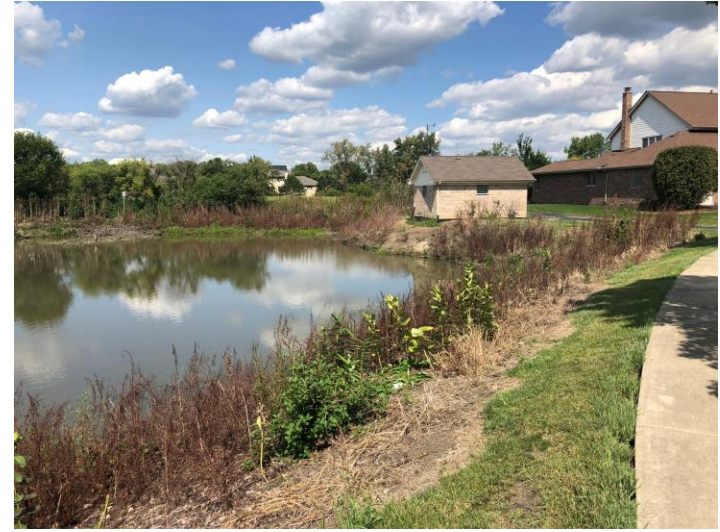
IMG\_7008

Management was completed but nothing installed to replace the weeds. Needs to be supplemental seeded.
